## A SERIES OF PRESS INCIDENTS AND THE RESULT OF THE ROOT CAUSE INVESTIGATION

Jaroslav Konarik (Austin Detonator s.r.o.), [jaroslav.konarik@austin.cz](mailto:jaroslav.konarik@austin.cz)  
Antonin Kovarik (Austin Detonator s.r.o.), [antonin.kovarik@austin.cz](mailto:antonin.kovarik@austin.cz)

Press Building 221, Vsetin, Czech Republic

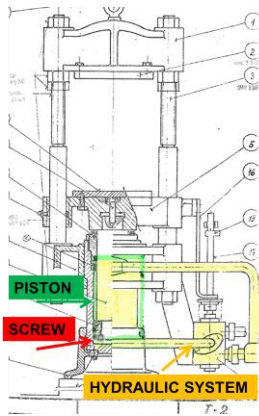
Figure 4:  
Diagram of press

After much hard work we observed that after the third explosion half of a screw blocked the valve in the hydraulic unit. This piece of broken screw must have worked loose over 40 year's operation. The blocked valve changed the pressure drag and raised speed of the press equipment. Then the piece of loose screw disappeared again into the hydraulic system after equipment returned to the base position. The screw was now in the hydraulic system and it was only a matter of time until it found its way back into the valve and cause another blockage - and possible explosion.

Three months after the first explosion we dismantled the "old design" valve and we found the other piece of the screw inside.

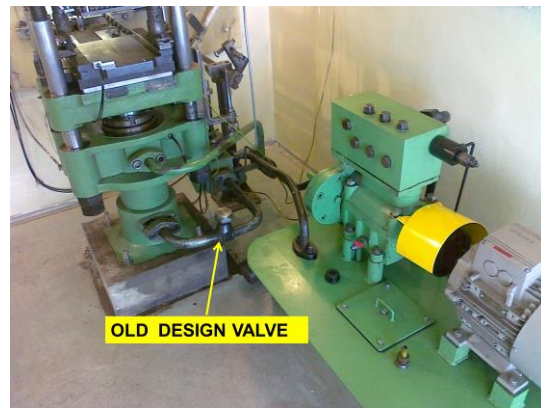
Figure 5:  
Layout of press

A lot questions but no clear answers. The investigation team checked 27 possible causes (sensitivity of explosives, metal parts, design, human factor ...) but all causes were ruled out. We also checked the press equipment several times without success. After the first explosion we replaced the "old design" valve of the hydraulic unit with a "new design" valve to save press time during reverse running.
