# ACCIDENT

13-03-2013

NITROERG S.A.

at production plant in Bieruń

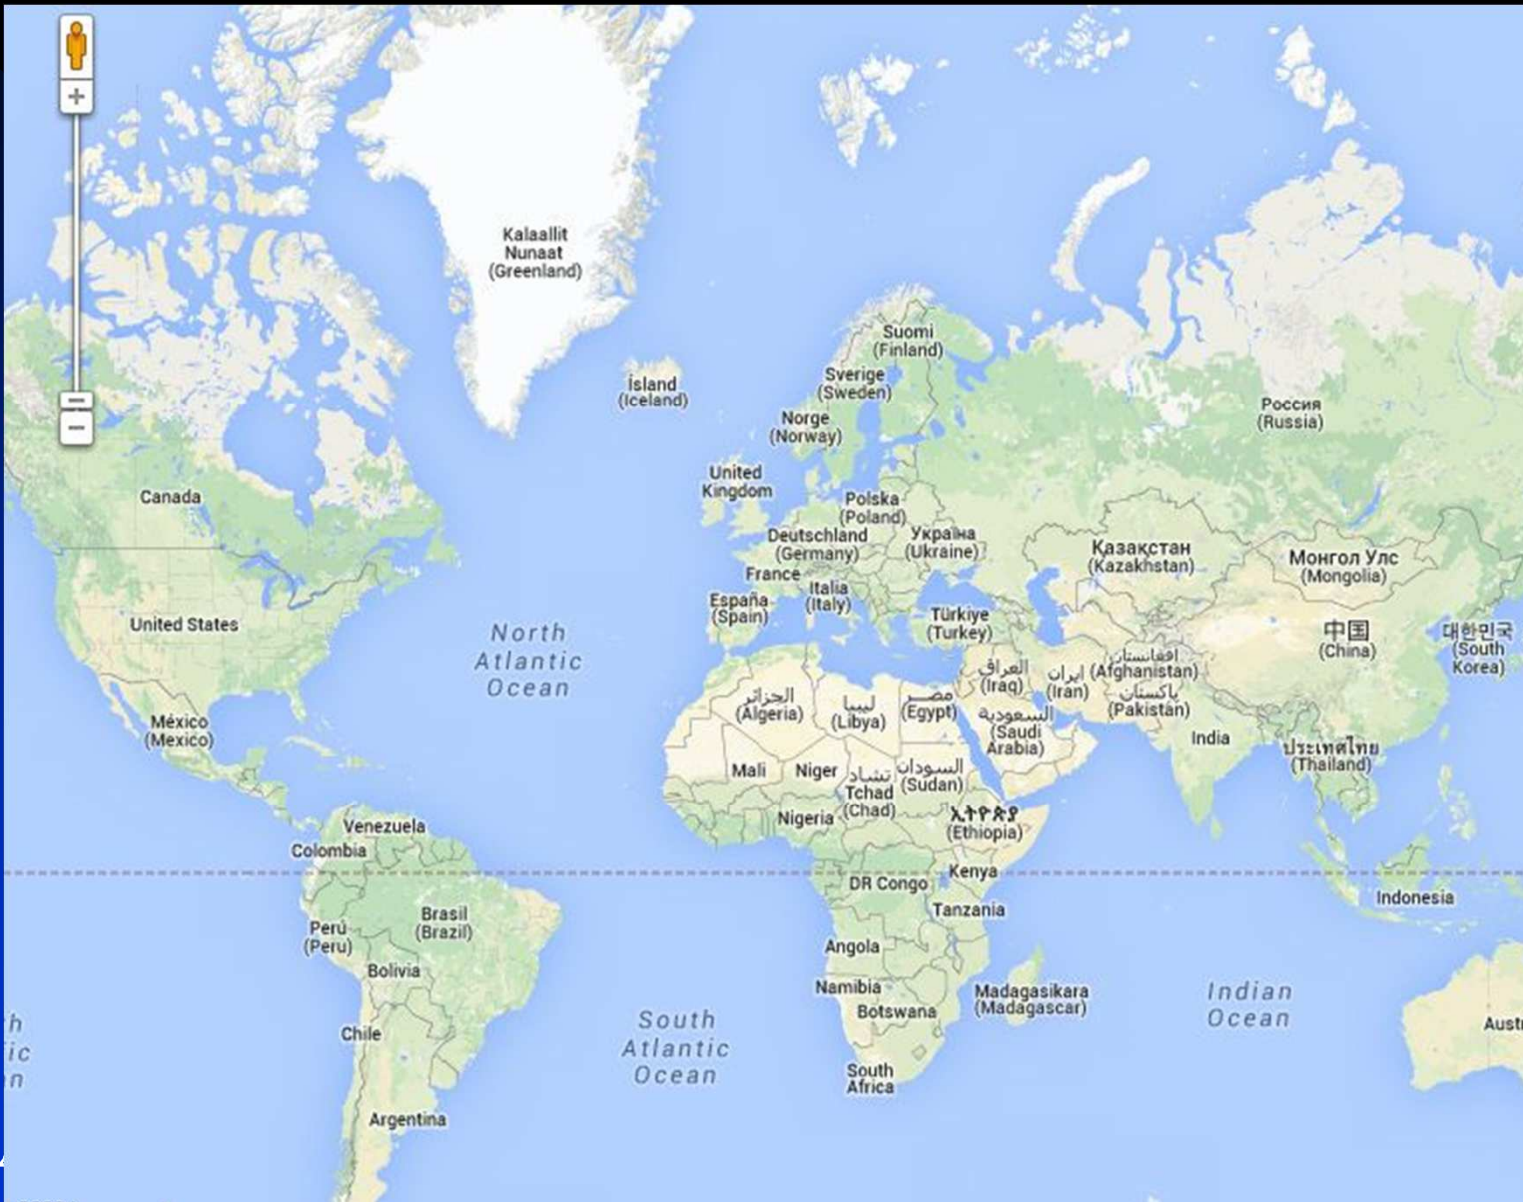
# LOCATION

**13.03.2013. at 07:05:28 am an explosion occurred  
An accident took place inside the transitional  
magazine of nitroesters.**
