RDX EXPLOSIVE ACCIDENT INVESTIGATION  
REPORT

# Background to the incident

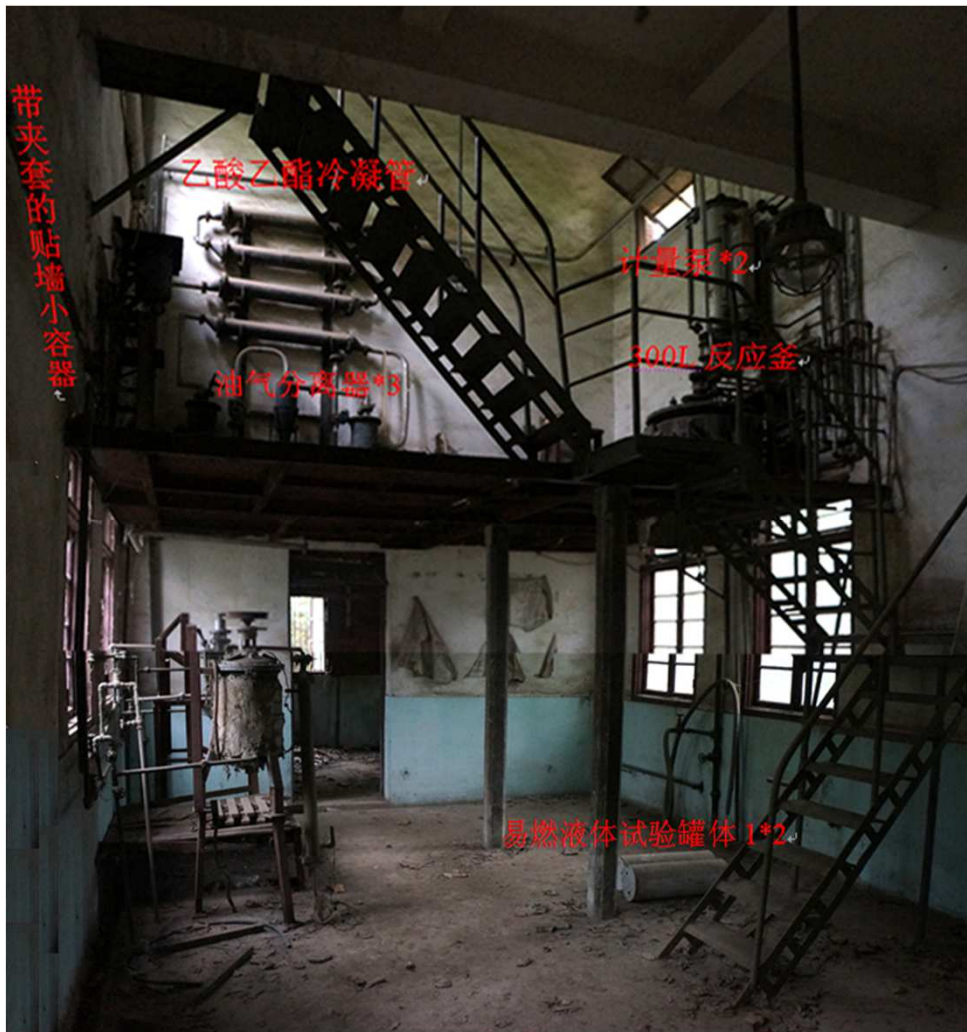
The internal structure of the accident room

- This room in Workshop 819 was a steel structure with three floors.
- On the Northeast side of the first floor there were two kilogram stage reactors .
- At the South wall of the second floor there was a 300 liter reactor (also known as granulator). This was connected with two high level measuring tanks.
- At the North side of the East wall of the second floor there were four shell and tube condensers, below the condensers two gas-liquid separators and a cyclone separator were positioned.
- Floor three contained a 300 liter reactor with one 20 liter reactor and one 100 liter reactor just above the 300 liter reactor.

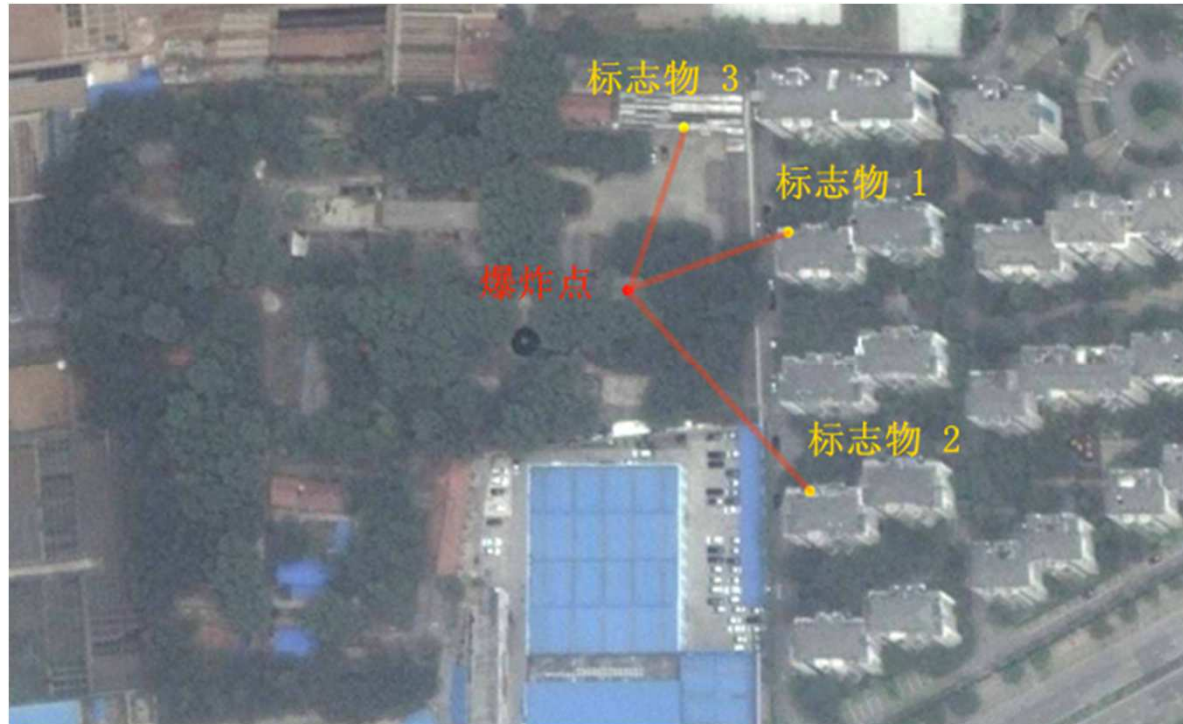
- After the explosion, two damaged windows were selected (marker 1, marker 2) from the surrounding residential area as well as a wooden door and window (marker 3) of the workshop 827 as the markers for estimating the TNT equivalent. The results are shown in Table 1. According to Table 1, we can determine the TNT equivalency of the explosion at about 3.8kg ~ 8.2kg.
