**Sierra Chemical Company**  
**Mustang, Nevada**

Investigation Report into an incident on 7<sup>th</sup> January 1998 on the cast booster plant by  
The US Chemical Safety and Hazard Investigation Board (CSB)

Report No. 98-001-1-NV

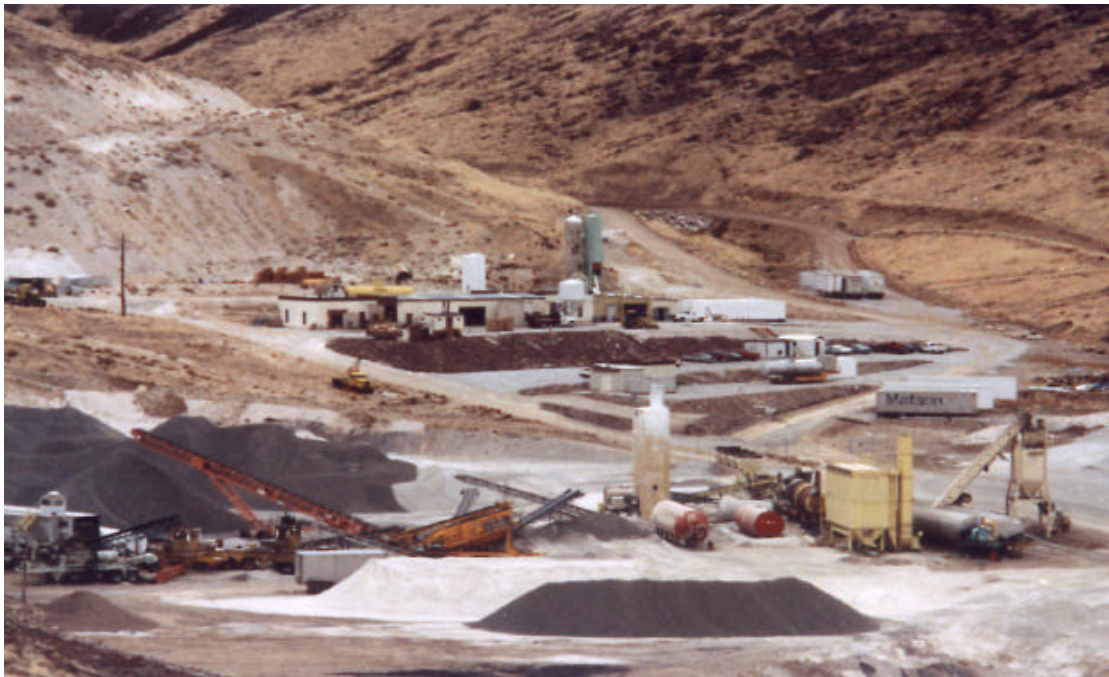
Figure 1

The plant's facilities were built on a series of terraces as shown in Figure 1. The highest terrace was a storage yard for equipment and materials. The next terrace contained storage tanks for process water and soda ash. Booster production, flux mixing, and soda ash repackaging operations were located in the production building on the third terrace down, approximately ten feet below the previous terrace. A chemistry lab, an employee break room, and a parking area were located on the fourth terrace, which was 18 feet lower than the previous terrace. The PETN building and magazine were located on the fifth terrace, approximately five feet below the previous one, or about 23 feet below Booster Room 2.

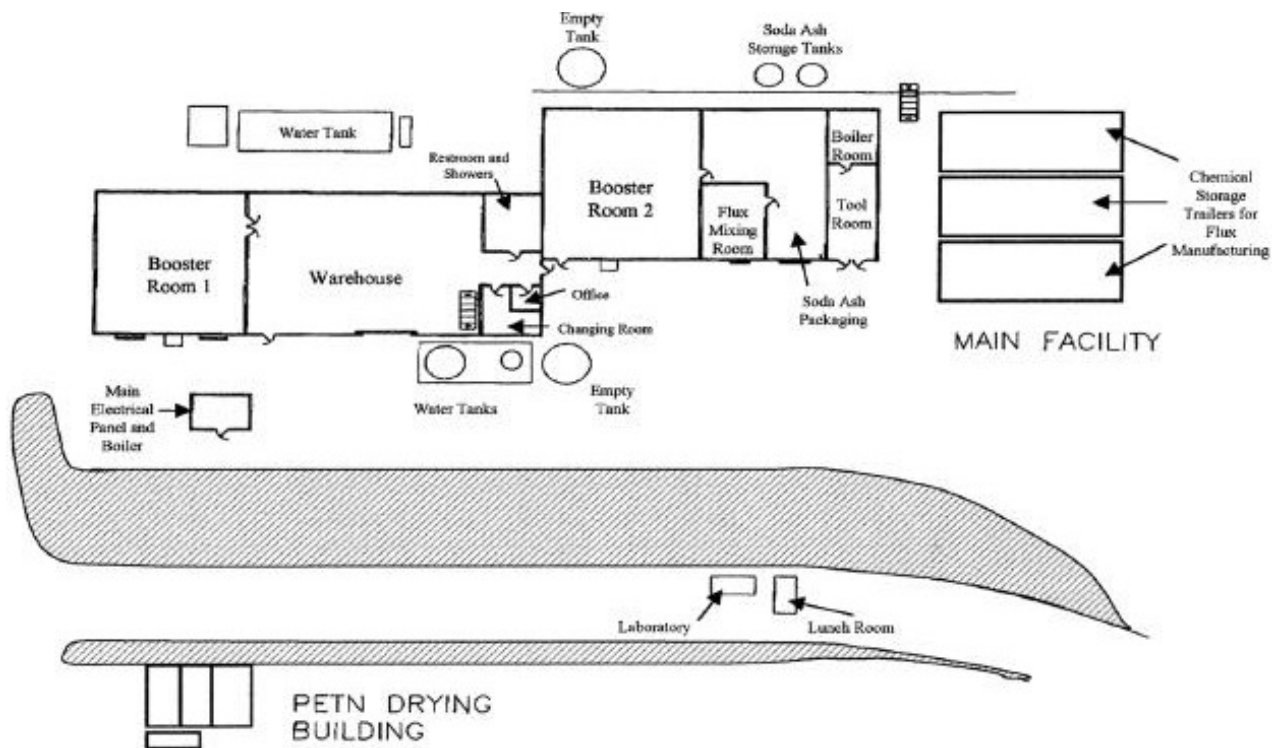
**Figure 2**

The production buildings housing the booster manufacturing, flux, and soda ash operations were constructed over several years as add-ons to an expanding operation. The explosives manufacturing buildings were constructed of fully grouted, reinforced, 8-inch concrete block. They had asphalt and tar roofs supported by wooden trusses. A pre-fabricated metal building warehoused paper products and finished flux. Figure 2 shows the various buildings and rooms used in the melt/pour, flux, and soda ash operations. Booster Room 2 was built before 1974 and was refurbished for the melt/pour operation in 1996. For convenience, north is shown to be at the top of Figure 2, perpendicular to the back wall of the production buildings. True north is 44 degrees clockwise.

PETN is shipped wet to reduce its sensitivity. The PETN building, where the water was removed from the PETN, was constructed of fully grouted, reinforced, 8-inch concrete block. The reinforced-concrete roof had a skylight over the drying room. The building consisted of three rooms (see Figure 2). One room was a weather room to permit the offloading of material during inclement weather. The second room, called the drip room, was where wet PETN was transferred to canvas bags and spun in a centrifuge to remove water. The last room, called the drying room, was where workers placed de-watered bags of PETN on racks to dry. Adjacent to the PETN building, and connected to it via heating ductwork, was the PETN magazine. The magazine was a skid-mounted steel structure also used for storing the PETN while it was drying. The PETN building and magazine were normally locked.

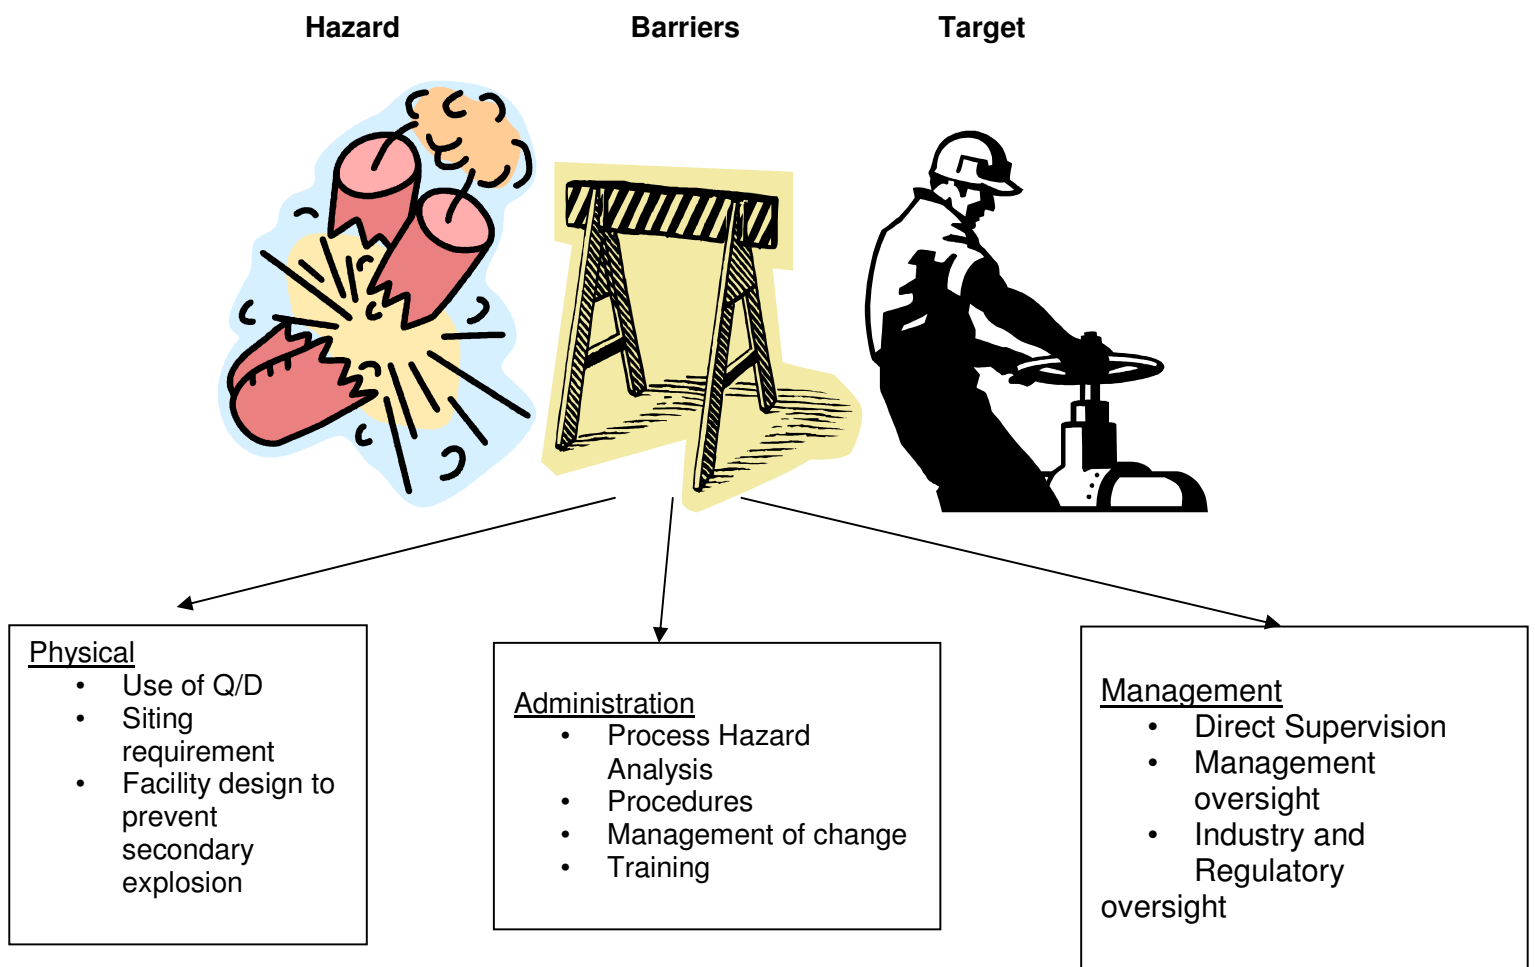
Barrier analysis is used to identify administrative, management, and physical barriers that could prevent, control, or reduce energy flows such as explosions to targets such as people or objects. This barrier analysis was concerned with those barriers that could have prevented or mitigated the impact of explosions but that either failed or were missing.
