# **Explosion in an HMX plant**

**- SAFEX Closed Day Incident Session -**

**Martin Held**

**XVII SAFEX Congress  
Istanbul, May 25th – 28th**

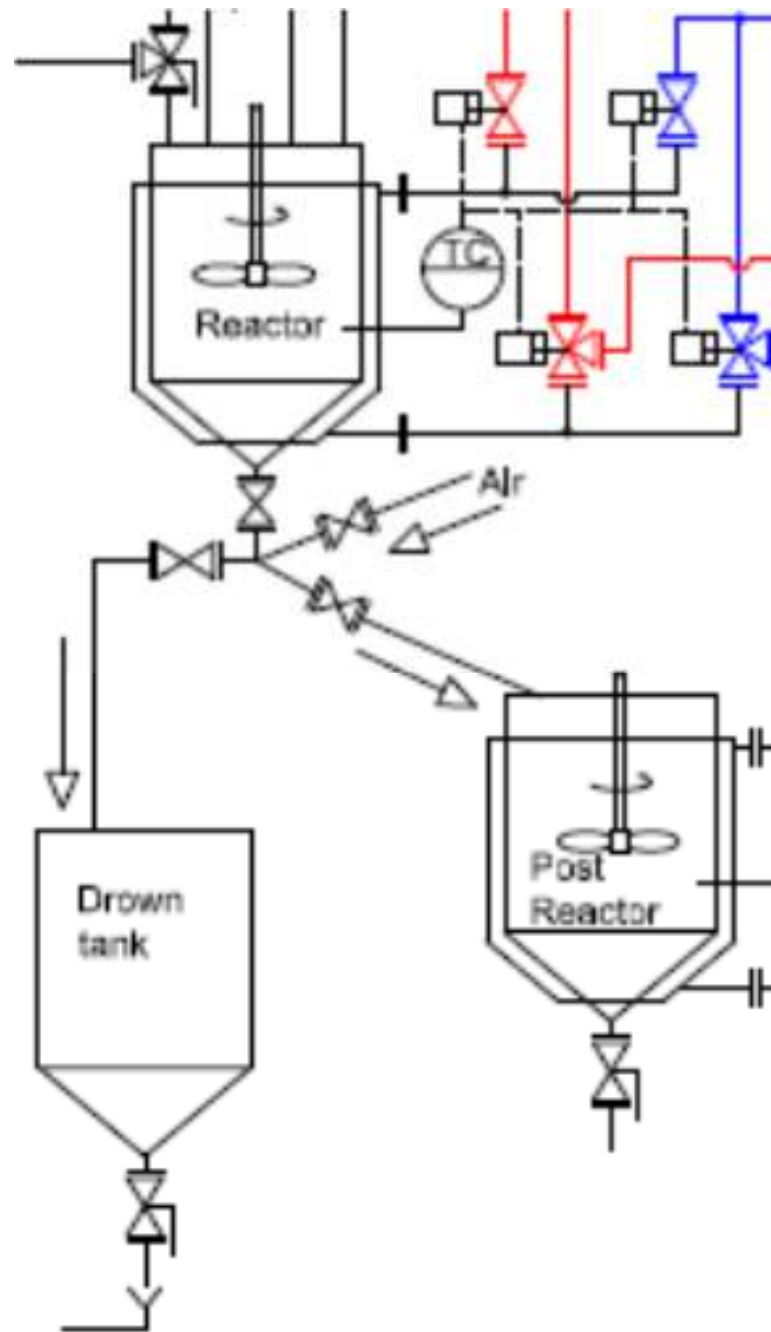
- Batch process – complex chemical reactions involving hexamine, acetic acid, acetic anhydride, nitric acid and ammonium nitrate.
- Reaction vessel is a water jacketed vertically mounted reactor with a vertical stirrer. Reaction T around 44 °C.
- Upon completion the reactor is discharged by gravity through a series of hand operated valves to another vessel.
- Lines are purged by compressed air after each discharge.
- Several batches already produced that day.
- Nothing unusual observed.
- Appears that explosion coincided with the valve on a compressed air line being opened manually.

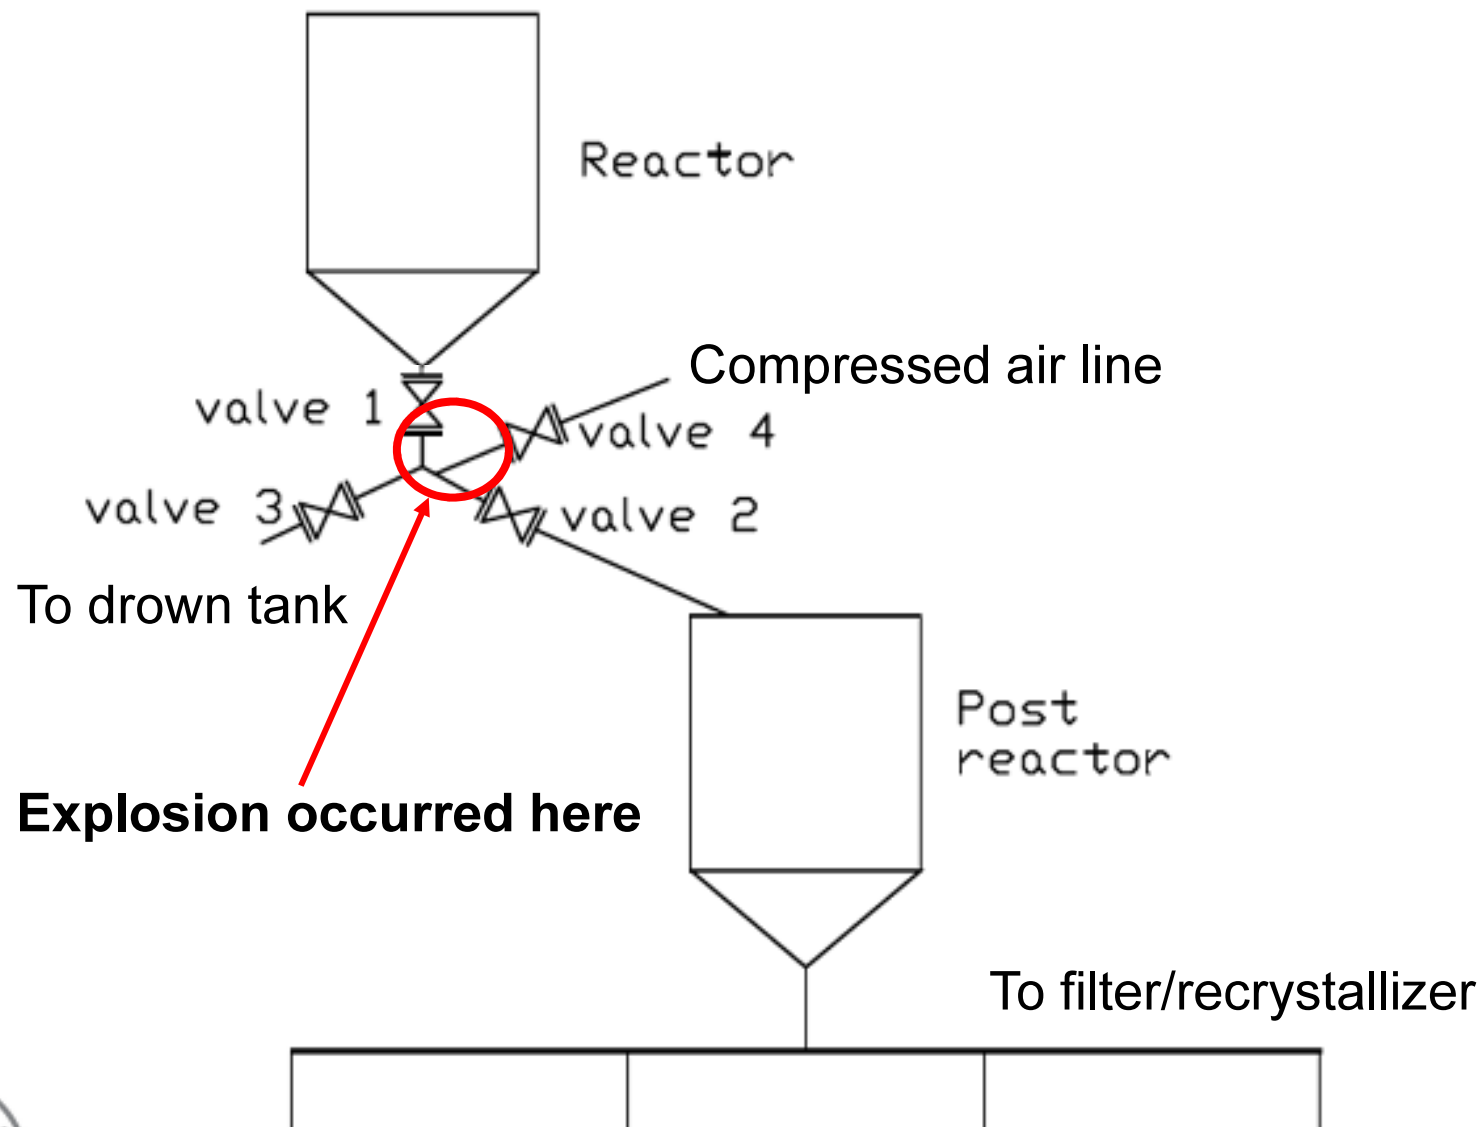
Valve N° 1:  
The sphere  
was damaged

Pieces of pipe

Valve N° 3:  
Dilutor tank  
Minor damage

Pieces of Valve  
N° 1

Valve N° 4: Air  
Minor damage

Sphere from  
Valve N° 2  
Minor damage

Valve N° 2:  
Post reactor  
Minor damage

Pieces of valves and pipe

- Process flow was studied in detail. Hazard and HAZOP studies. Other items identified that did not contribute to this incident.
- Reactor outlet enlarged and metal piping replaced with reinforced plastic hose.
- Compressed airline removed.
- Total number of valves reduced (from 4 to 1).
- Ball valves replaced with diaphragm valves.
- Improvement of maintenance plan.
- Periodic Hazard Studies in other plants on that site.

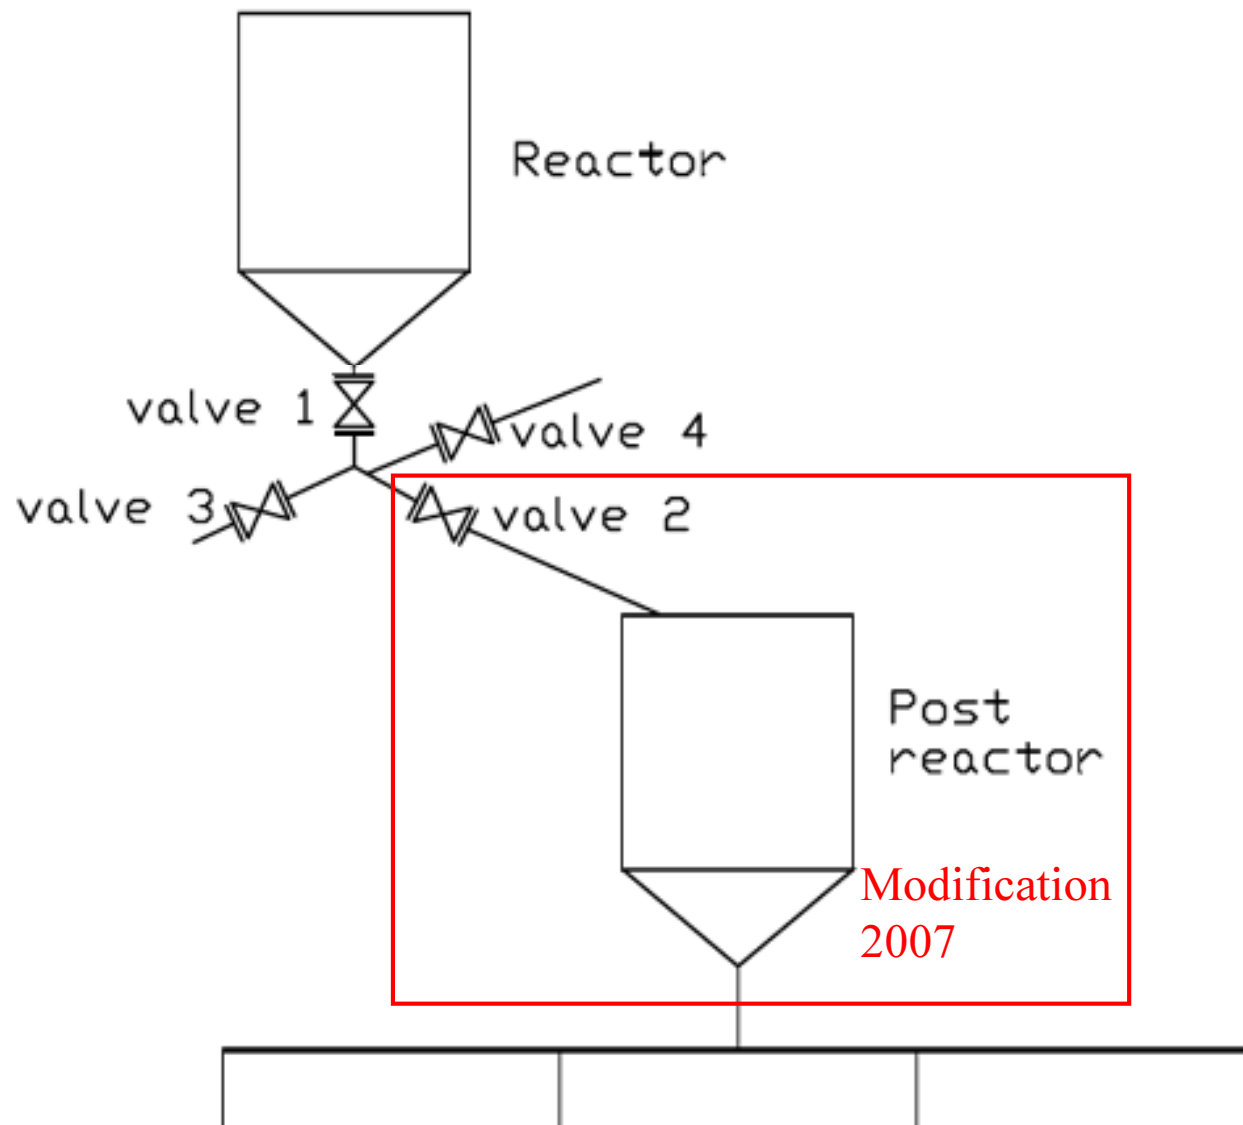
- Started in 1990 and the basic reaction process was the same as today.
- 4 reactants added to the nitrator.
- Reaction is slow – requires 1 hour mixing after addition of reactants.
- Initial design required discharge of nitrator every 2 hours.
- In 2007 process modified by installation of “post reactor” to allow discharge every hour – doubled plant output.

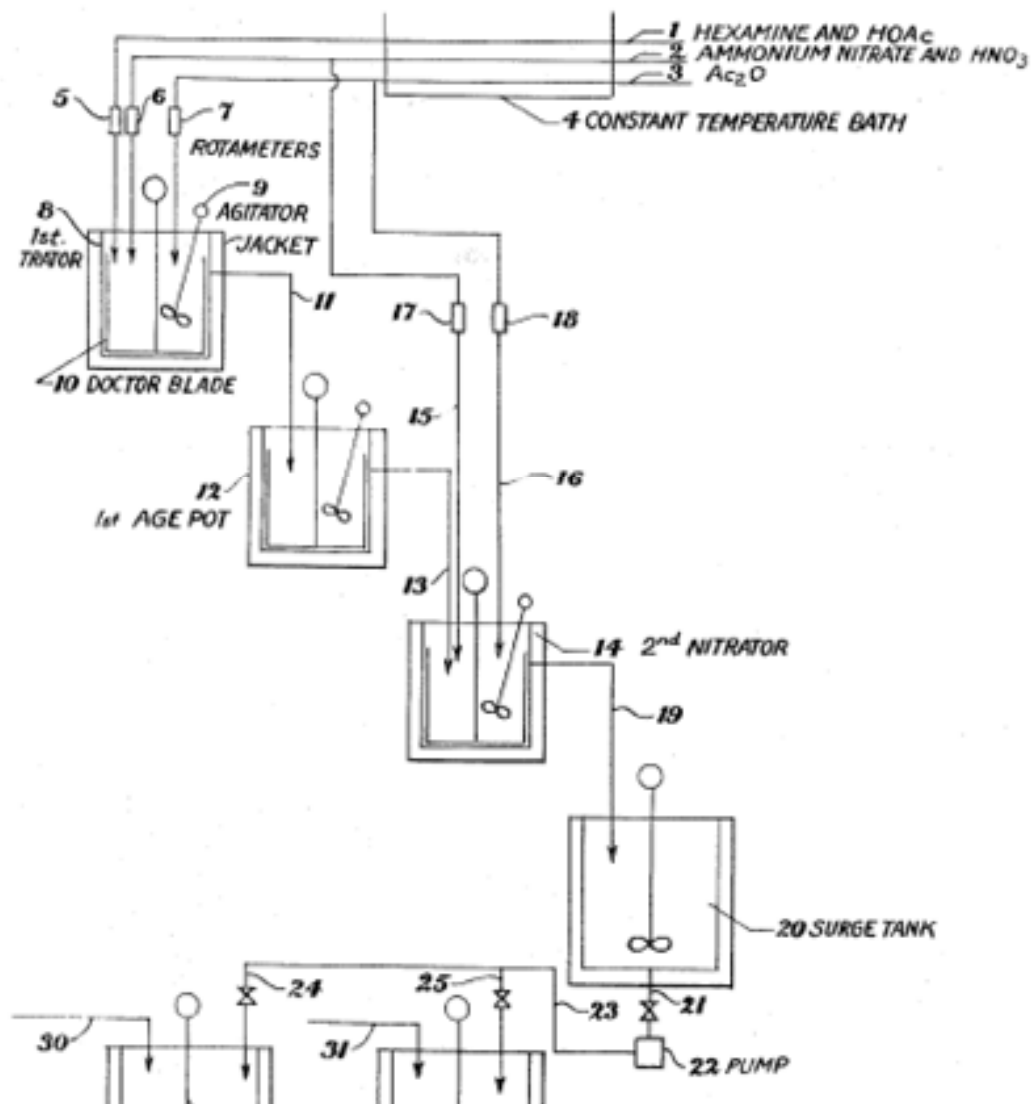
DIRECT PRODUCTION OF BETA-HMX

- The patent (that was referred to) drawing deviates from the plant installation showing gravity overflows from one reaction tank to the other; there were neither piping nor (ball) valves that might cause confinement and friction or impact. **Hazard study**
- Based on the experience with the 17 years running failure-free single reactor system there was confidence that process control was safe.
- Risk of more sensitive intermediates in mixture transferred from the main to the post reactor and accumulation of these in piping and valves or compressed air causing friction or impact (in accelerating small solid particles (corrosion)) not considered. **Hazard study**
- The system for **maintenance and inspection** in place was not tailored to the existing hazards.
