# U.S. CHEMICAL SAFETY AND HAZARD INVESTIGATION BOARD

# Incident in Sierra Chem. Co. 1998

4 fatalities and 6 injuries in  
booster plant explosions

Report No. 98-001-1-NV

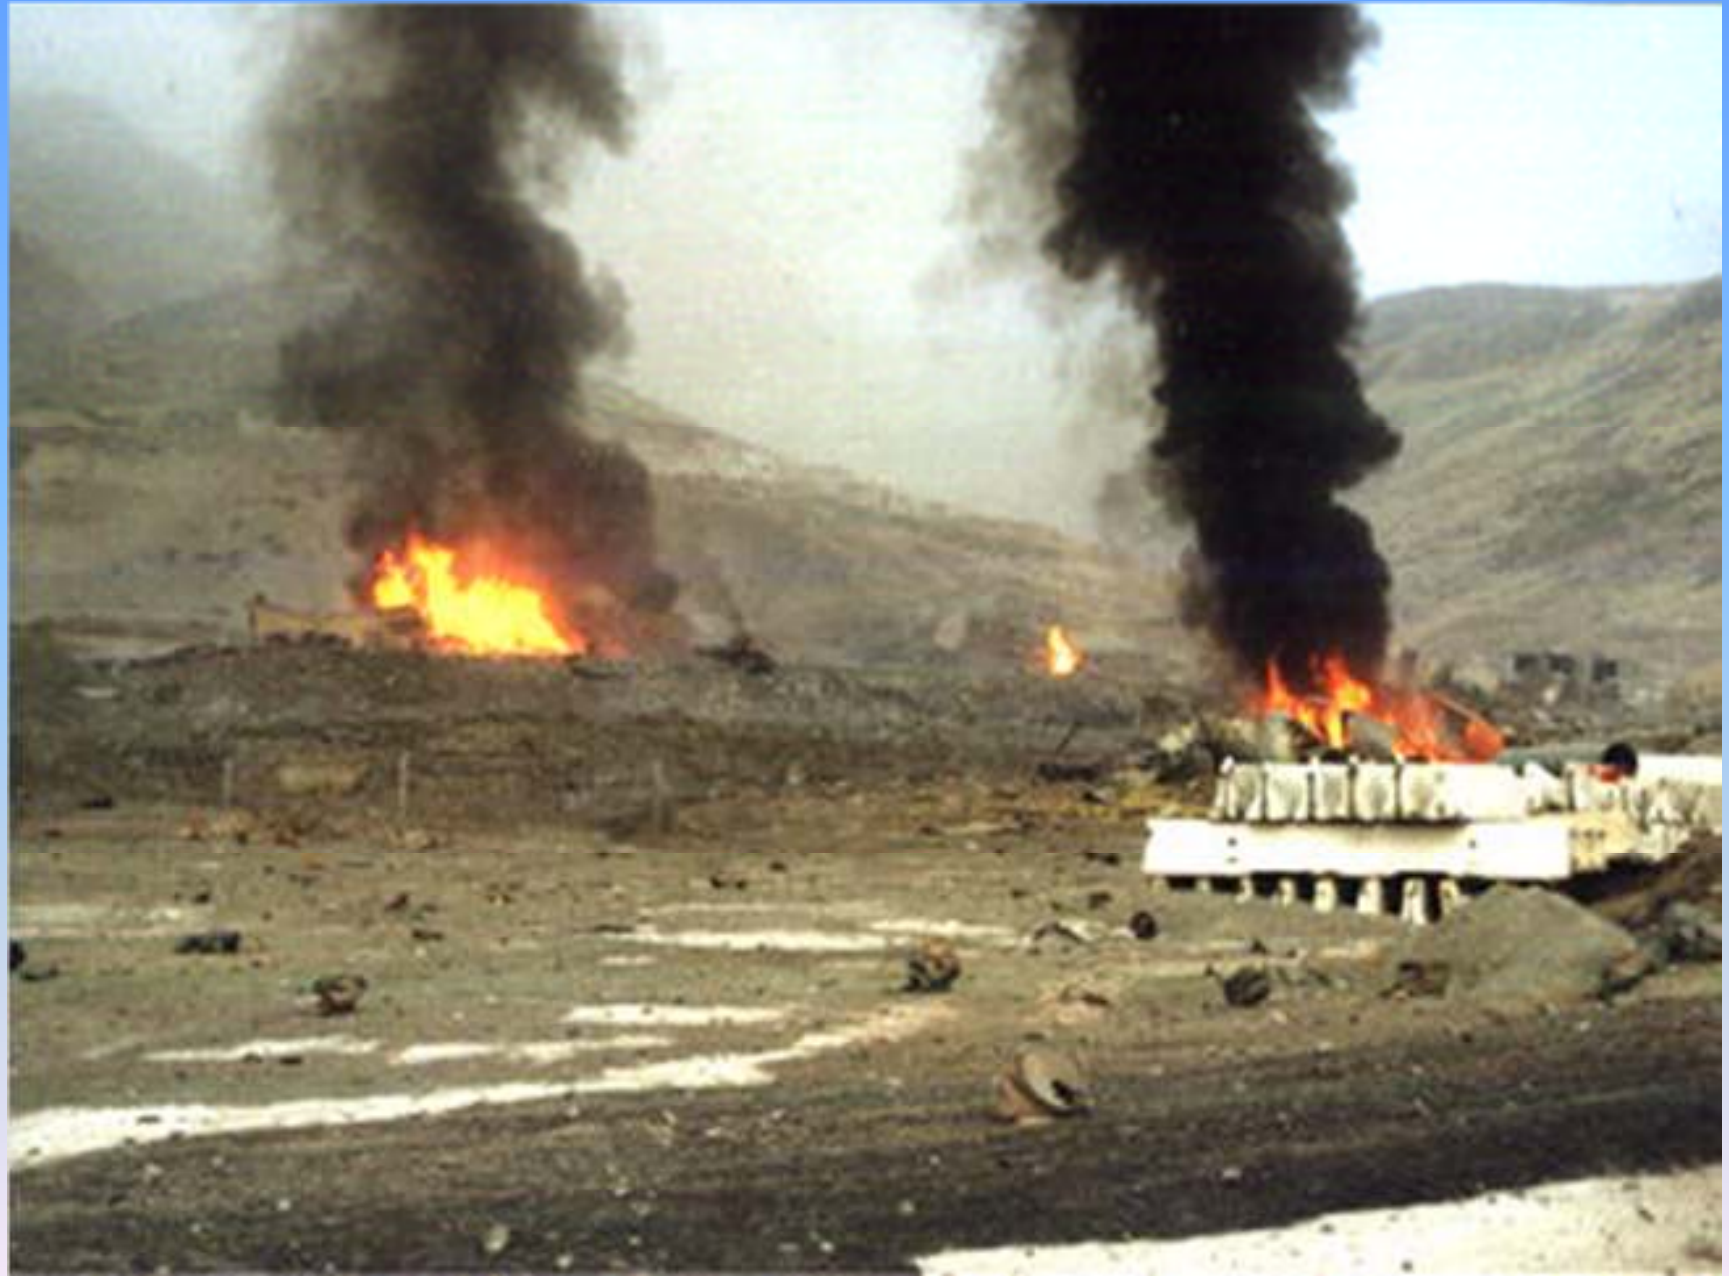
# Explosions

- 6 am - plant start up in room 1
- 8am - 4 personnel in or near room 2 for start-up
- First explosion
- Seconds later explosion in PETN building
- 5 personnel trapped in room 1 but survived
- Crater 40x60x6ft where PETN building had been
