# Lorena Packaged Emulsion Plant Explosion, 11 November 2004

# Prefatory note

The Packaged Emulsions Plant located at Lorena, Brazil was completely destroyed by the explosion that occurred on November 11, 2004. As a result of this, very little direct physical evidence of the causes of the explosion survived.

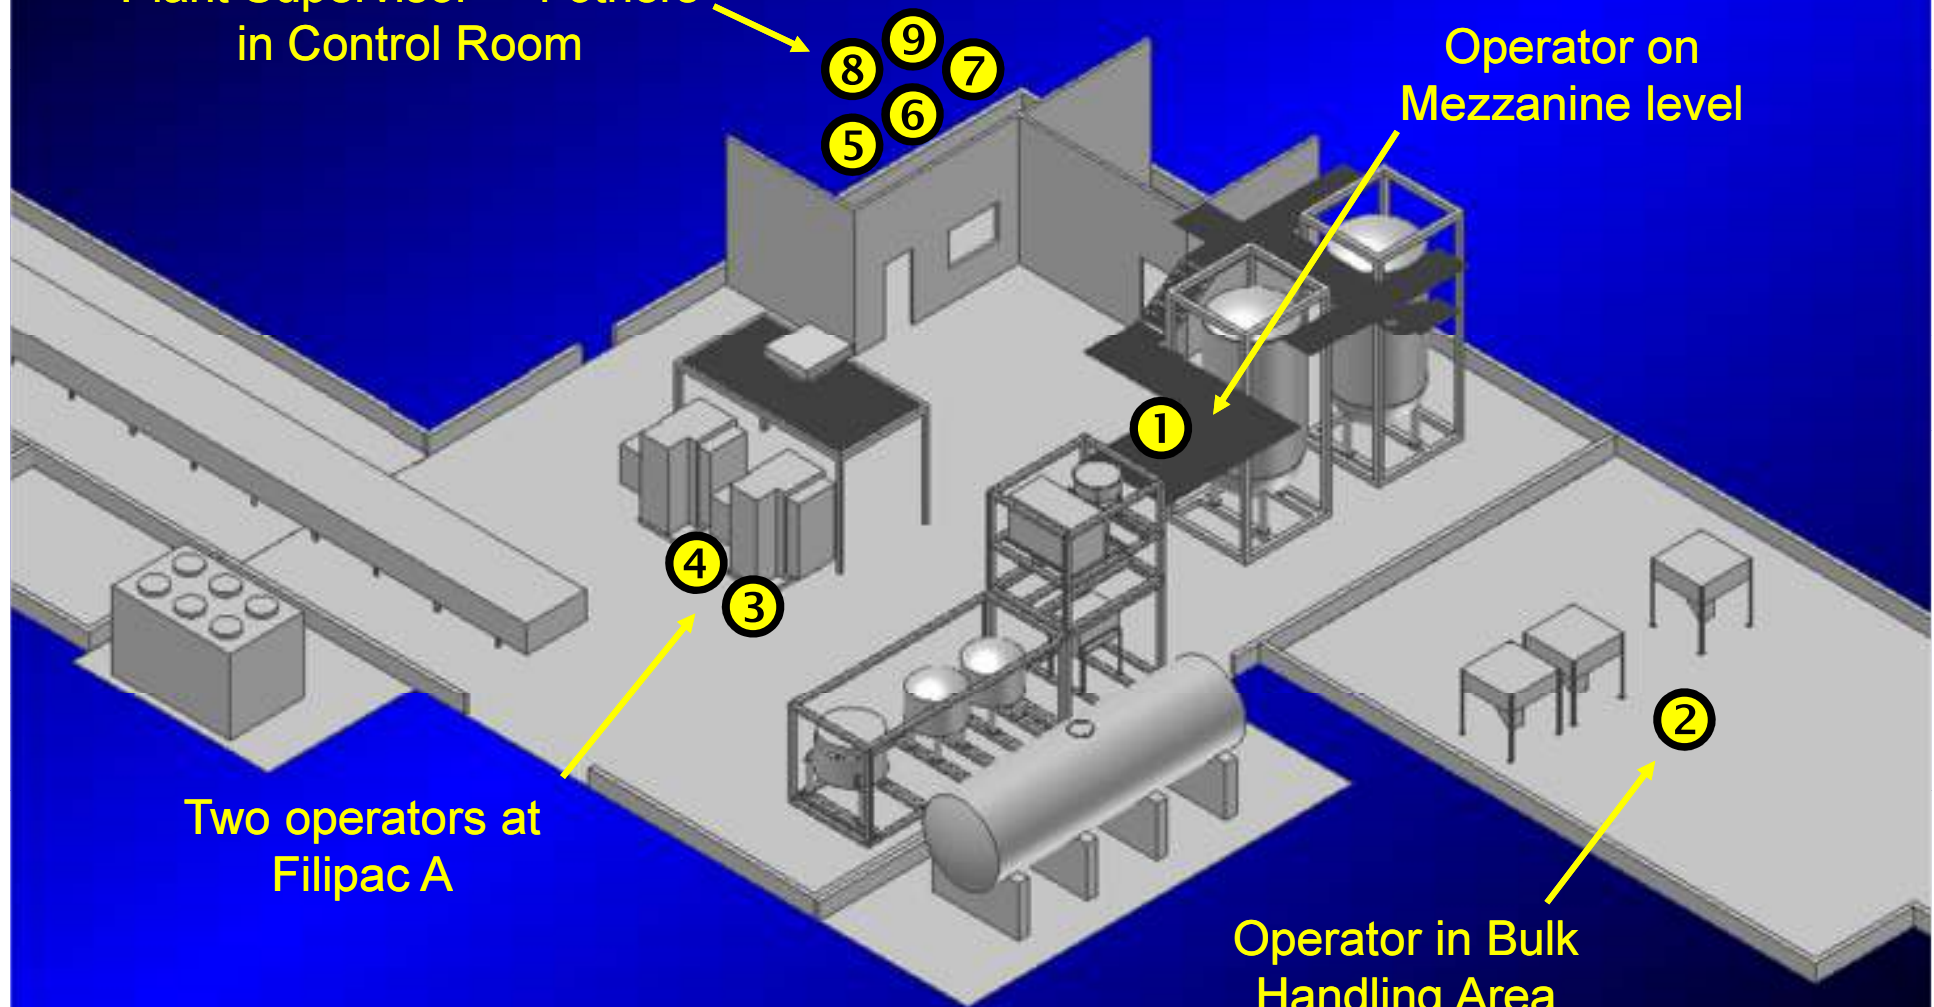
Plant Supervisor + 4 others  
in Control Room

Operator on  
Mezzanine level

Two operators at  
Filipac A

Operator in Bulk  
Handling Area

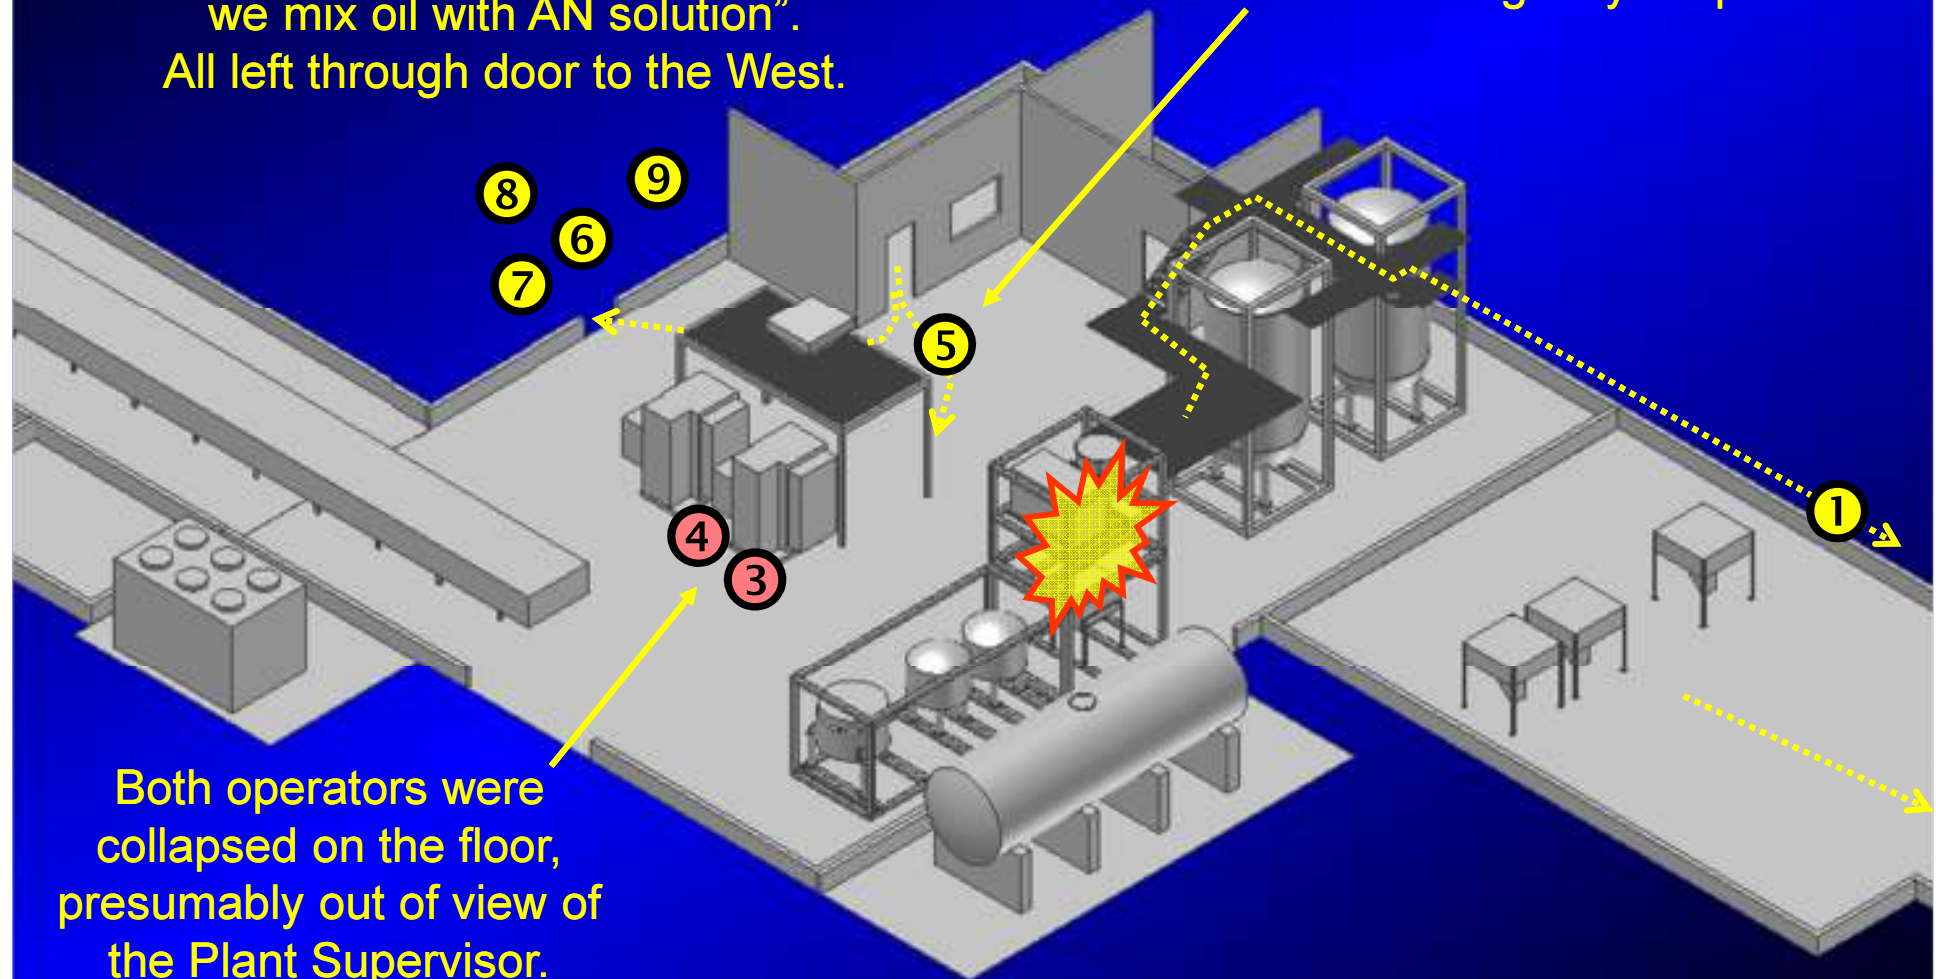
Someone from the Control Room saw  
“strong yellow fire at the blender where  
we mix oil with AN solution”.  
All left through door to the West.

The Plant Supervisor went  
to activate the  
Plant Emergency Stop.

Both operators were  
collapsed on the floor,  
presumably out of view of  
the Plant Supervisor.

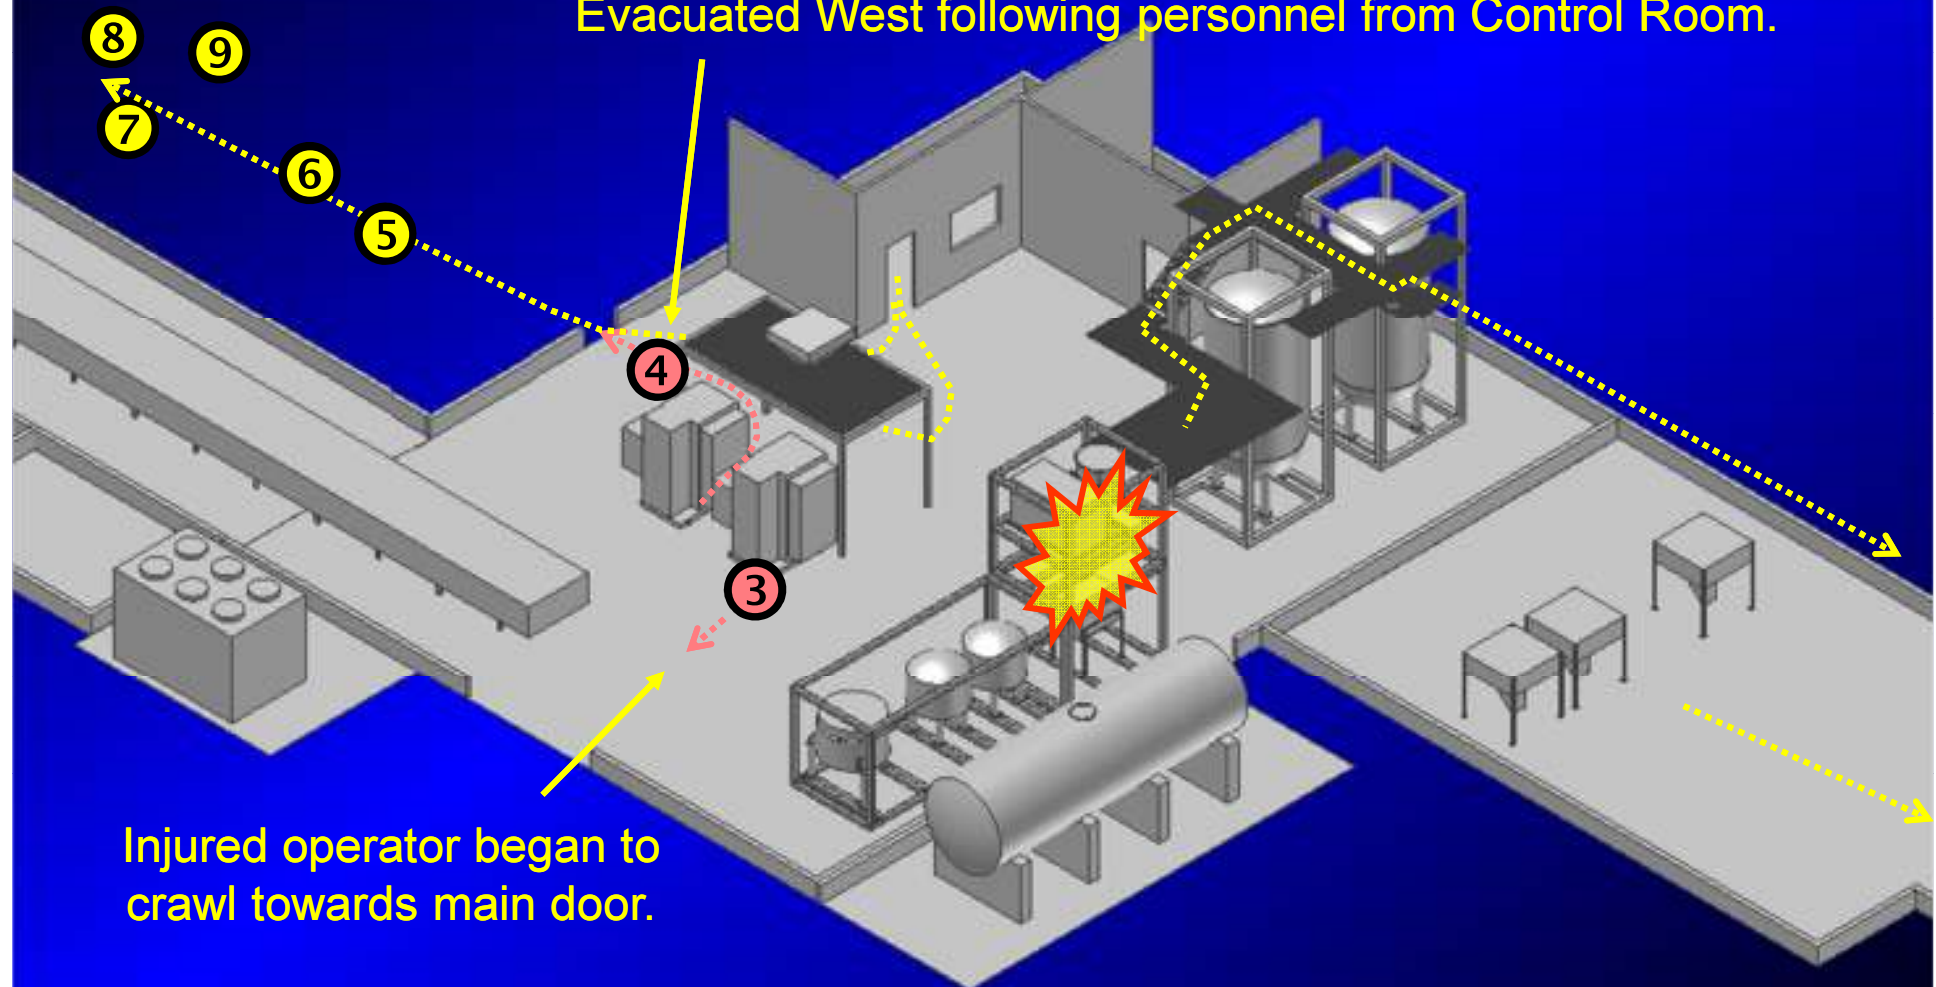
Injured operator recovered, and saw “big fire” around Emulsification module.

Evacuated West following personnel from Control Room.

Injured operator began to crawl towards main door.

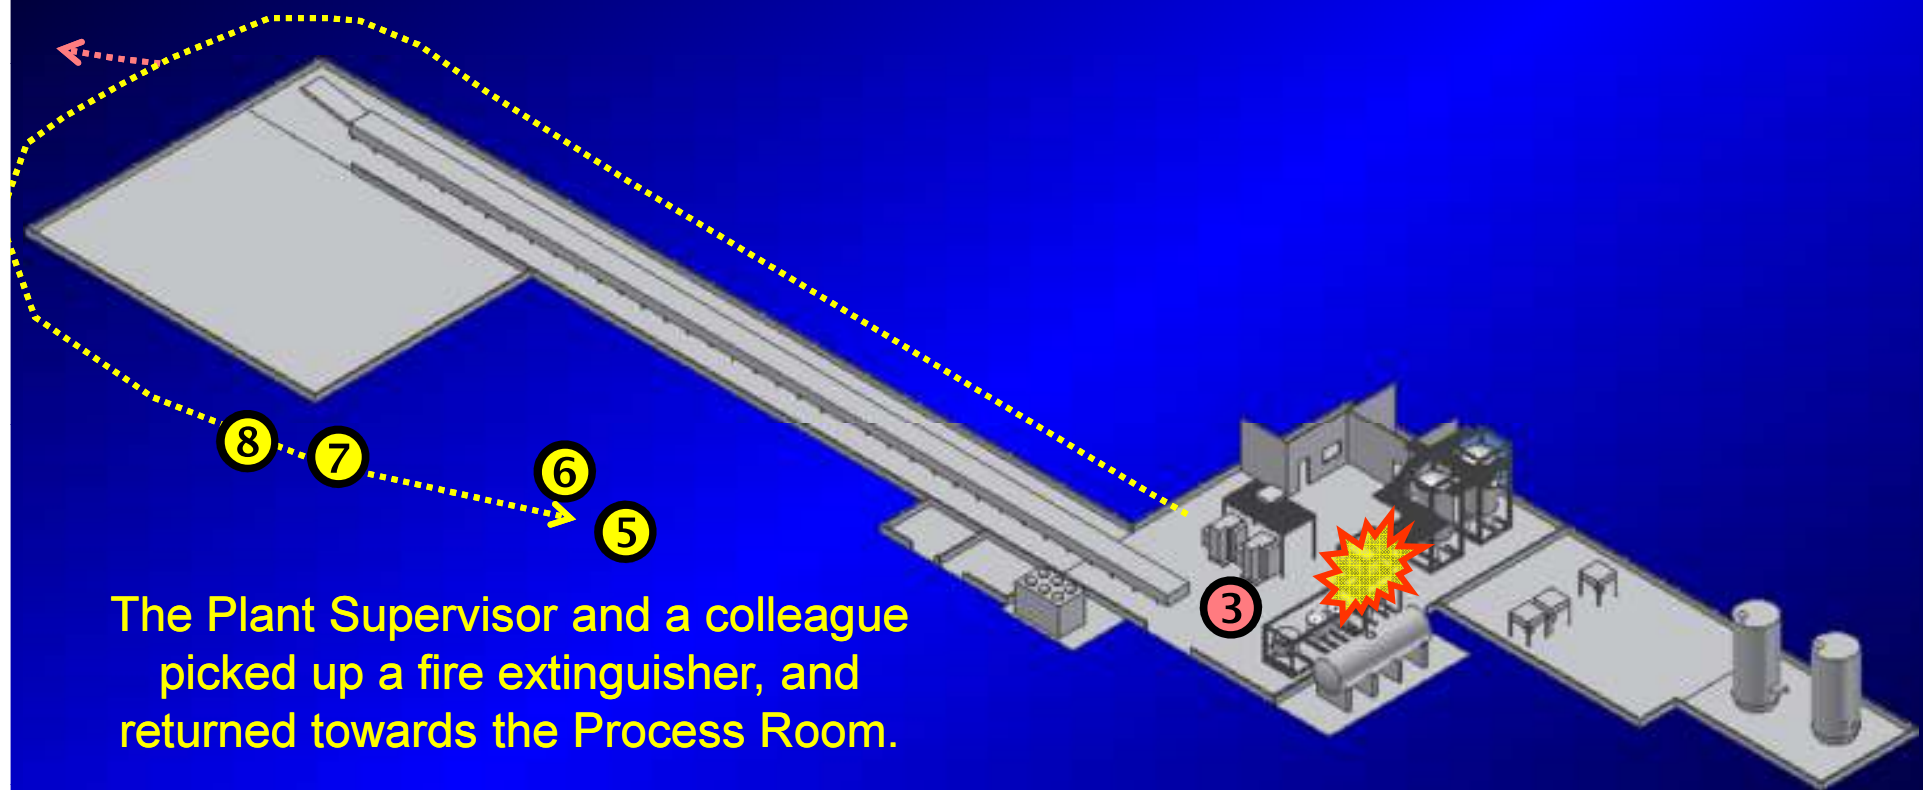
The Plant Supervisor and a colleague picked up a fire extinguisher, and returned towards the Process Room.

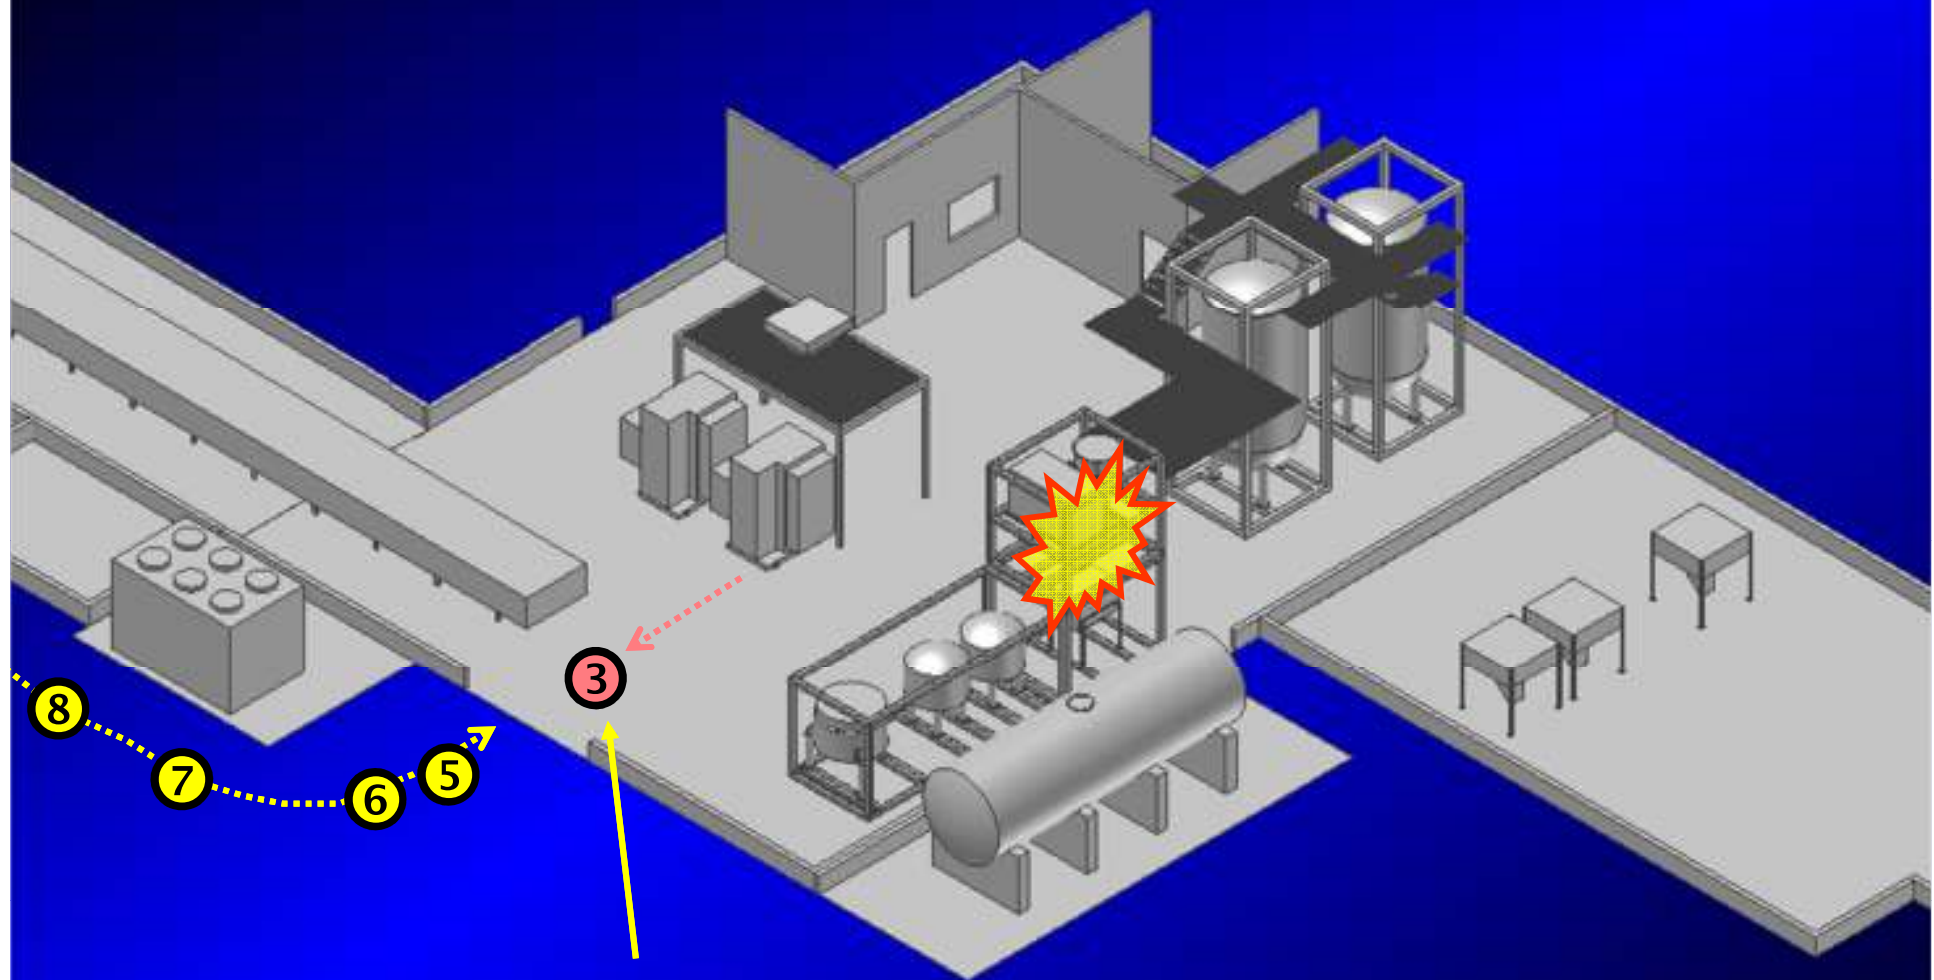
The injured operator had almost crawled to the main door.  
He saw the Plant Supervisor and a colleague approaching.

The prostrate operator was struck by several small fragments of shrapnel, and was thrown about 50 metres to the South. He survived.

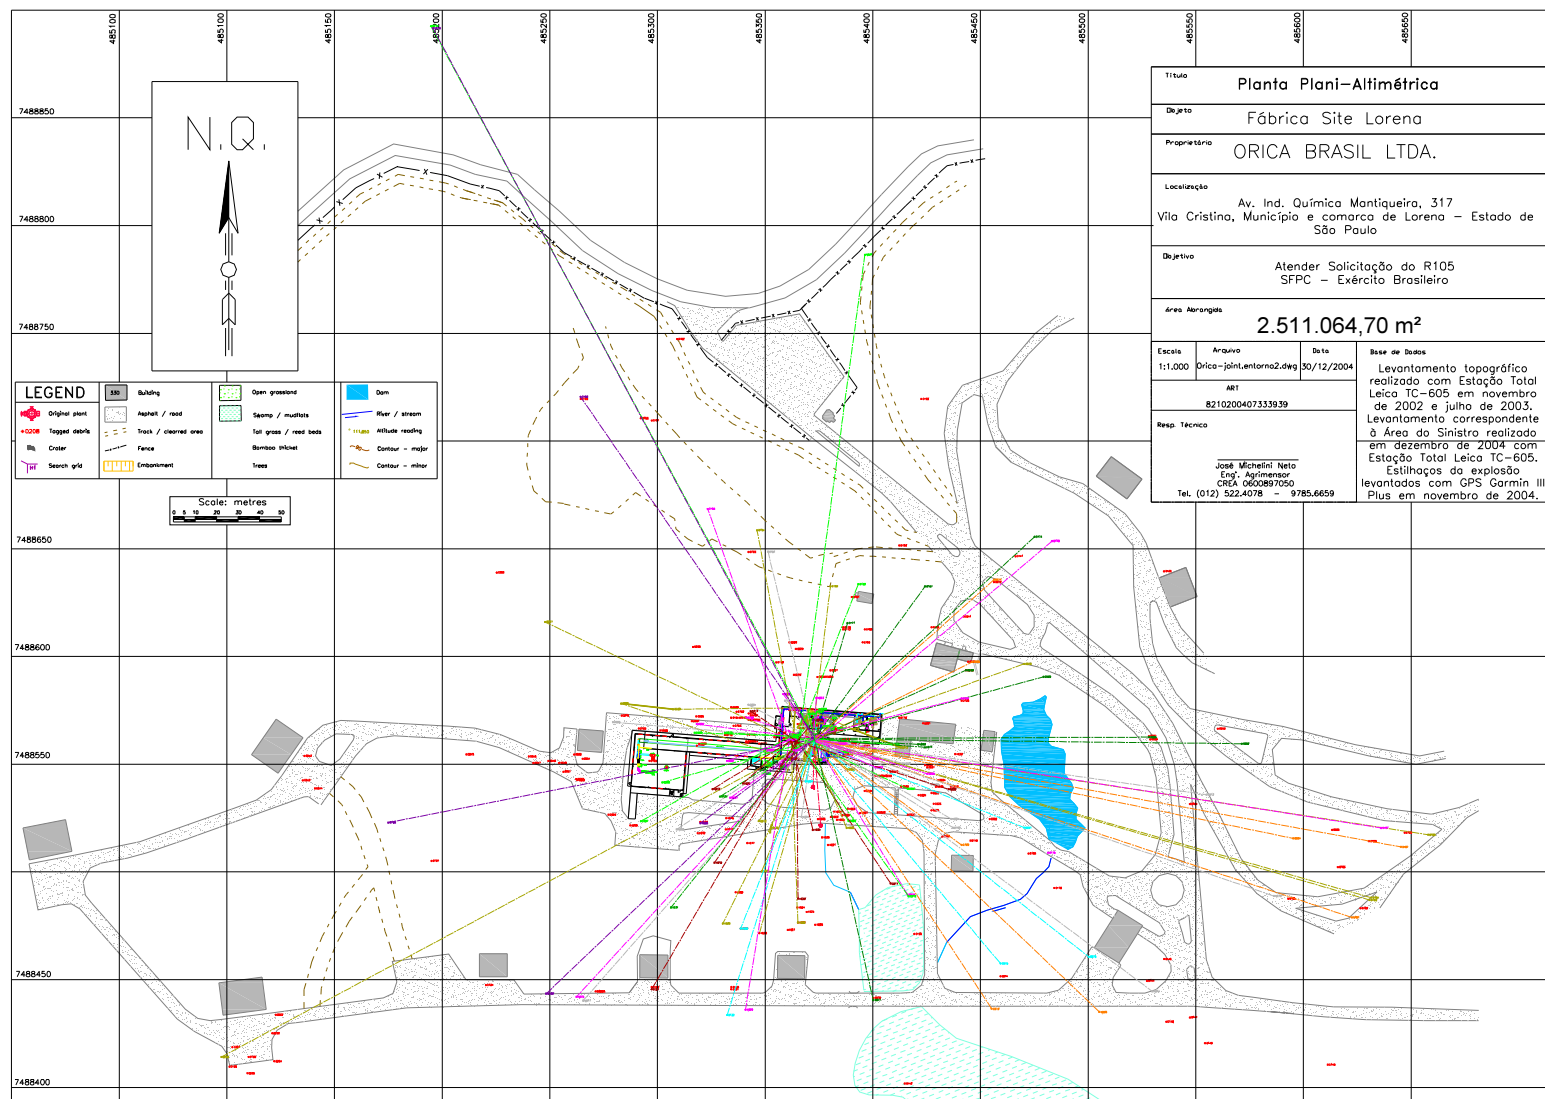
# Master debris distribution map

- Over 300 significant items of debris were surveyed, tagged and recovered. Each item was inspected for exposure to fire and to explosion.
- About 150 of these items could be identified positively, with their original location known.
- An individual debris distribution map was prepared for each of 20 significant process modules or sub-units.
- These maps indicated that there was one main explosion centre, and four secondary sympathetic initiation sites.
- Anomalies in the fire exposure and in the distribution maps established the consequences of the first small explosion prior to the main explosion.

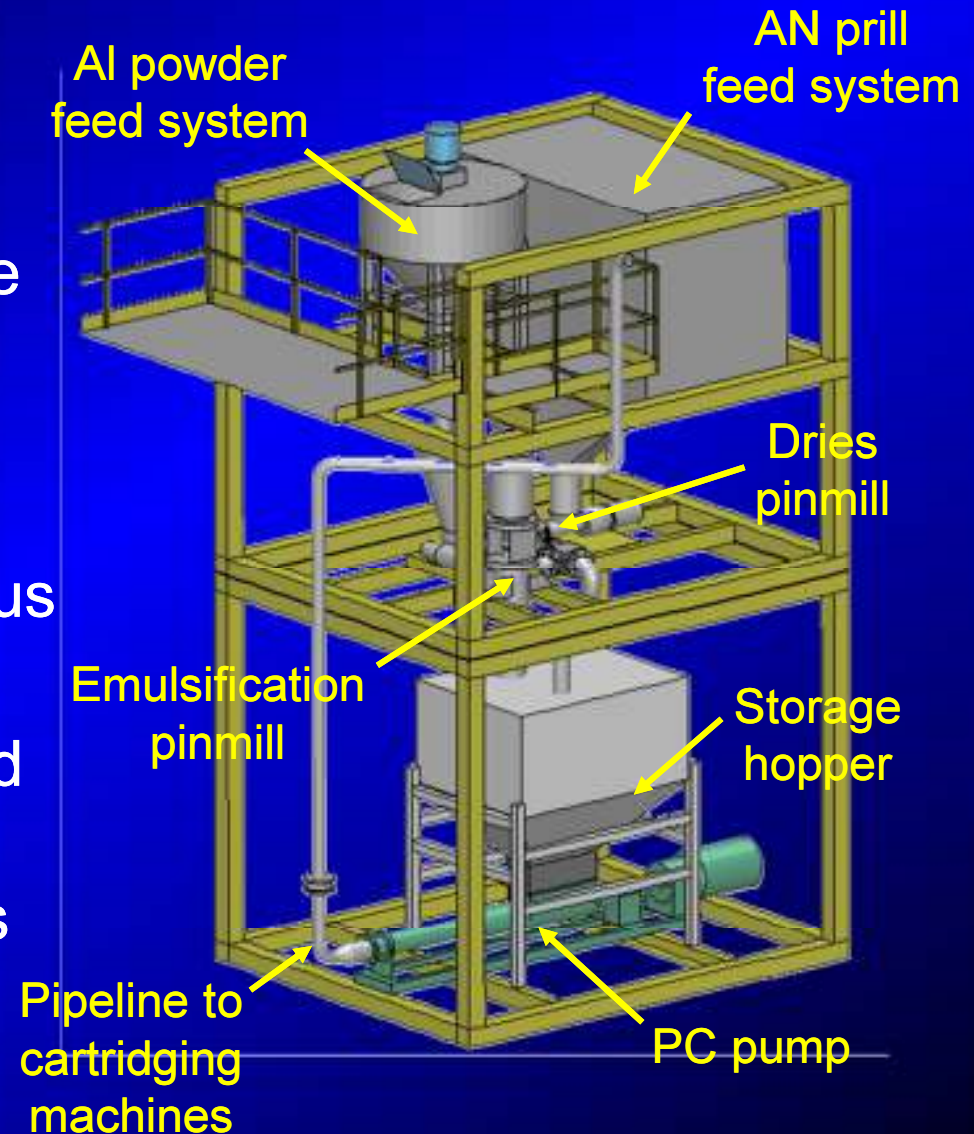
# The Emulsification module

- Leading up to the event, AN/SN/SP solution + fuel blend were being fed into the Emulsification pinmill.
- The refined emulsion matrix was then blended with aluminium powder and porous AN prill in the Dries pinmill.
- The doped matrix was stored in an intermediate hopper before being pumped across to the cartridging machines.

- Steam cleaning or water ingress into Aluminium system
- Lumping of Aluminium and possible evolution of hydrogen from water/aluminium reaction
- Friction event in Aluminium metering augers
- Friction/heat ignited hydrogen/aluminium dust
- Dislodgement of aluminium system allowing loss of containment of aluminium causing fire

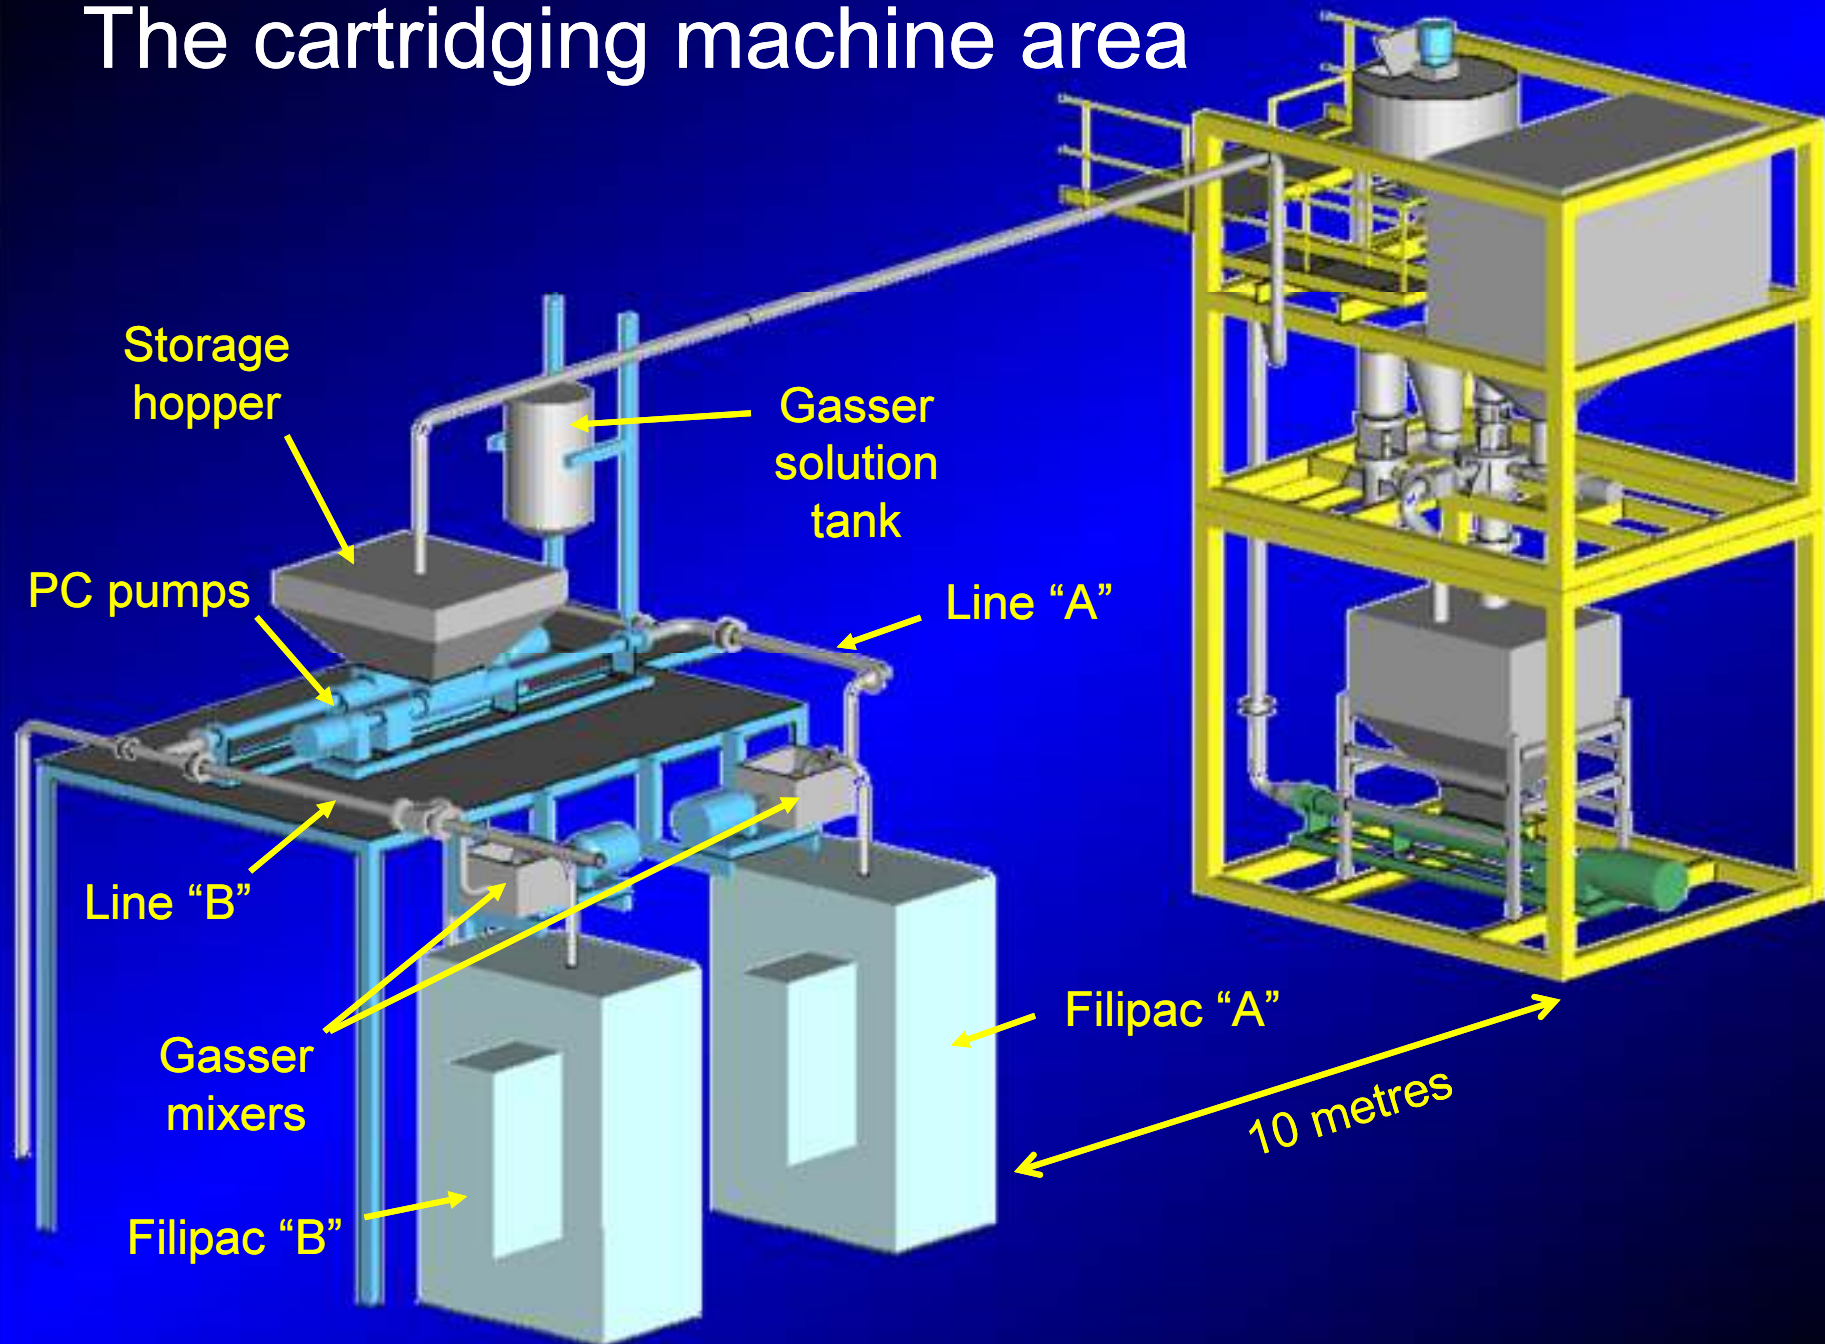
# The cartridging machine area

- The witness statements established that Filipac A and the associated platform and matrix hopper were destroyed during the main explosion.
- Filipac B was still in position after the main explosion, though on fire. (It was destroyed in the third, lesser explosion 15 minutes later.)
