# Watergel Plant Detonation

## Gladstone - South Australia

### May 2006

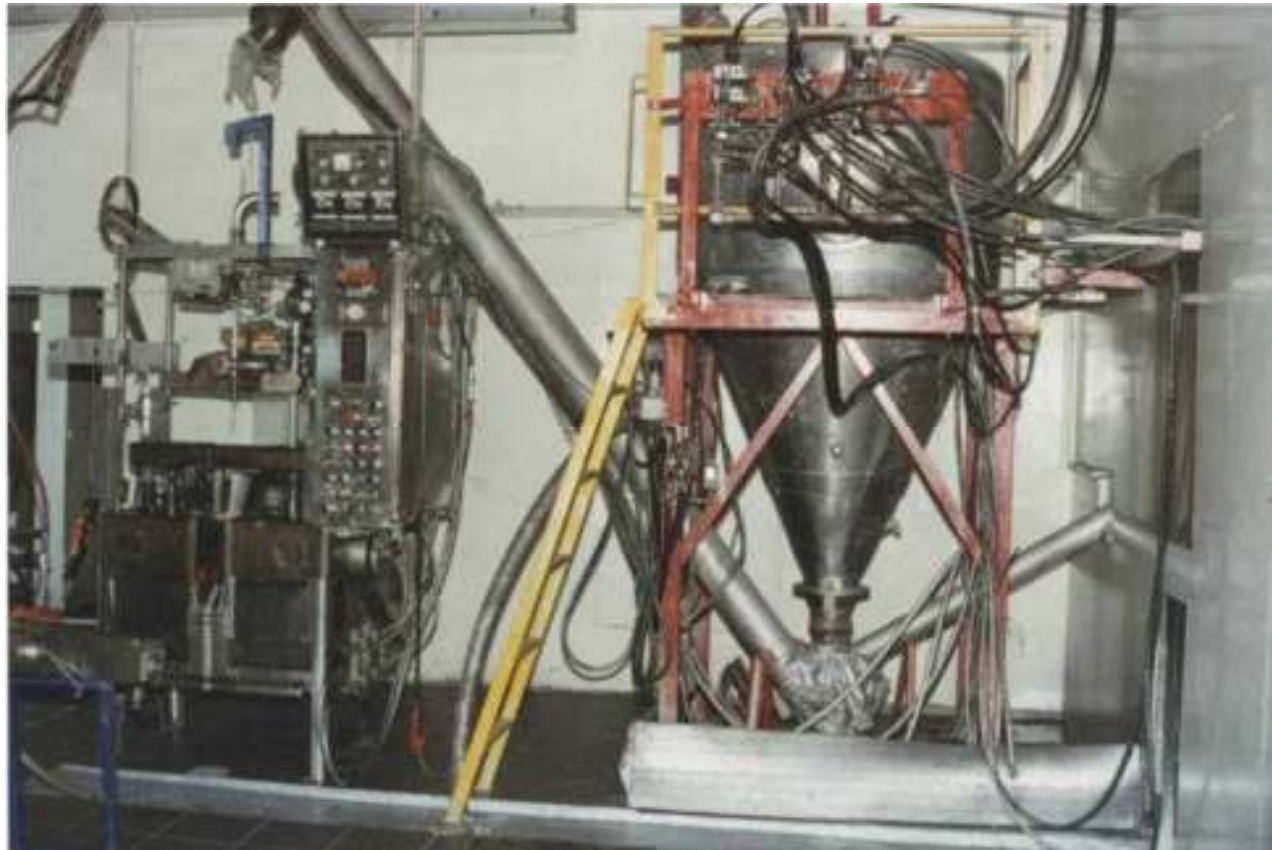
# Pre-mix Hopper and KP Machine

- Frictional ignition in either the inlet or outlet augers of the pre-mix hopper, leading to a deflagration to detonation transition.
- Hydrogen explosion caused by evolution of hydrogen from the paint grade aluminium initiating a subsequent dust explosion in the pre-mix hopper.
- Dust explosion in the extraction system that contained both gums and aluminium powder.
- AN decomposition reaction in the pre-mix hopper.

- 1) Poor design, construction and maintenance of the ribbon blender led to long term rubbing and wear of the shaft and the ribbon blender bowl end plate.
- 2) This rubbing produced on the morning of 9 May 2006 by friction a reacting volume of pre-mix.
- 3) This reacting material was then pumped up into the large auger to a location termed in this report Point A (2.8 metres "up the large auger").

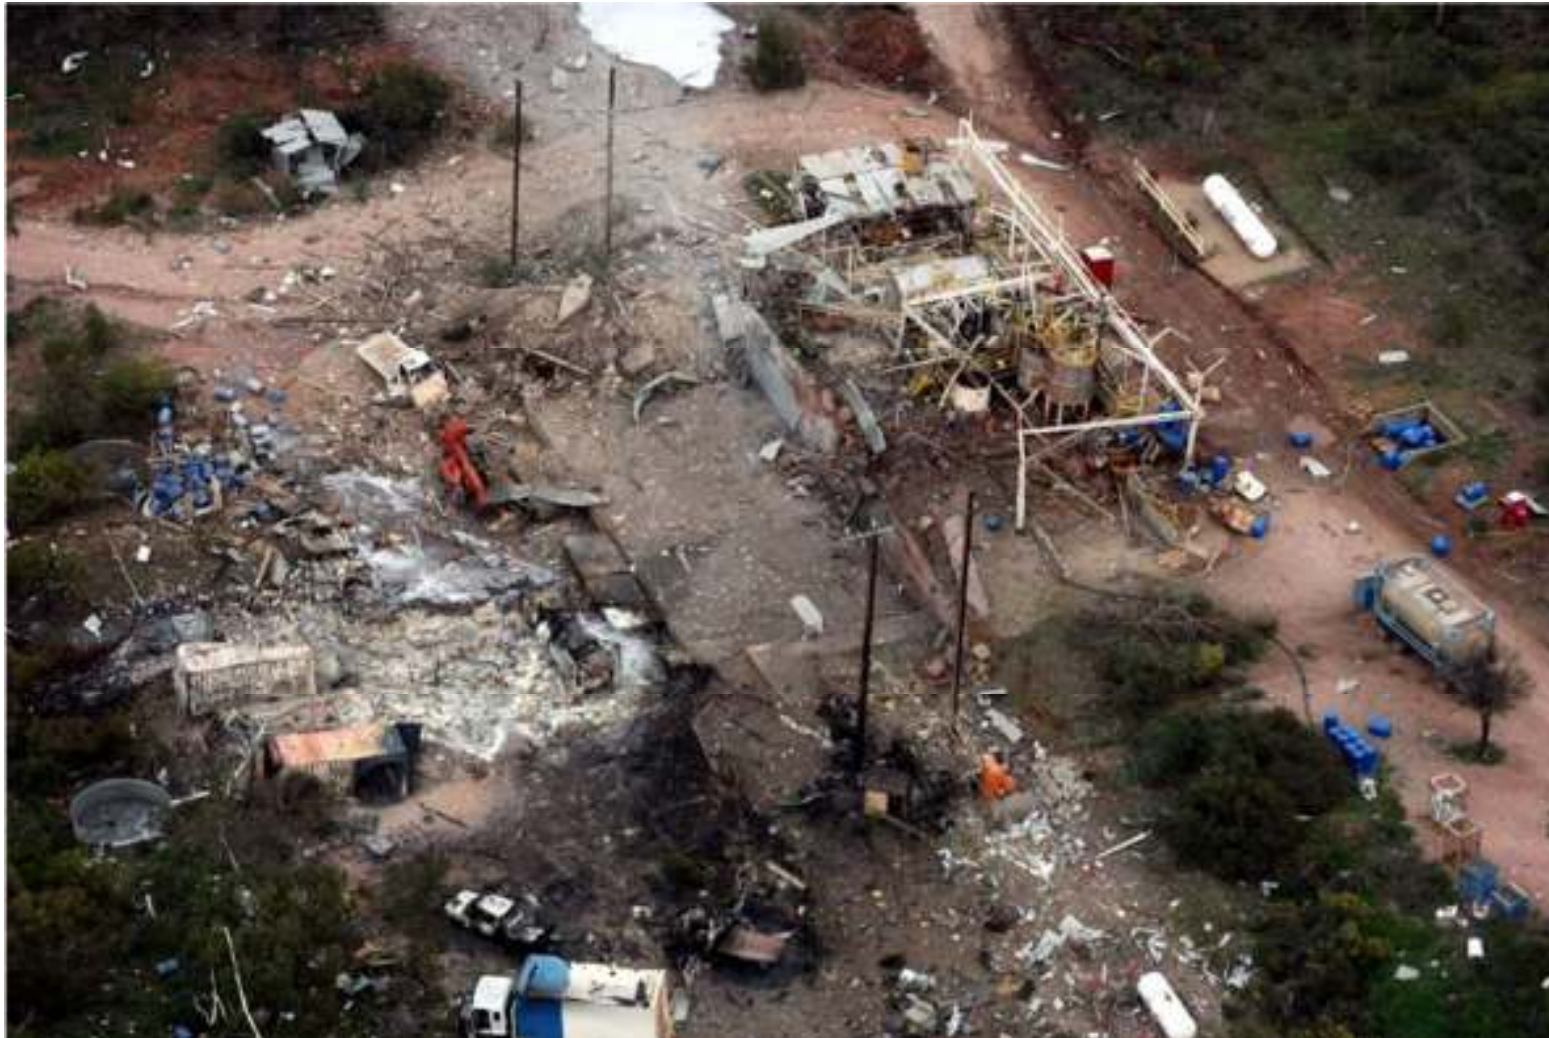
# The Incident

- The team in the Watergel Plant had spent the morning completing two weeks of TNT castings, and preparing a batch of pre-mix (a mixture of paint grade aluminium, crushed AN and a mixture of gums) prior to restarting manufacture of packaged watergel.
- Several batches of pre-mix were stored in the pre-mix hopper ready for a production run after lunch.
- After returning from an early lunch, the team began to get the plant ready.
- A large explosion took place just after the first operator entered the packaging room.

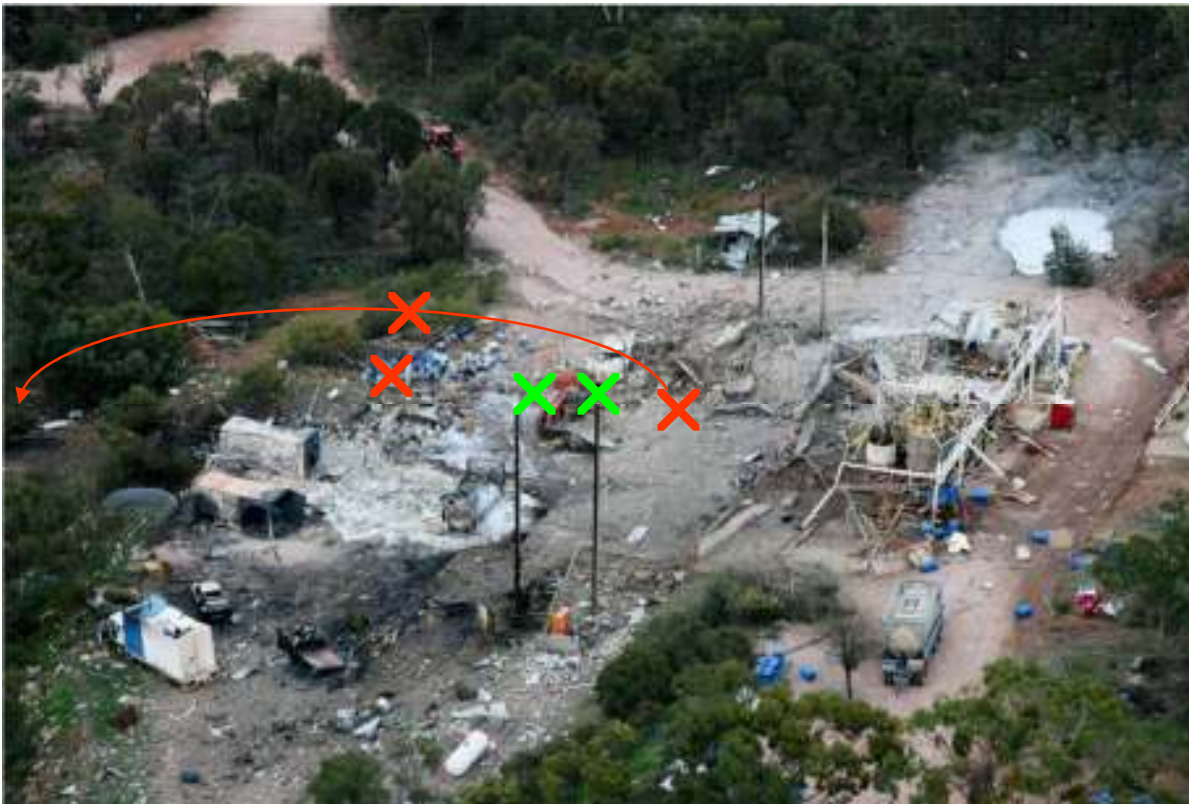
# The Incident

There were five people present in the plant at the time of the explosion

- Three of the team died
- Two survived
