## *AEL ignite...* SAFETY AND HEALTH

## DETONATOR PRIMING – IT'S SERIOUS!

# Priming Incident Details

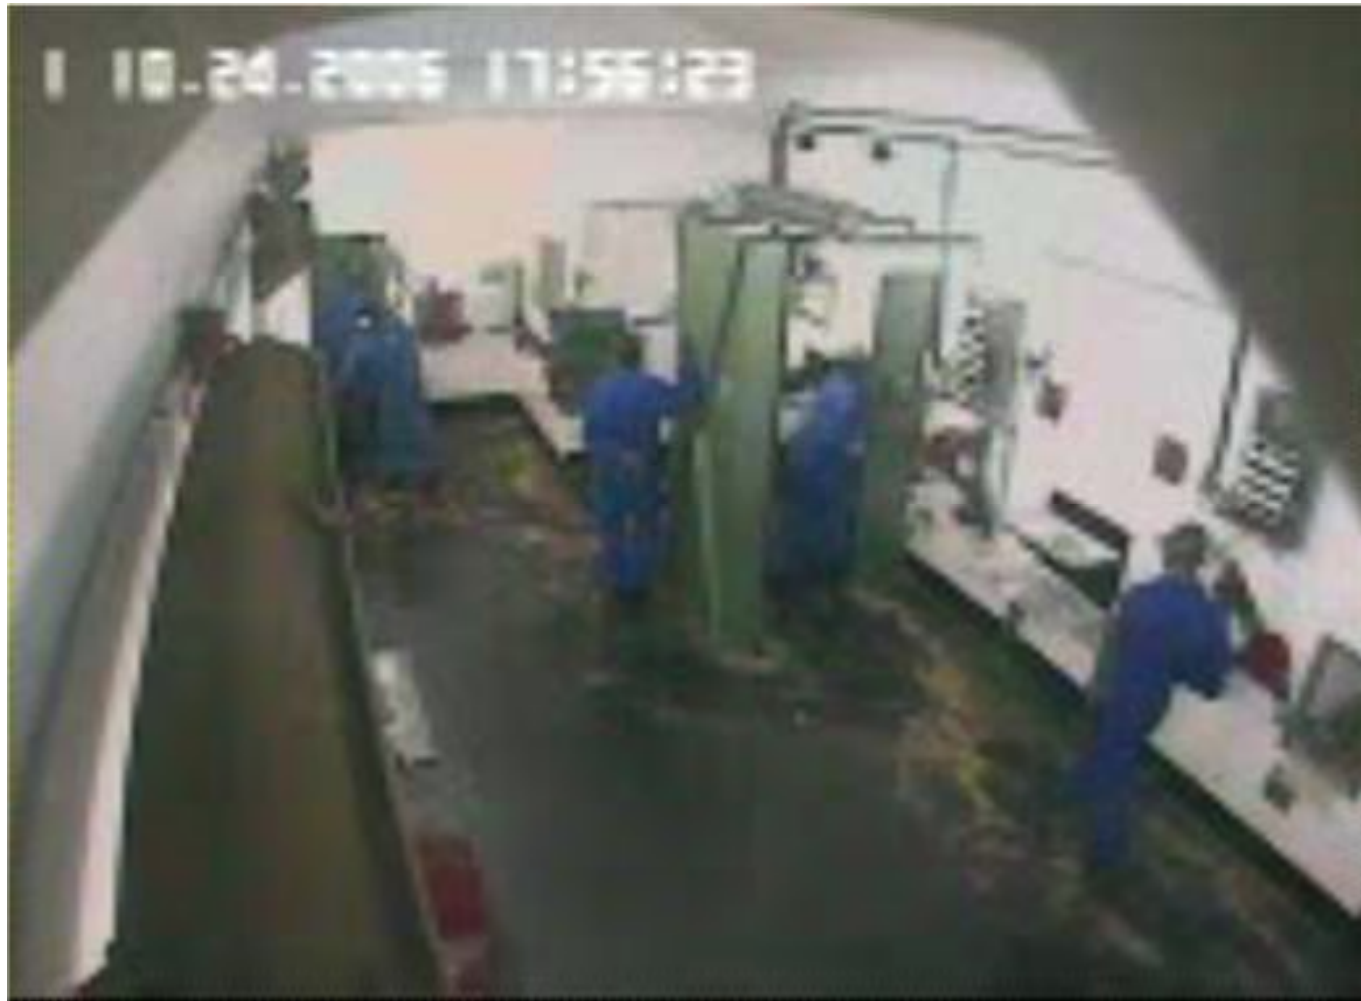
- This resulted in the spoon impacting on loose lead azide / lead styphnate (on the base plate) causing it to detonate.
- The detonation propagated to the spoon of tubes and the hopper of lead azide / lead styphnate.
- As the shutter was open the employee was exposed to the blast resulting in his injuries, he lost his arm.
- There is also evidence that the work team were working at an unsafe pace, which is a contributory cause of the incident.
