LEARNINGS FROM WUERGENDORF ACCIDENTS IN 2002

**Presented at
SAFEX May 2005**

EXPLOSIONS AT WUERGENDORF IN 2002

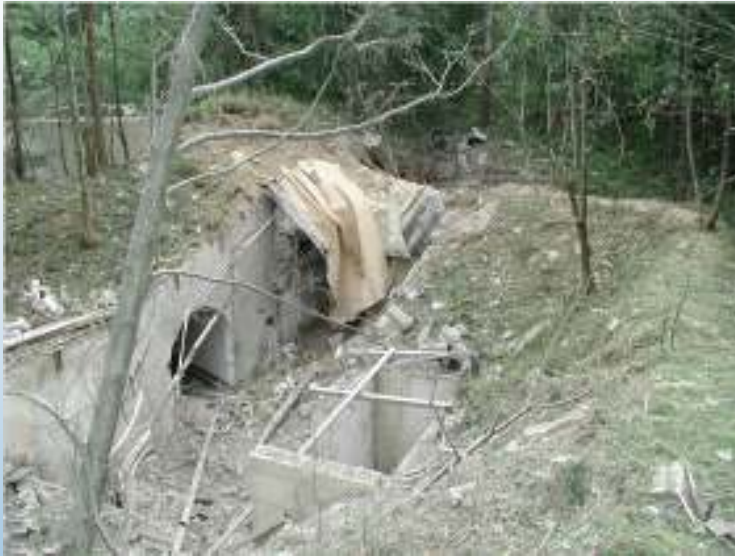
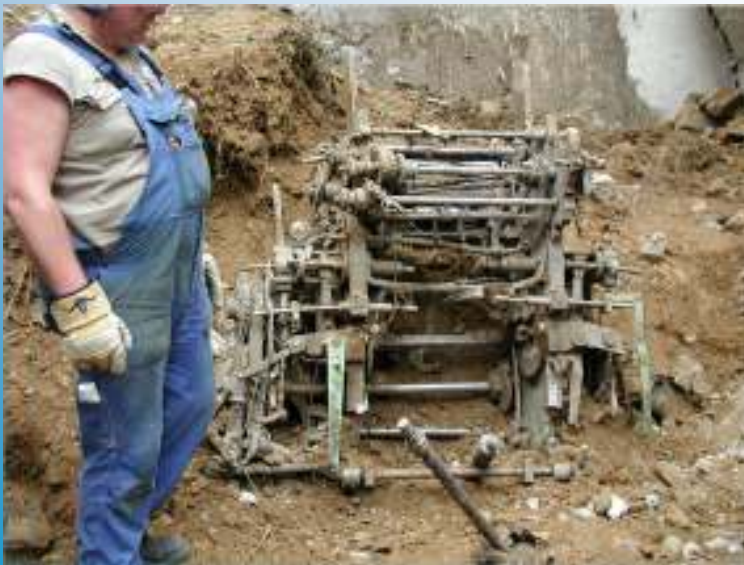
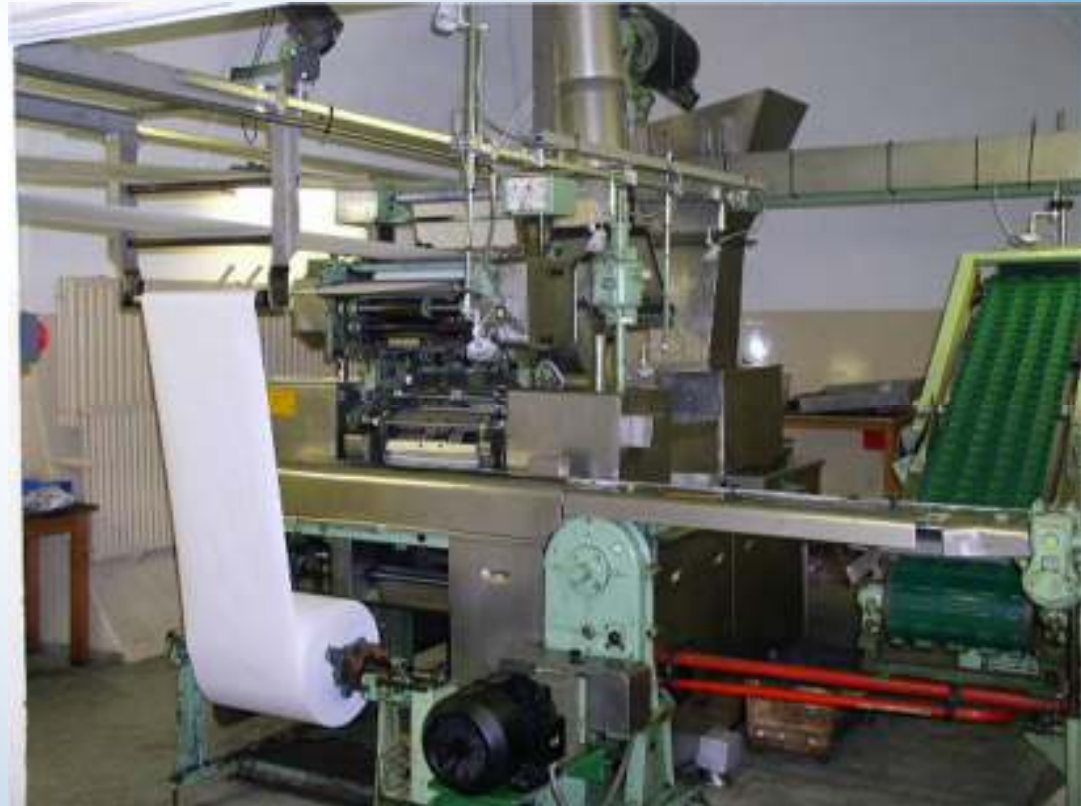
1st INCIDENT

- Occurred in a dynamite cartridging room (Rollex Machine)
- Approx. 90 kg NG explodes
- **One Fatality**
(Bruno Itschner,
 - 36 years - married, no children
 - 10 years' experience
 - 2 years in NG on Rollex Machine))
- **No other casualties** - fortunate as debris (broken concrete, steel, earth, etc.) rained down over adjacent operating areas
- **Extensive damage** (projectile and overpressure) in immediate area to equipment, building and roadways, up to 120 metres from blast.
- **Machine in 2000 pieces**

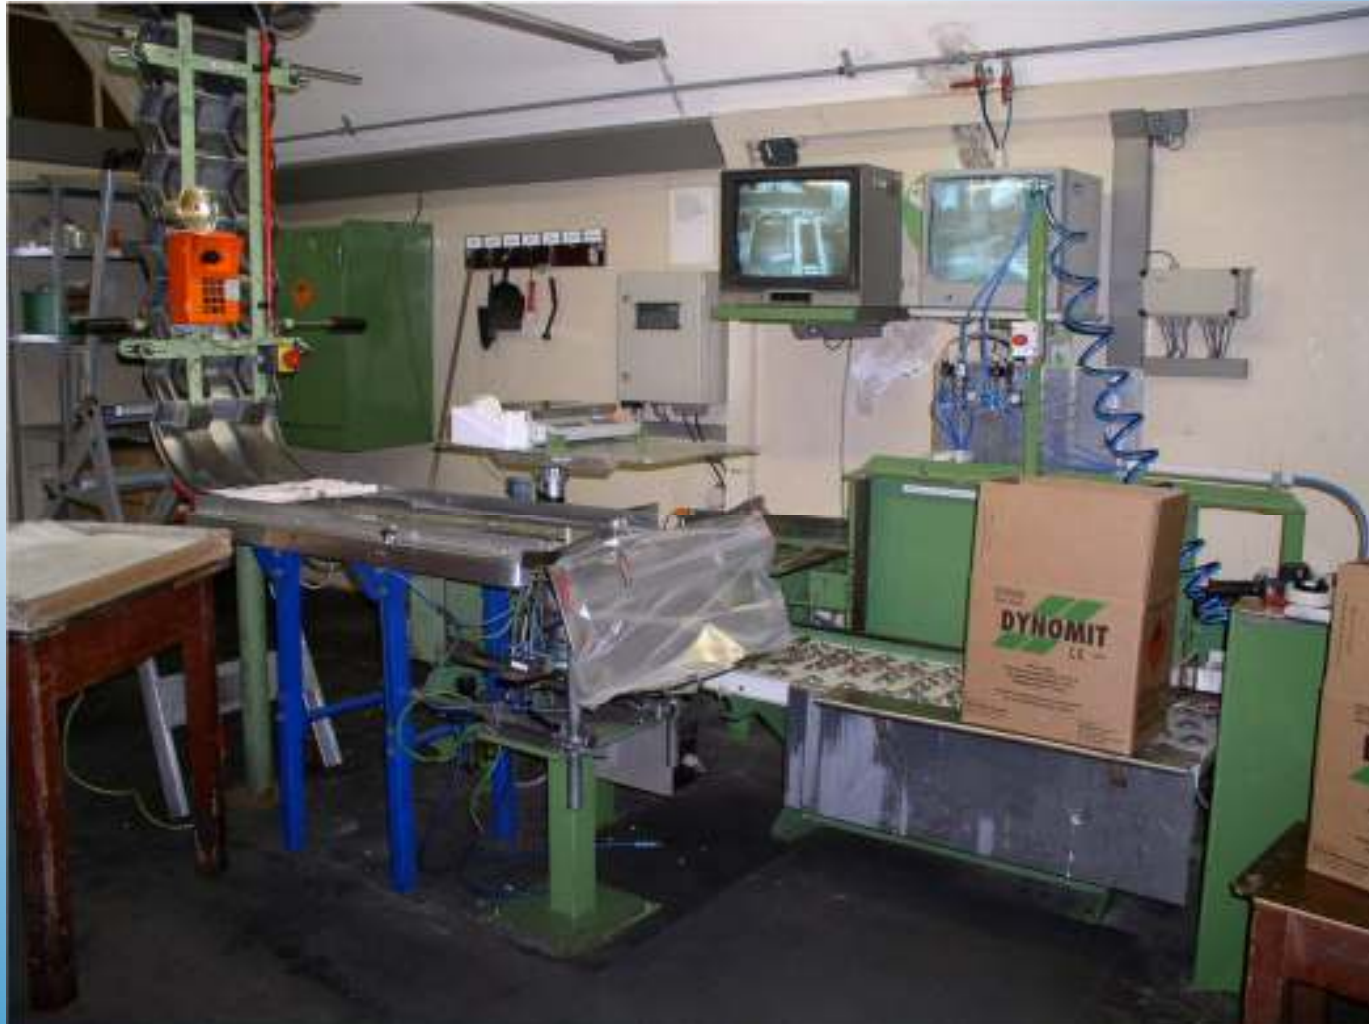
1st INCIDENT

- The victim was in the vicinity of the explosive cartridging room in breach of standard work practices. Whether he contributed in any way to the explosion could not be determined and because of the extent of damage caused by the explosion this may never be determined.

- Over the thirty years that this particular cartridging machine and associated facilities had been operated work practices have evolved which do not have a sound safety base taking into consideration that explosives were being handled. Complacency to the hazards and risks associated with NG based explosives has crept into the organisation at all levels on the site.

- Engineering changes had been made with little or no concern to the hazards and risks at hand. Many of these changes had been made some years ago and at the time may have been based on sound safe operational and engineering assessments. The reasons for such changes have been lost or forgotten in the current management structure.

- A number of likely ignition sources for the explosion were identified but none could be determined as the main source of ignition. A foreign body catching in the stainless steel feed auger or at the knife of the cartridging machine are regarded as highly probable ignition points but whether this foreign body was introduced further up-stream in the process or inadvertently by the operator could not be determined.

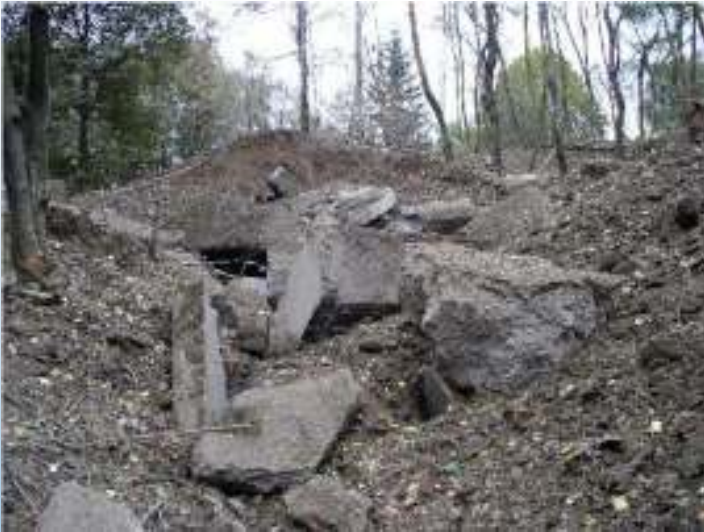
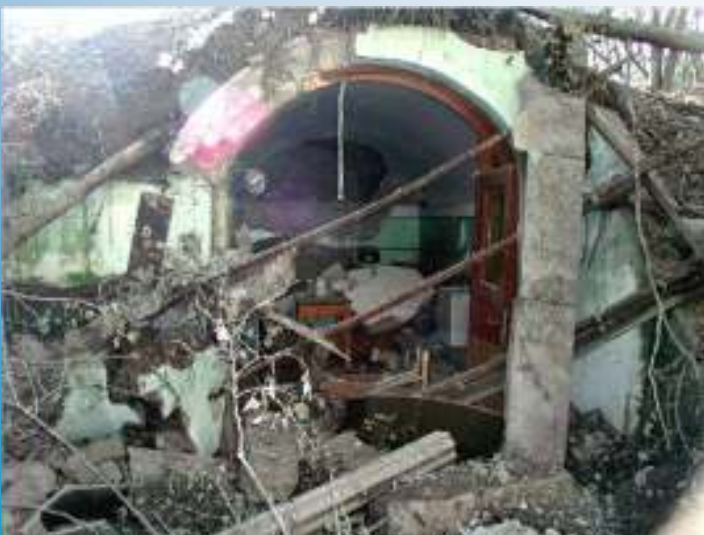
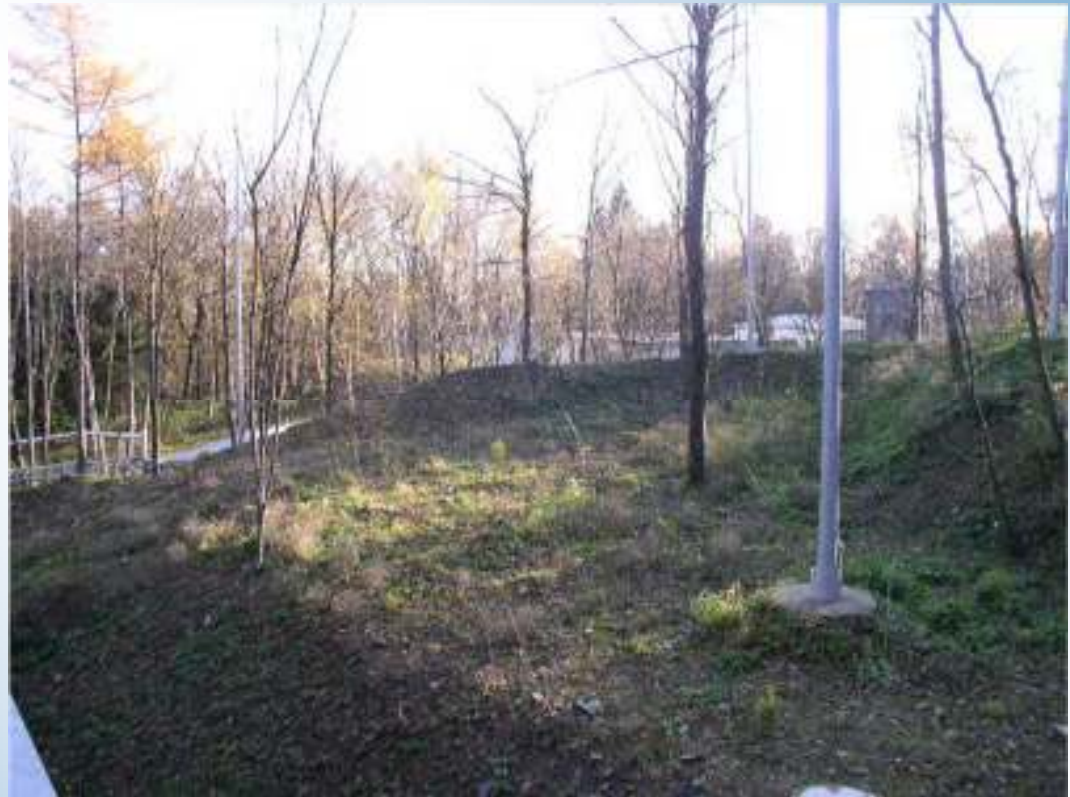
2nd INCIDENT

- Building 207: Third wash process of EGDN.
- Explosion in building after production start over a weekend, around about 60 kg of EGDN.
- Possible causes: friction in ball valves of the EGDN transport; Vacuum forced EGDN to collapse.
- Consequences: Building and machinery destroyed.
- Last event prior to the explosion was the commencement of NG transport to the storage house which involved the remote opening of the valve.

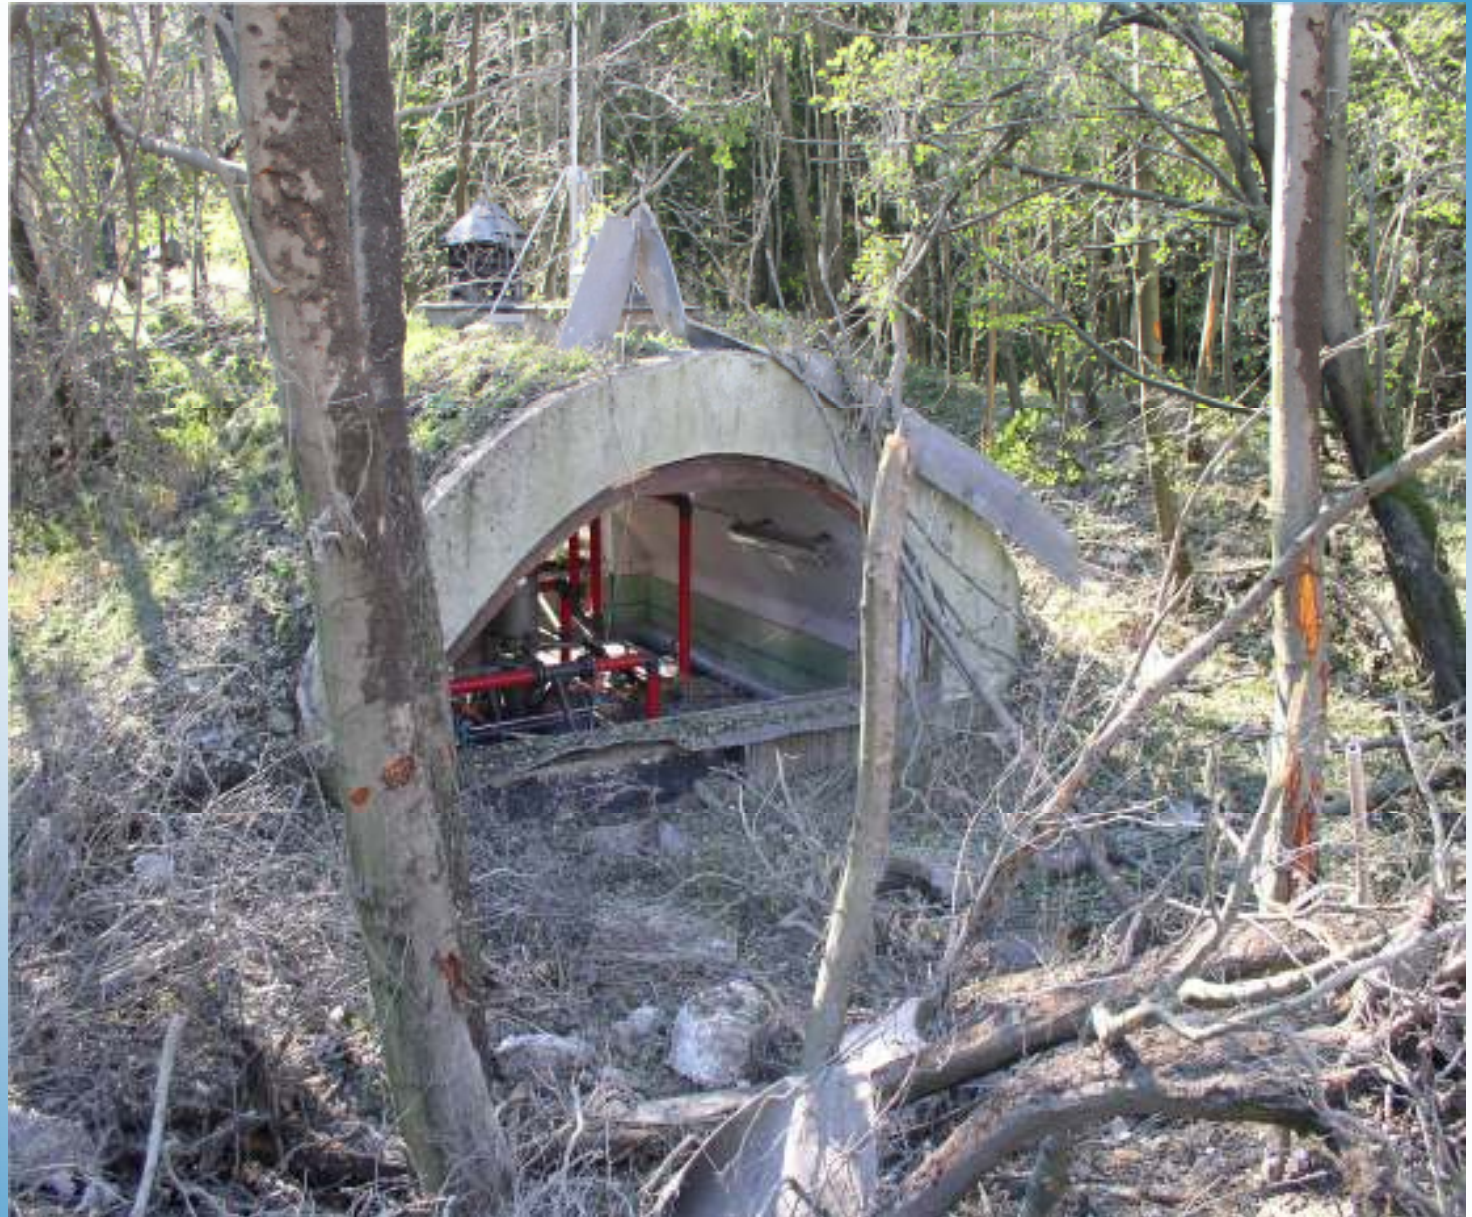
**Wash Building
204 after
explosion**

**Safety issue:
Disposal of
nitroglycol
contaminated
material (liquid/
solid) in a bund**

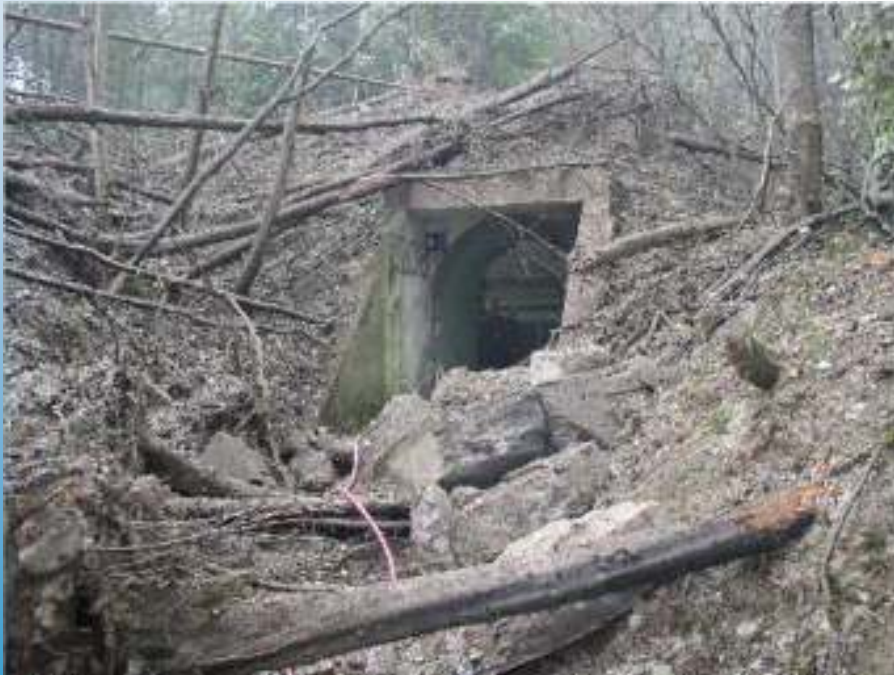
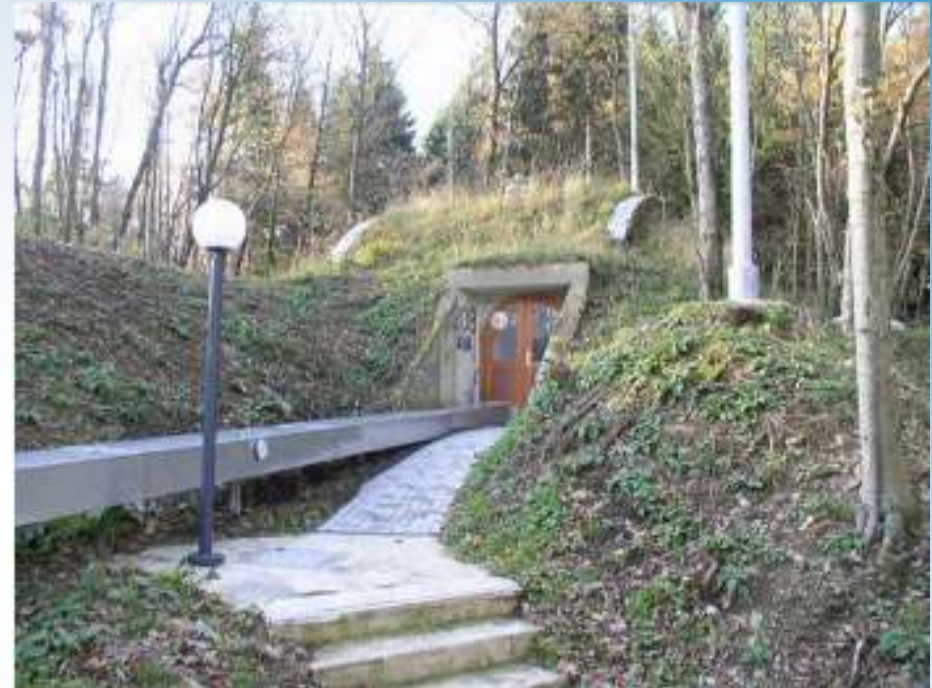
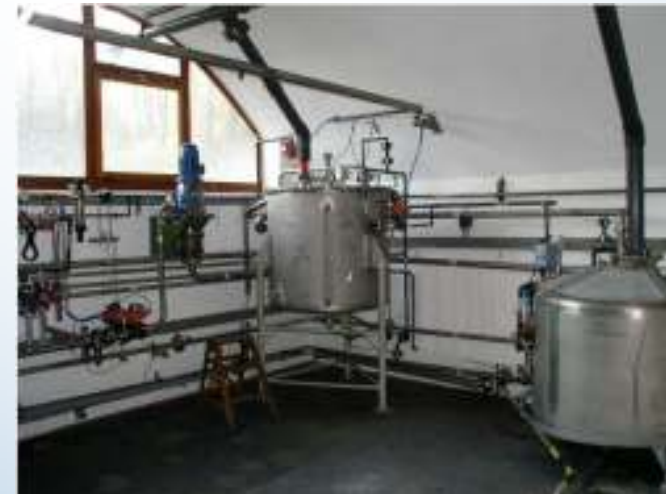
2nd INCIDENT

**Testing Vessel
Building 208**

Pump Building 207.1
Partly damaged

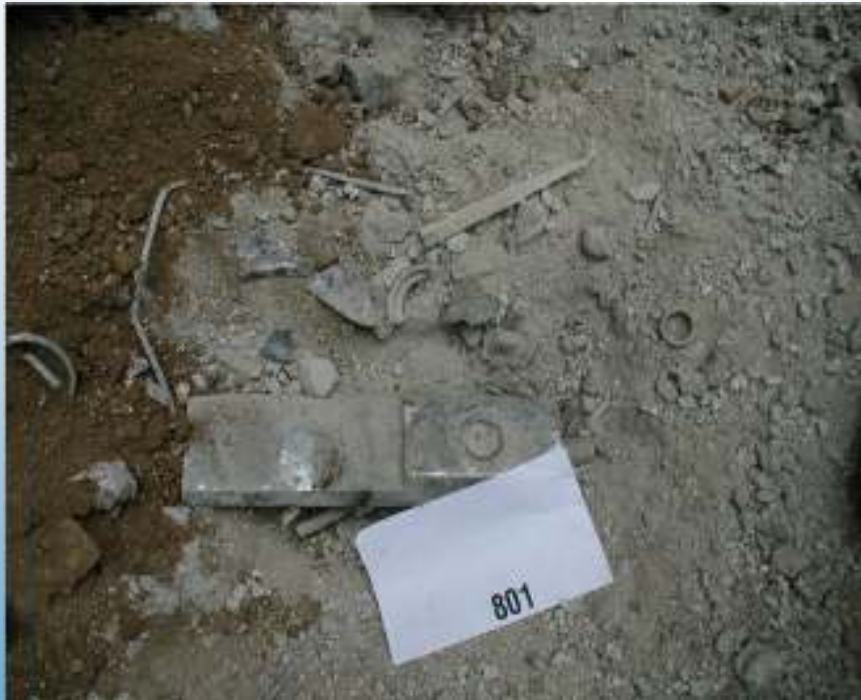
Individual items numbered and photographed

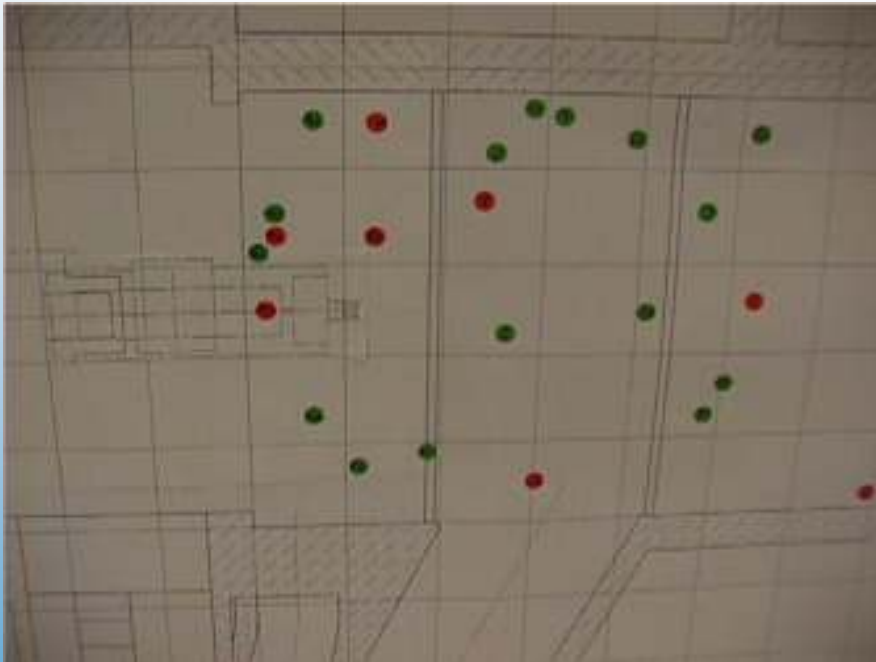
Projectile Analysis on a plot diagram
