Powder GmbH

Heinz Krätschmer

Deflagration of
Nitrocellulose
in the Lab

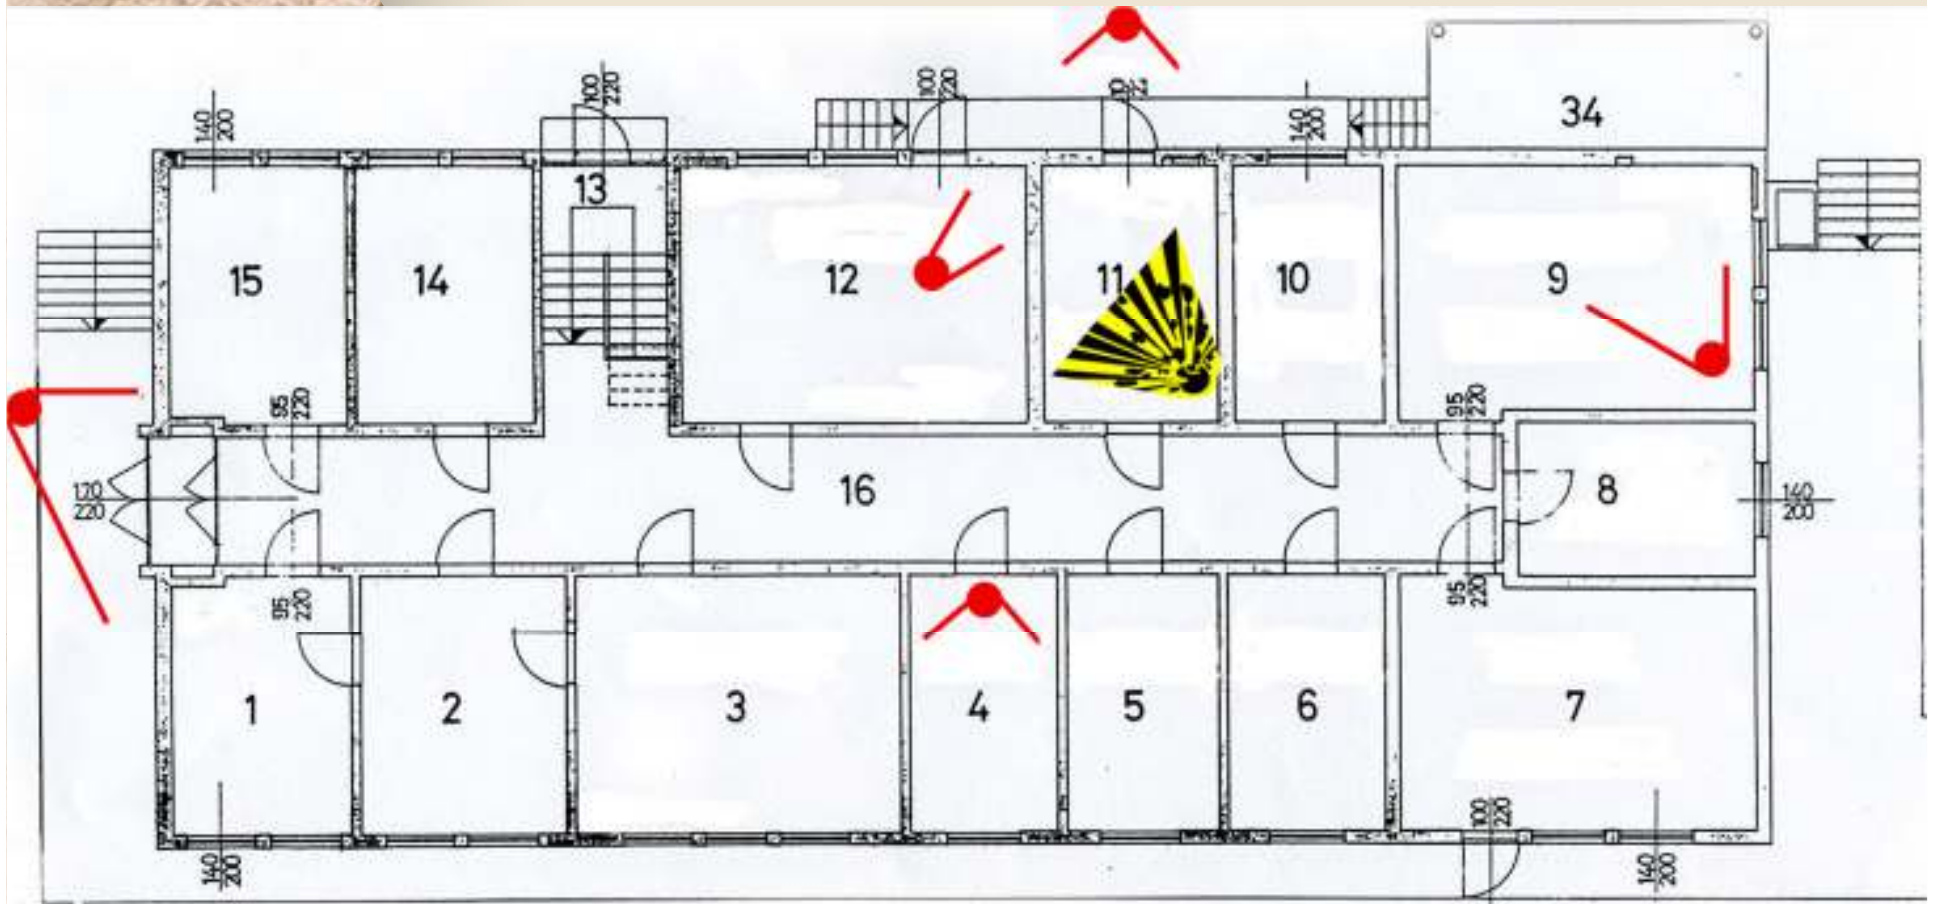
Plan of the laboratory

- ◆ January 7th 2002, 07:56 am
- ◆ Explosion in room #11 of the lab
 - deflagration of app. 800 g NC
inside a convection oven
 - temperature in the lab 18 °C (64 °F)
 - outside temperature -3 °C (27 °F)
 - relative humidity 55 %
