# Explosion during primary explosive process

Presented by Tsuyoshi MURASHITA  
ASAHI KASEI CHEMICALS CORPORATION  
JAPAN  
May 27 2005

XV CONGRESS SAFEX INTERNATIONAL

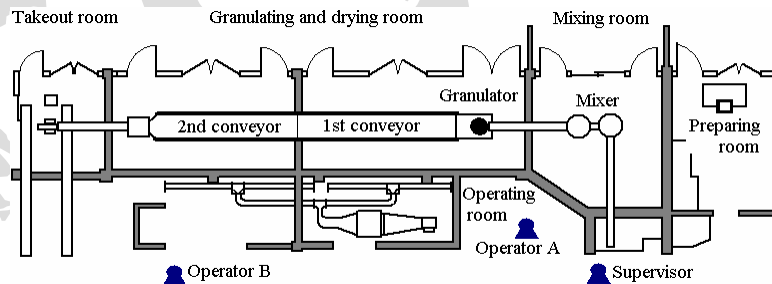
Layout view of the accident place

- At 8:58 on Wednesday, 12th June, 2002, an explosion occurred in the continuous production process of DDNP powder.
- Approximately 2.6 Kg of DDNP powder fired and detonated.
- No persons were injured.
