Decontamination of the SmartDet Manufacturing Facility (RL26)

Kaylee Baker; AECI Mining Explosives; Modderfontein, Gauteng, South Africa

This paper deals with the methodology used to decontaminate the facility for the purpose of a change of licence of the explosive facility.

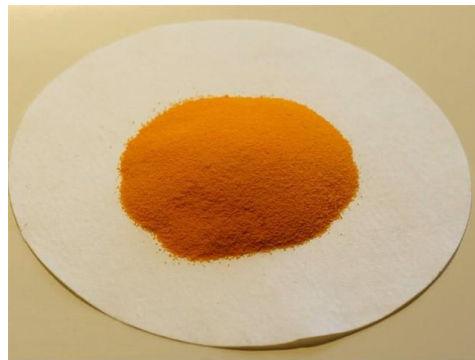
Figure 2: Lead Styphnate powder

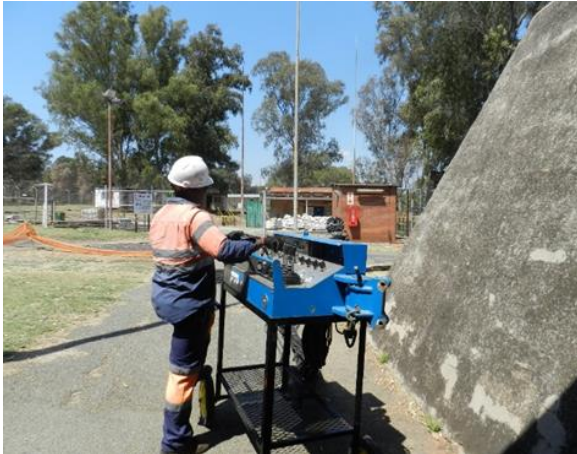
A possibility existed that the lead styphnate had migrated through the ground. Due to this, the full extent of the area of contamination was uncertain. As such, a remotely operated drill rig was brought in to sample the area around the building. Drilling was done to a depth of 3m and samples of the ground were taken every 500mm. The samples were tested for the presence of lead and hot plate testing was also conducted. It was found that the contamination of the ground was localised to an area of 6.0 x 3.0m. Figures 5-8 illustrate the remote drilling and soil sampling.

Figure 6: Drill operator

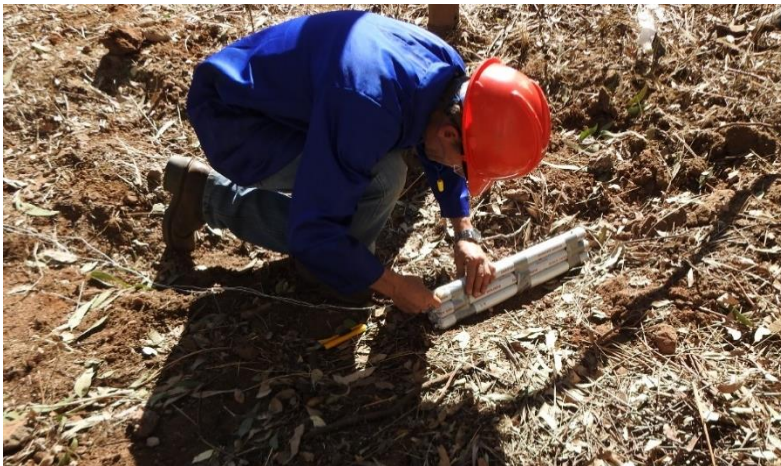
Pipe charges were used in two instances: 4½ m and 1½ -m lengths in the surface gutter from the sink to the external concrete slab, and a 2.1m length across the slab. In total, 18 blasts were conducted between 9th July and 12th July 2019. Of these, 16 were with 5kg bombs; the remaining 2 used pipe bombs. After placement, bundled bombs were covered with bags of stone-free sand, forming a dome over the bomb of approximately 0.6m in height and 1.3m in diameter. The sandbags weighed approximately 20kg each.

Figure 11: Placing of Charge
