Angellala Creek Ammonium Nitrate Incident – 10 years on

By Geoffery Downs, Expert Panel

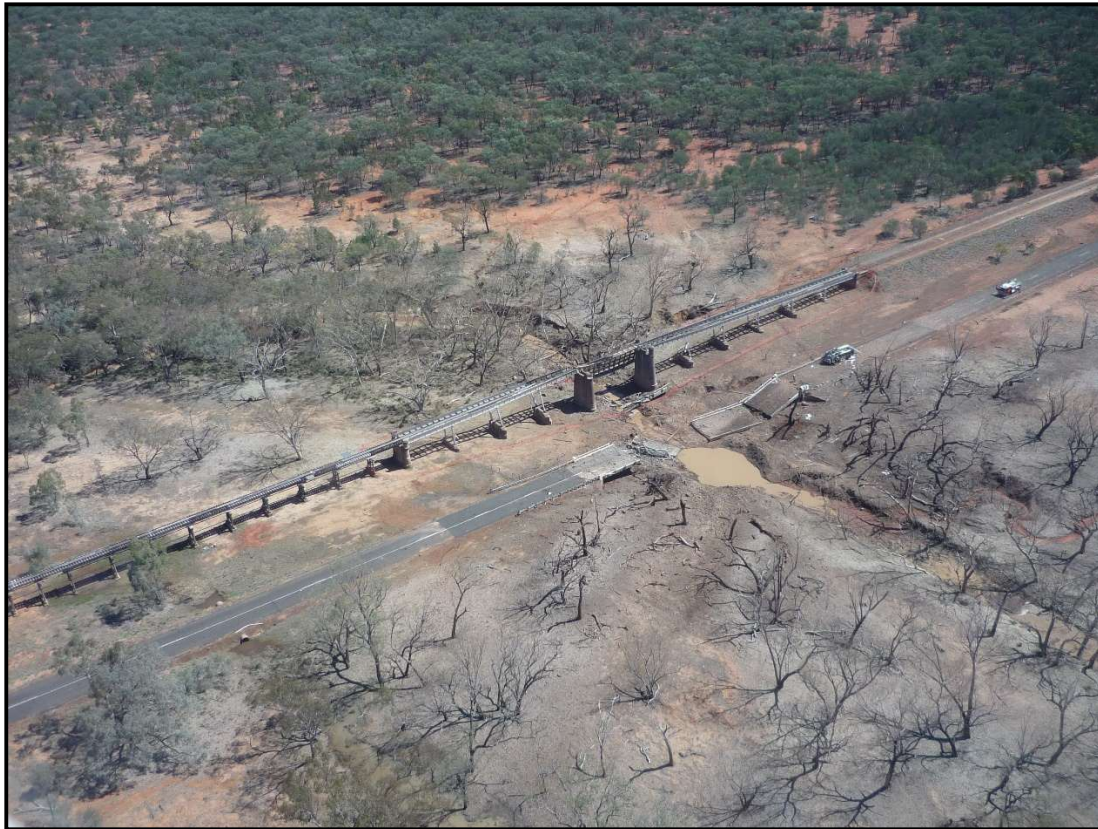
The area was littered with all types of debris. An example of the debris is shown in Picture 14. Aerial photos of the scene are also shown in Pictures 15 and 16.

Picture 15 – Aerial photo of incident scene looking towards the east

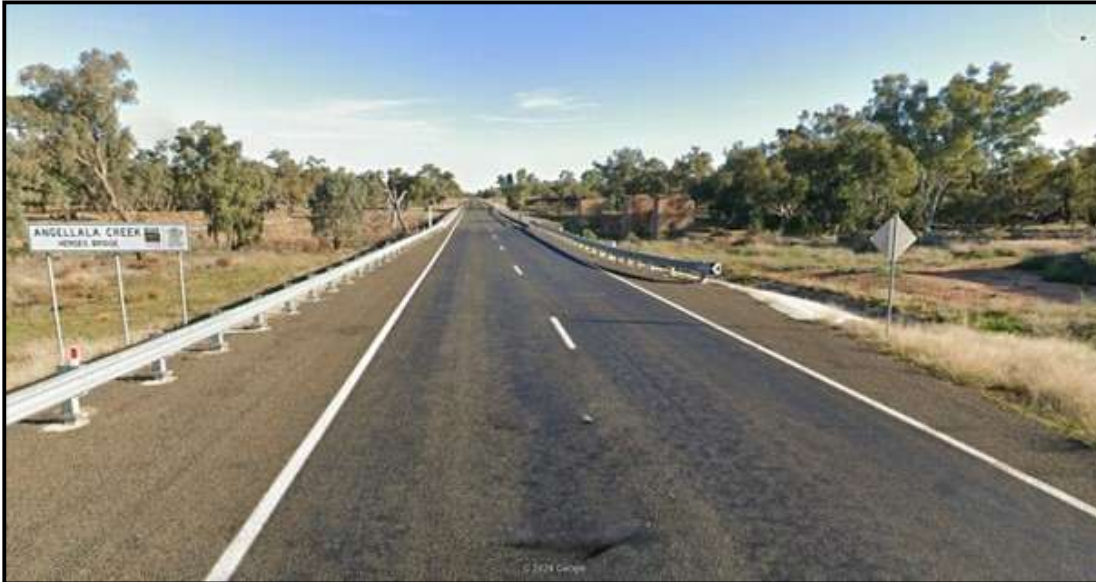
To complete the story, the site is seen in Pictures 24, 25 and 26 heading south, heading north and from overhead courtesy of Google Earth. The new bridge has been called Heroes Bridge. The railway

Picture 23 – Heroes Bridge at Angellala Creek heading south

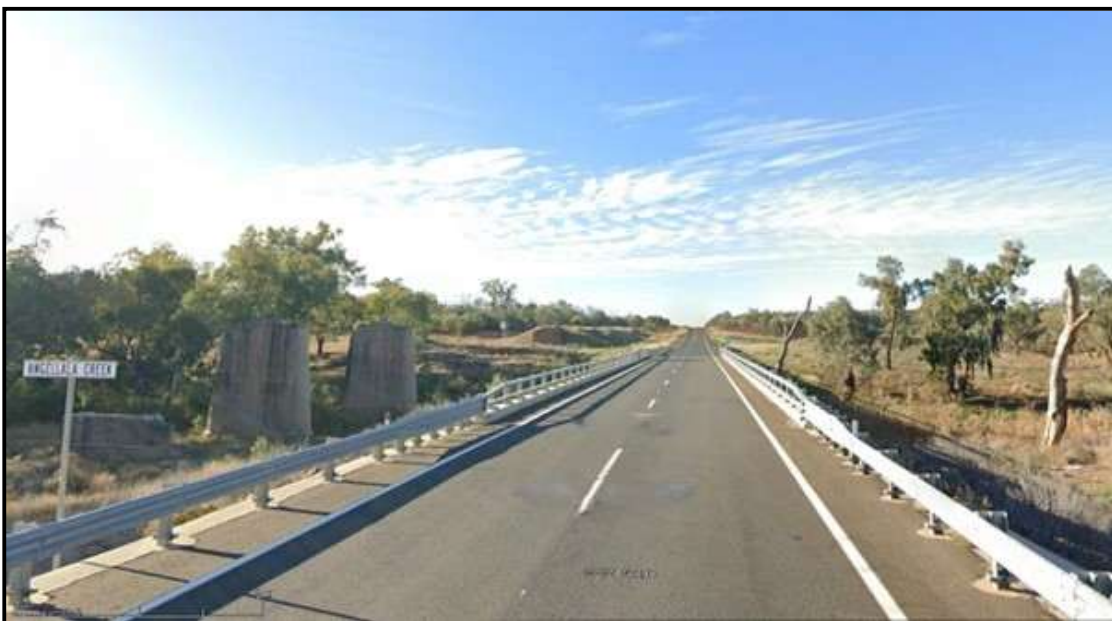
Picture 24 – Heroes Bridge at Angellala Creek heading north

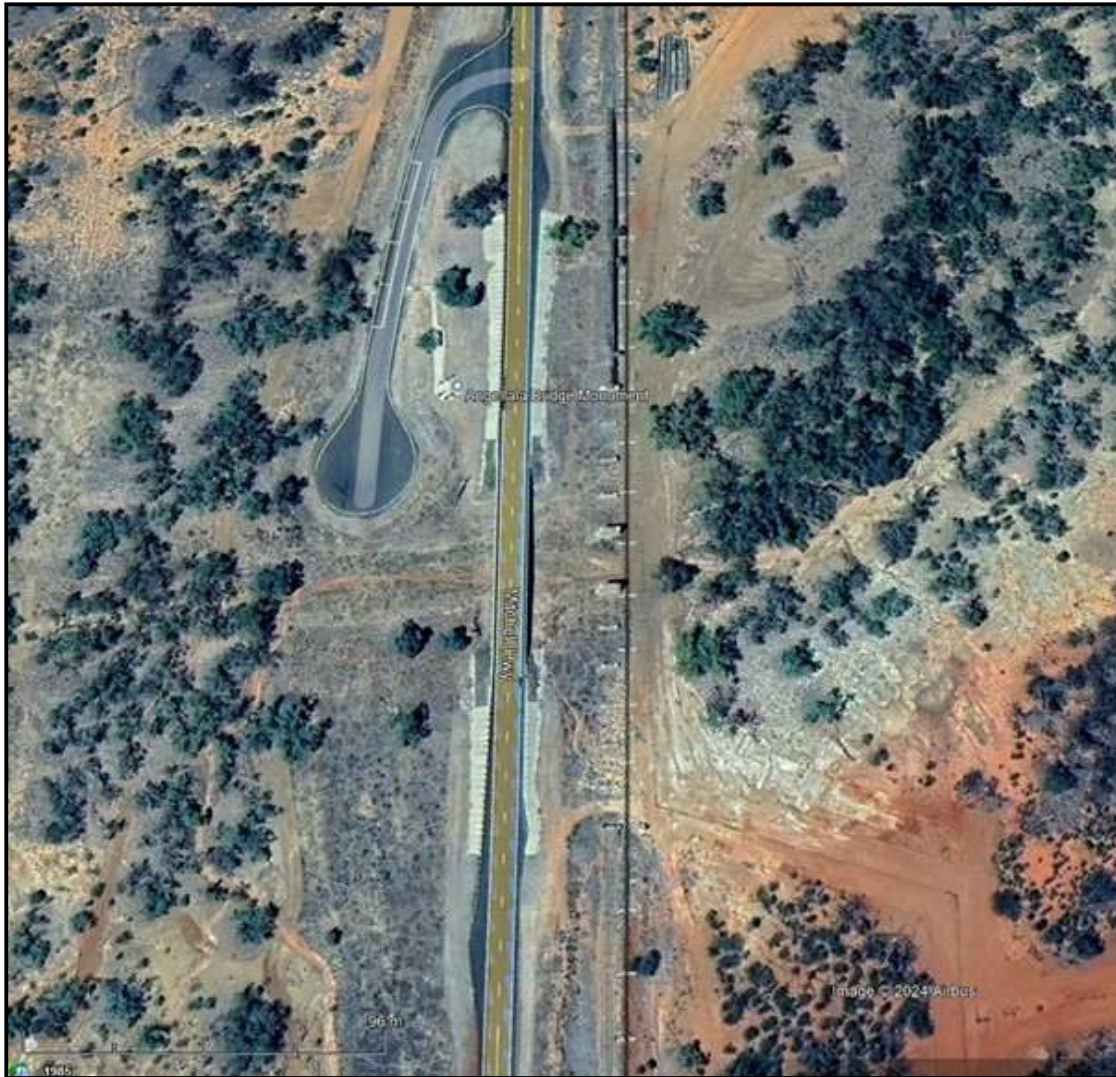
bridge has been removed leaving the piers as a reminder. There is a pull off area suitable for caravans, motorhome and camper trailers to the south of the new Heroes Bridge. This area is shown in Picture 26 and is the dedicated and fitting tribute called the Angellala Bridge Monument.

Picture 25 – Overhead of Angellala Creek Bridge and monument site
