Emulsion Truck Fire Incident

SAFEX Webinar - October 2022

Ammonium Nitrate
Emulsion Bulk Trailer Fire
Wowan – Lecharadt Highway
Queensland
12/03/2018

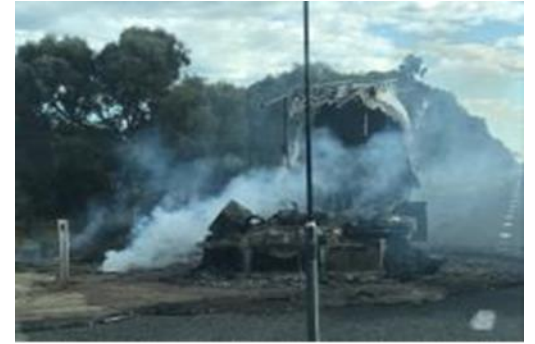
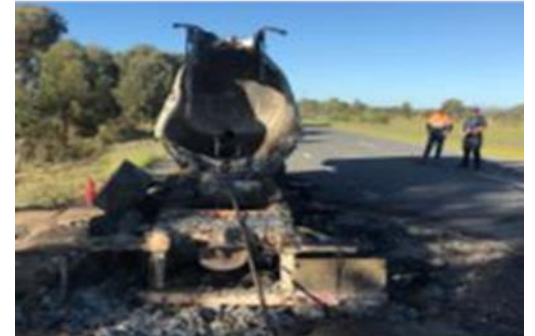
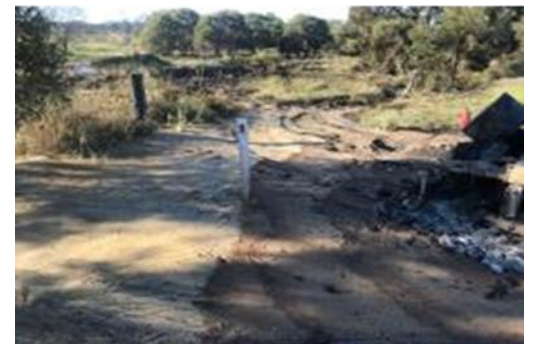
Remains of the trailer

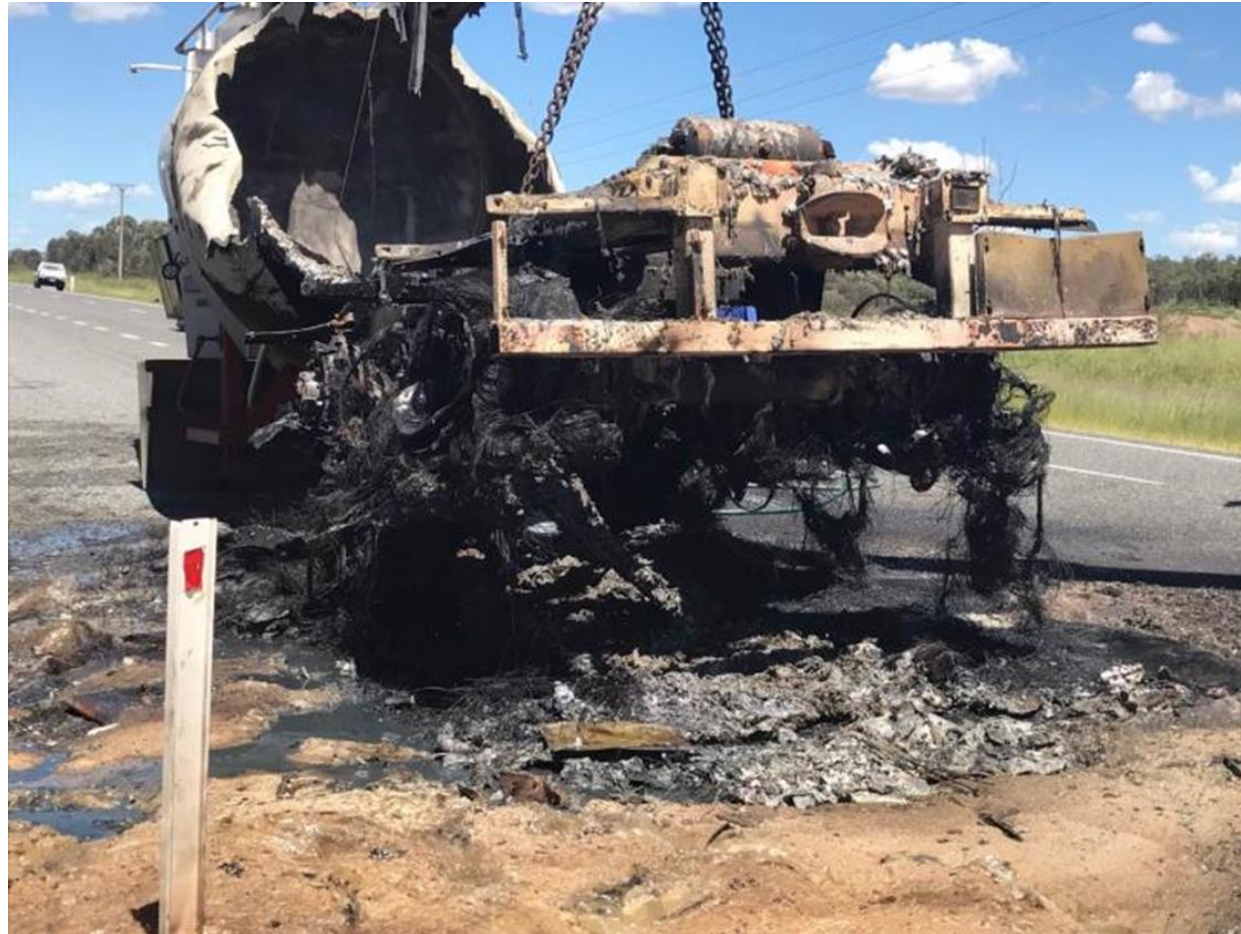
- A 20 ton crane was used to lift the remains of the trailer onto a flatbed to transport to Crawford's Yard in NSW for further investigation.

Loading of trailer

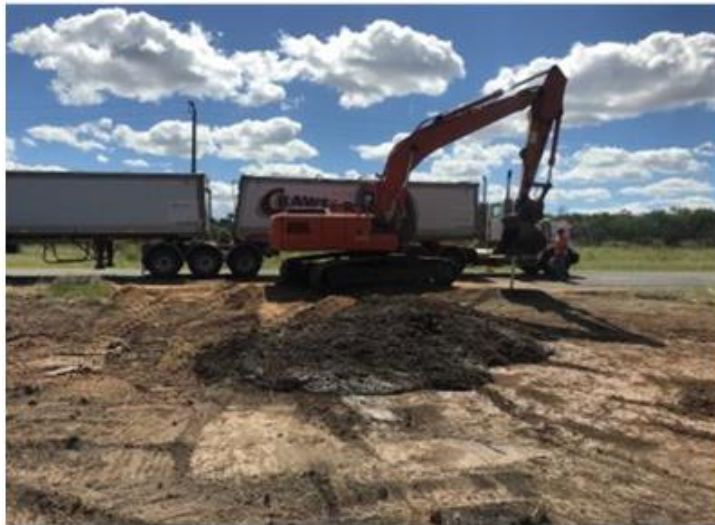
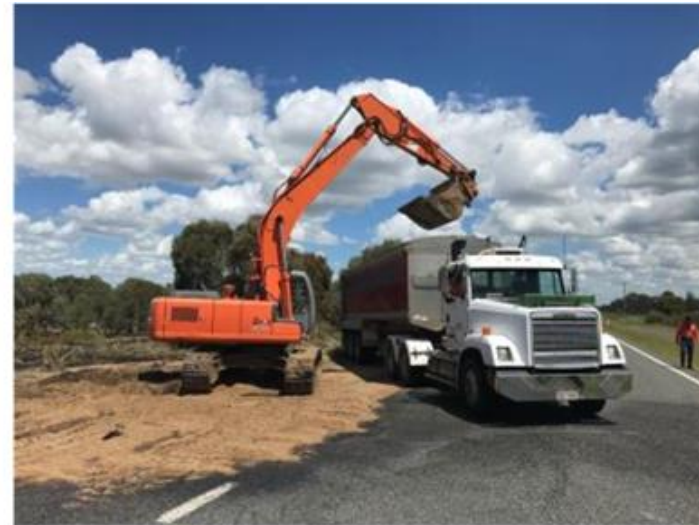
- As mentioned, it was agreed with authorities that by mixing the contaminated product with an inert substance like sand to below 45% concentration it would negate the 1.1 explosive classification. The agreement was between the local Explosives Inspector and also via telephone by the DNRM Scientific department based in Brisbane.
- 27 tons of fine sand was imported to mix with the 23 tons of Ammonium Nitrate Emulsion.
- An excavator was used to mix the sand into the spilled product and load into the top of trailers for disposal.
- 2 x Trucks (a single and a B-Double) were utilised to collect the waste materials and transport to JJ Richards Regulated Waste Depot in Gladstone.
