SAFEX Webinar #4: Transportation of Explosives

19 October 2022: Session 2

AN TRANSPORT INVESTIGATION BY DEPT OF NATURAL RESOURCES AND MINES QLD

NOËL HSU

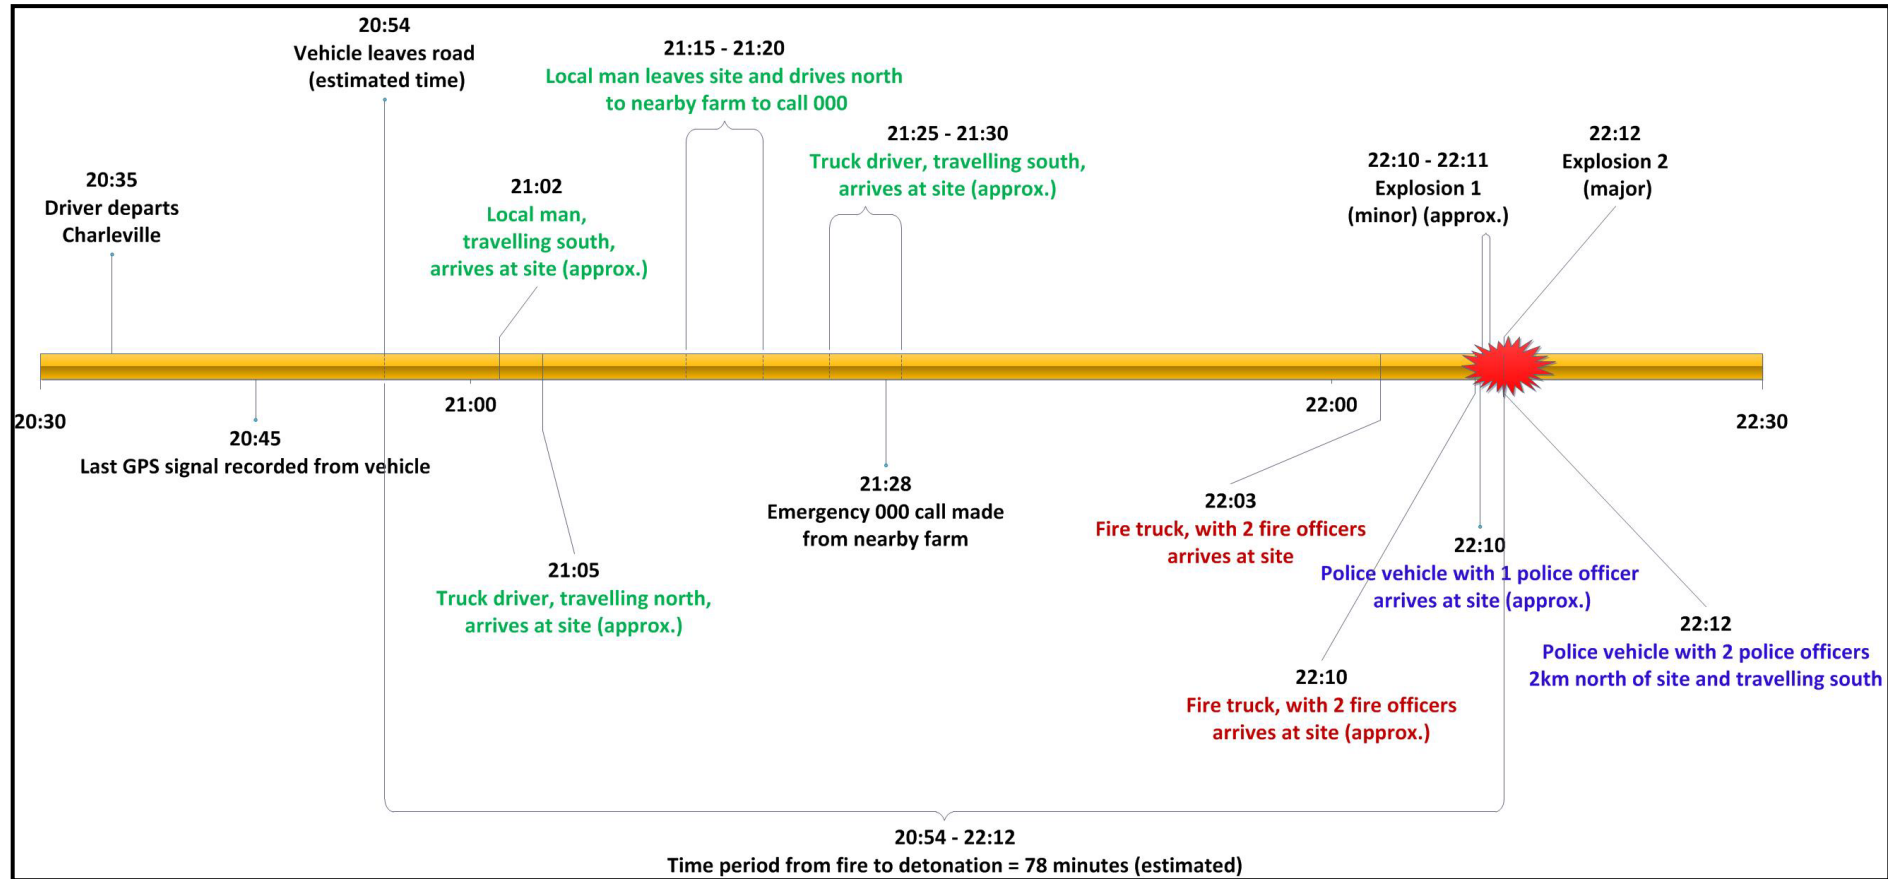
Incident Timeline

Incident date - 5 September 2014

- Exact time fire started unknown; likely result of crash
- No phone signal at site; 30 minutes to contact emergency services
- Fire burned for about 1 hour 20 minutes
- Two explosions about 1-2 minutes apart
- Explosion measured 2.1 on Richter Scale at the site
- Estimated to be equivalent to 10 to 15 t TNT
- Blast injuries to eight people, some serious
- Driver 35% burns, crash and blast injuries

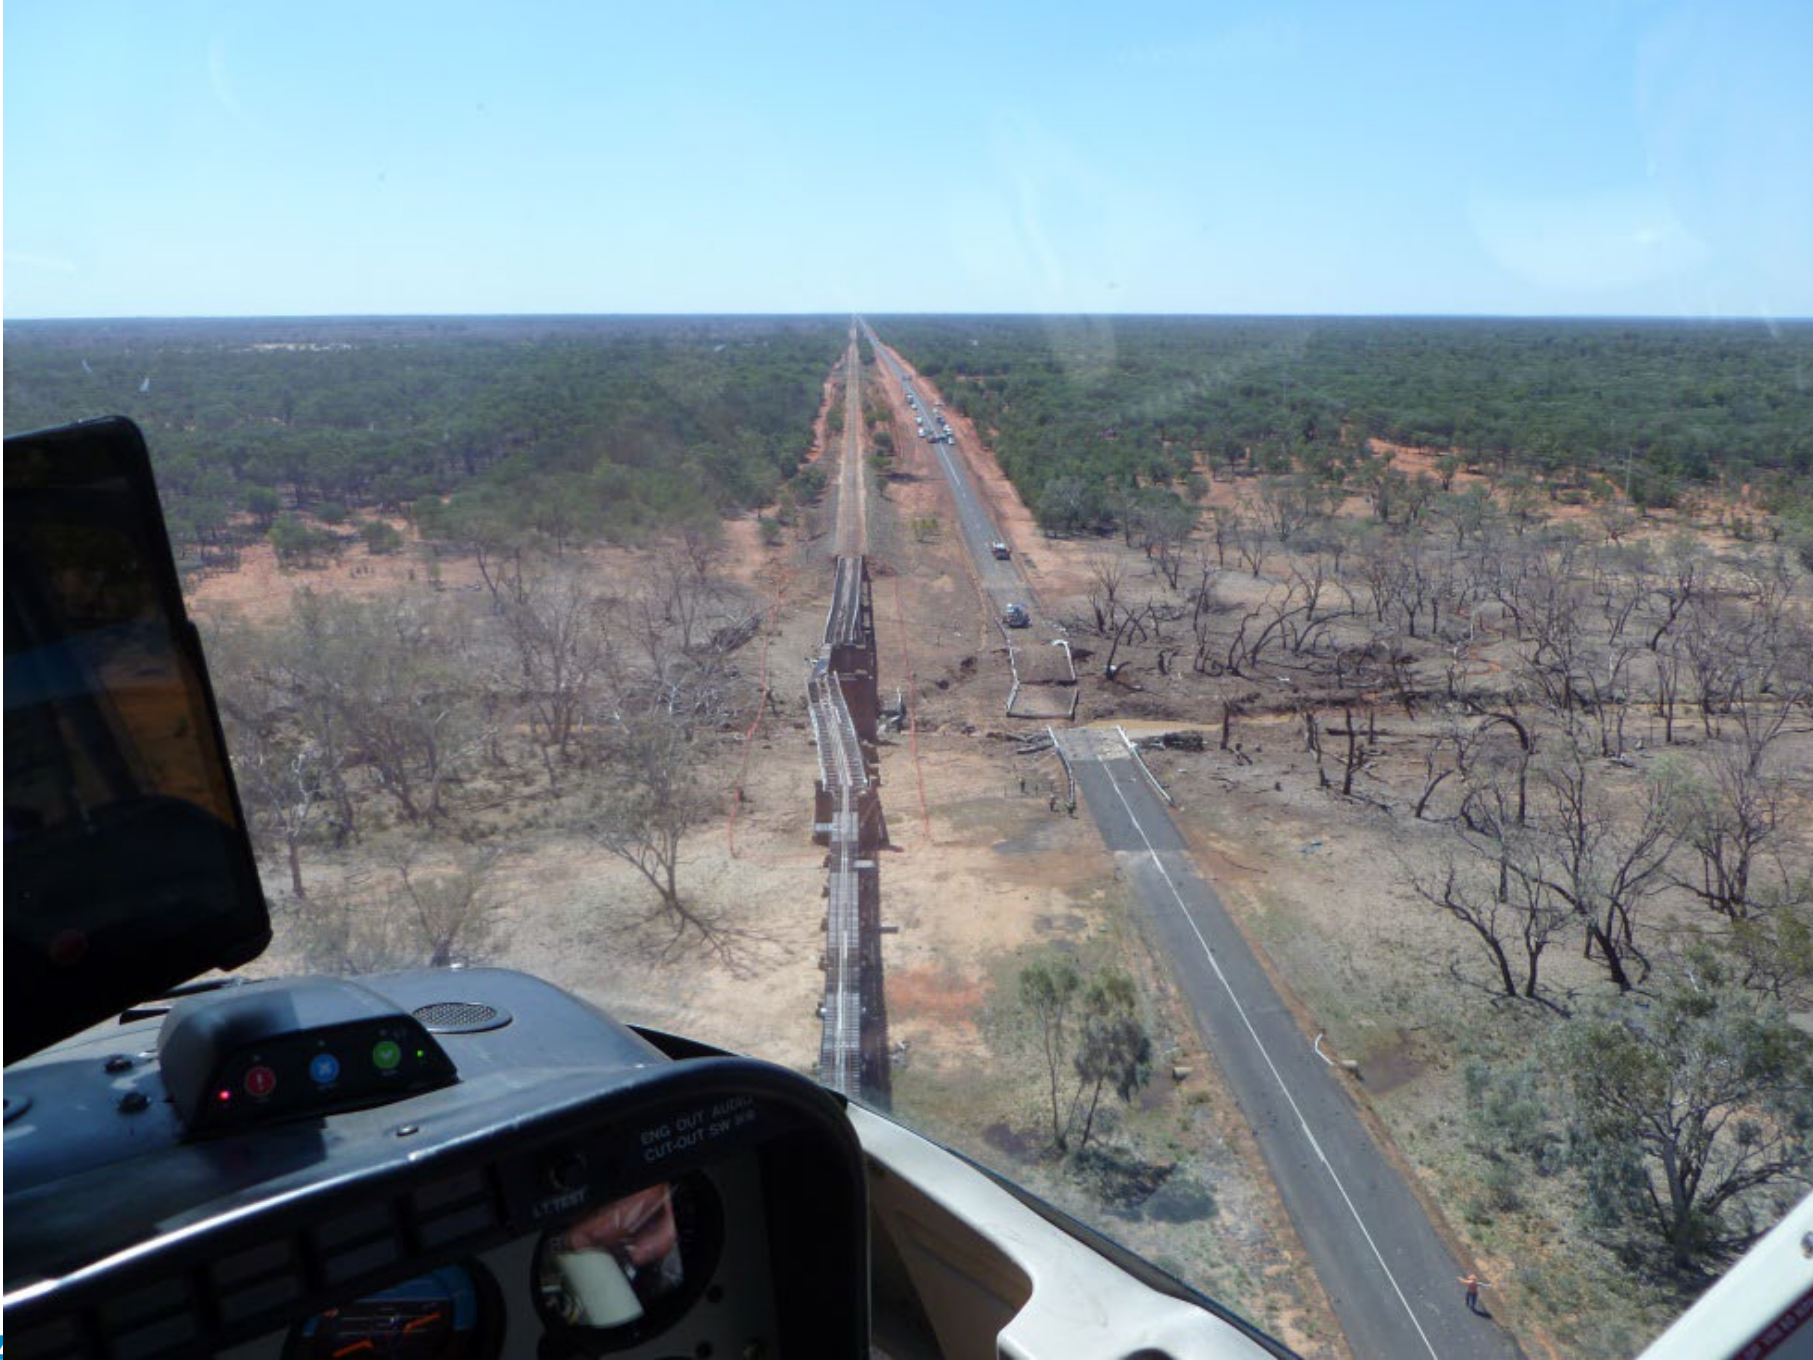
Explosives Inspectorate response

- Initially provided advice to police and emergency services
- Site handed to EI 2 days after incident
- Assistance from QPS, QFES, SES, TMR and DNRM Charleville
- 8 Explosives Inspectors on site for up to two weeks (half of Qld EIs)
- Collected and documented over 2,500 pieces of debris
- Interviewed witnesses and other parties
