ACCIDENTS AND INCIDENTS IN SOUTH AMERICA DURING 2002 TO 2005

This is a brief description of accidents and incidents that occurred in South America from 2002 to 2005. Some reports have been obtained from public control and emergency institutions as well as from news media of the countries where these events occurred, and from SAFEX files.

Geneva, May 2005

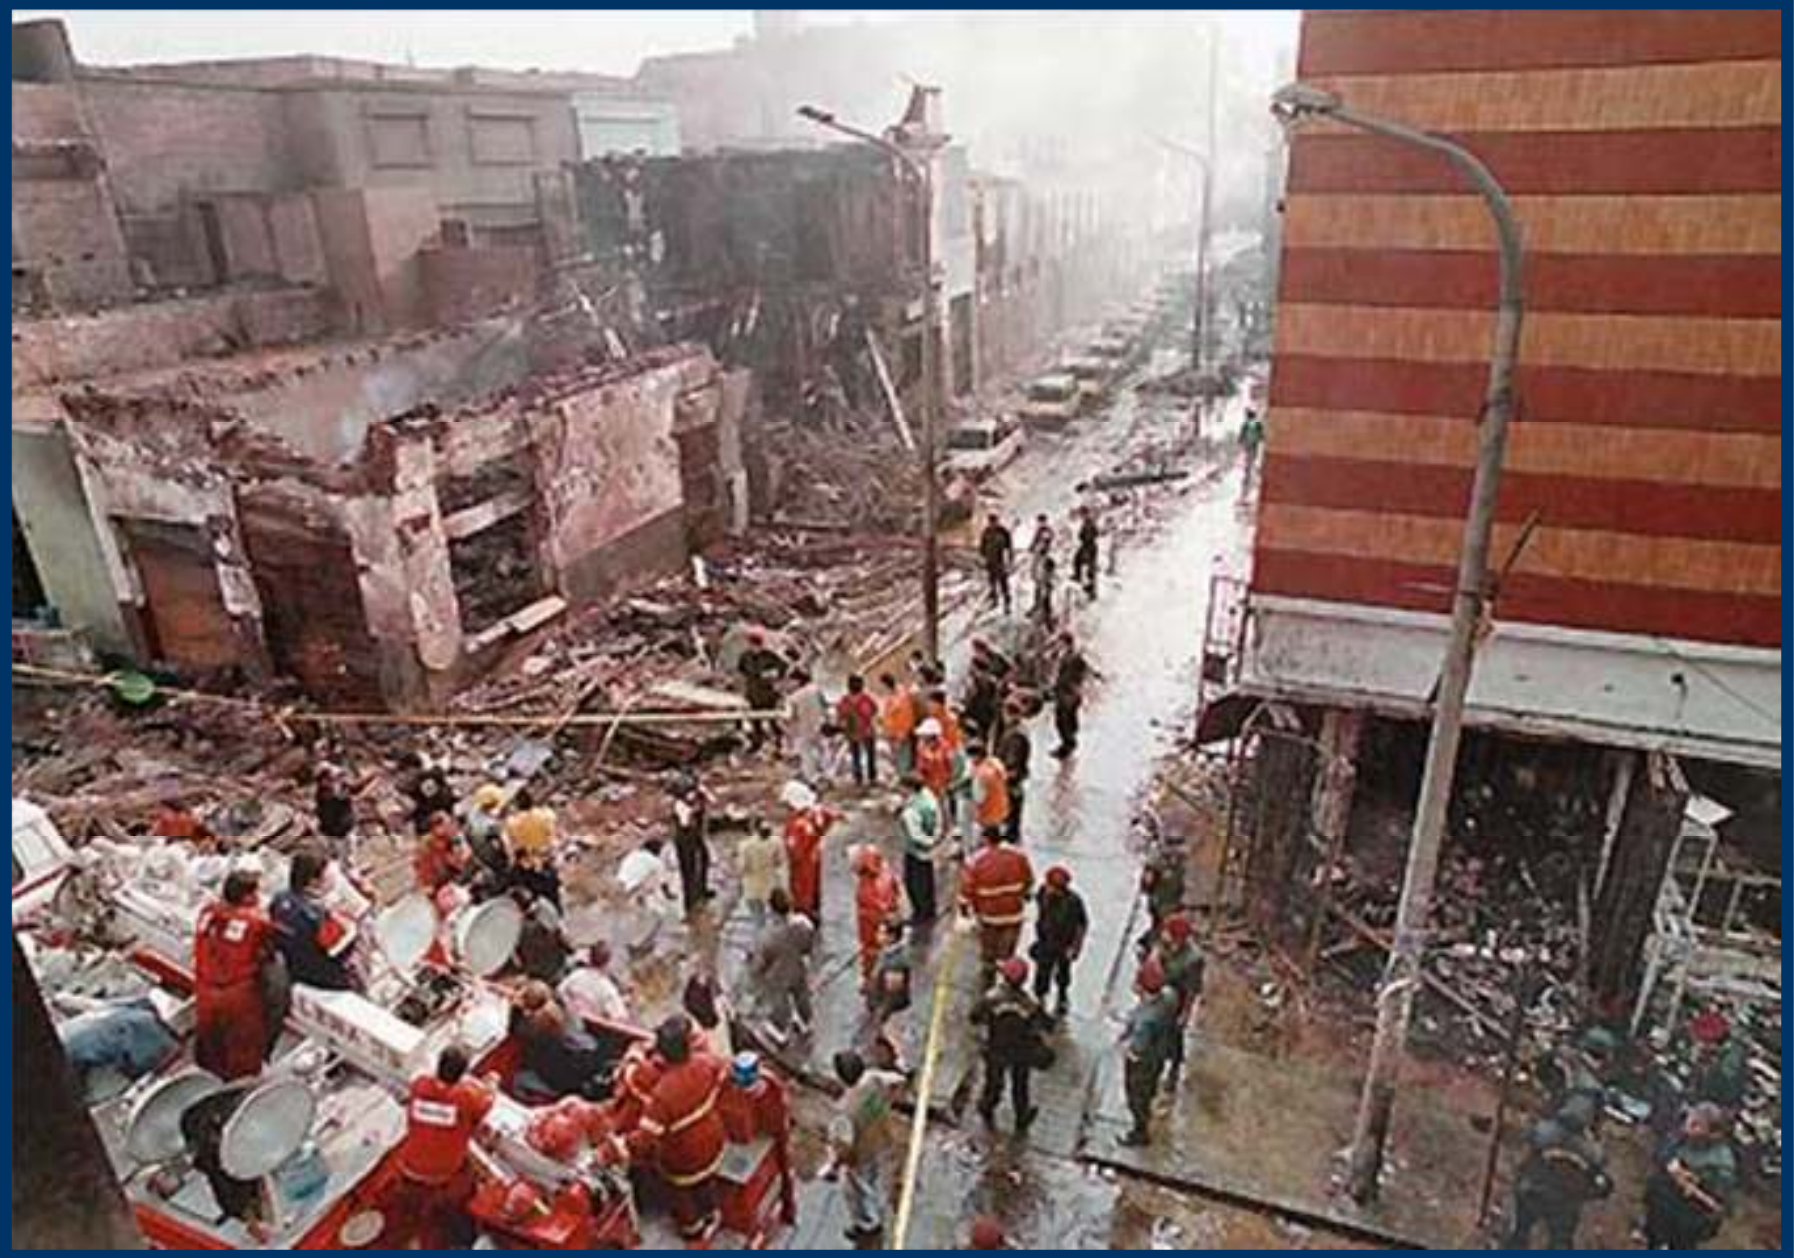
Date:	December 29, 2001
Company or entity:	Centro Comercial Mesa Redonda (an informal sales center)
Address:	Downtown Lima, Peru
Exact location:	Public street, buildings, houses, parking lots and business establishments
Information source:	Fire brigade and news media
Description:	A fire of major proportions occurred involving mainly fireworks that was to be sold during the holiday season in spite of existing legal restrictions. The fire started when a street vendor lighted fireworks during a sales demonstration.
Fatalities and injured:	300 dead (including missing persons) and more than 100 injured
Material:	Approx. 970 m ³ of fireworks, both of Chinese and Peruvian origin
	Informal storage and sales, and the failure of informal vendors and authorities to comply with and enforce the law

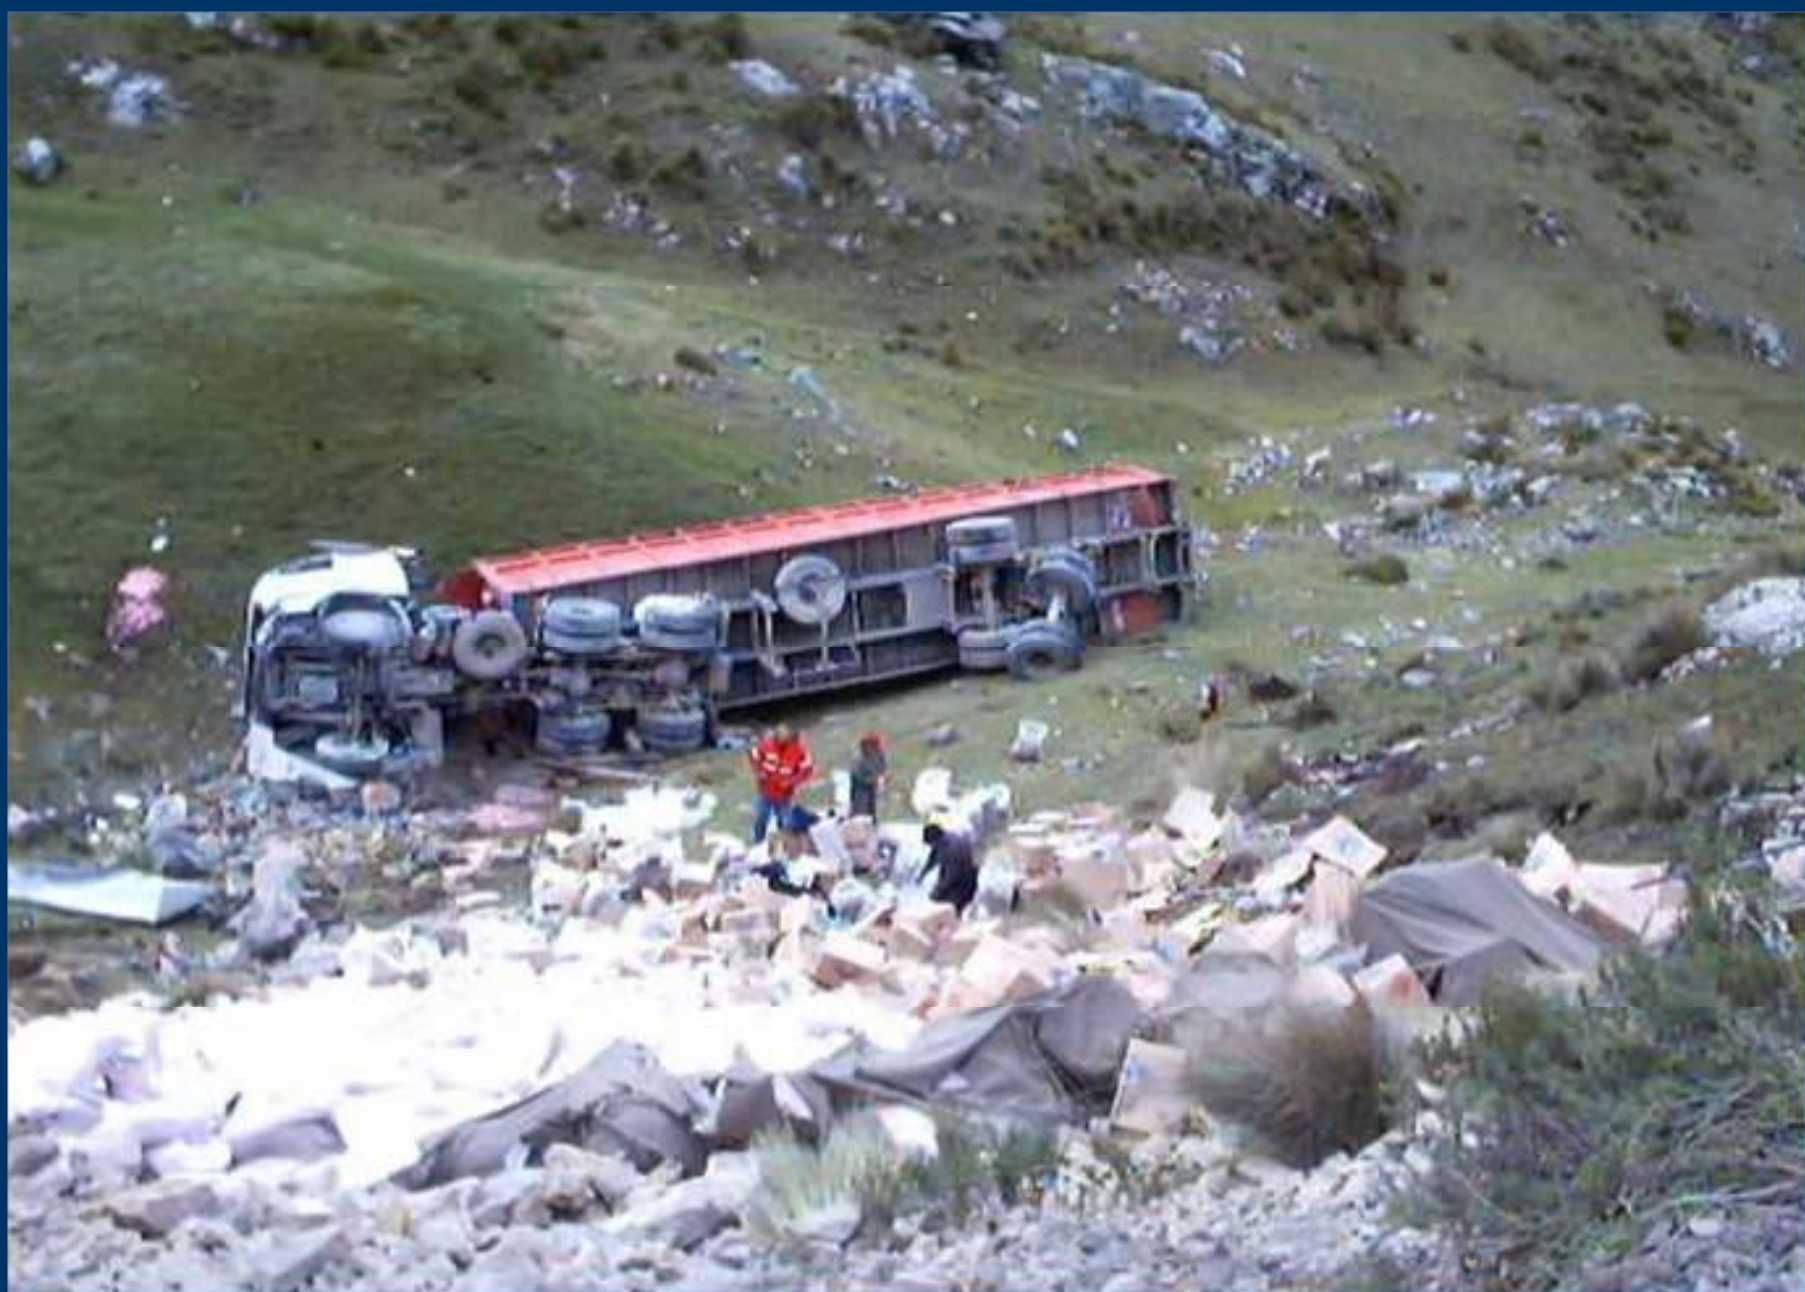
Date:	January 21, 2002
Company or entity:	Empresa de Transportes POMA (POMA Transport Company)
Address:	Oyon, Huanuco, Peru
Exact location:	Road at 4500 meters above sea level
Information source:	Empresa de Transportes POMA and EXSA S.A.
Description:	A truck with trailer carrying explosive material slipped off the road and rolled over 50 meters down a cliff causing spillage of the product.
Fatalities and injured:	One dead (a policeman, who was in charge of the custody of the material, as a result of the down falling truck) and 4 injured (stowers)
Material:	12,500 kg of ANFO and 7,500 kg of dynamite, which did not detonate
Causes:	The driver lost control of the vehicle due to bad condition and lack of maintenance of the only road to the destination, a mining unit.

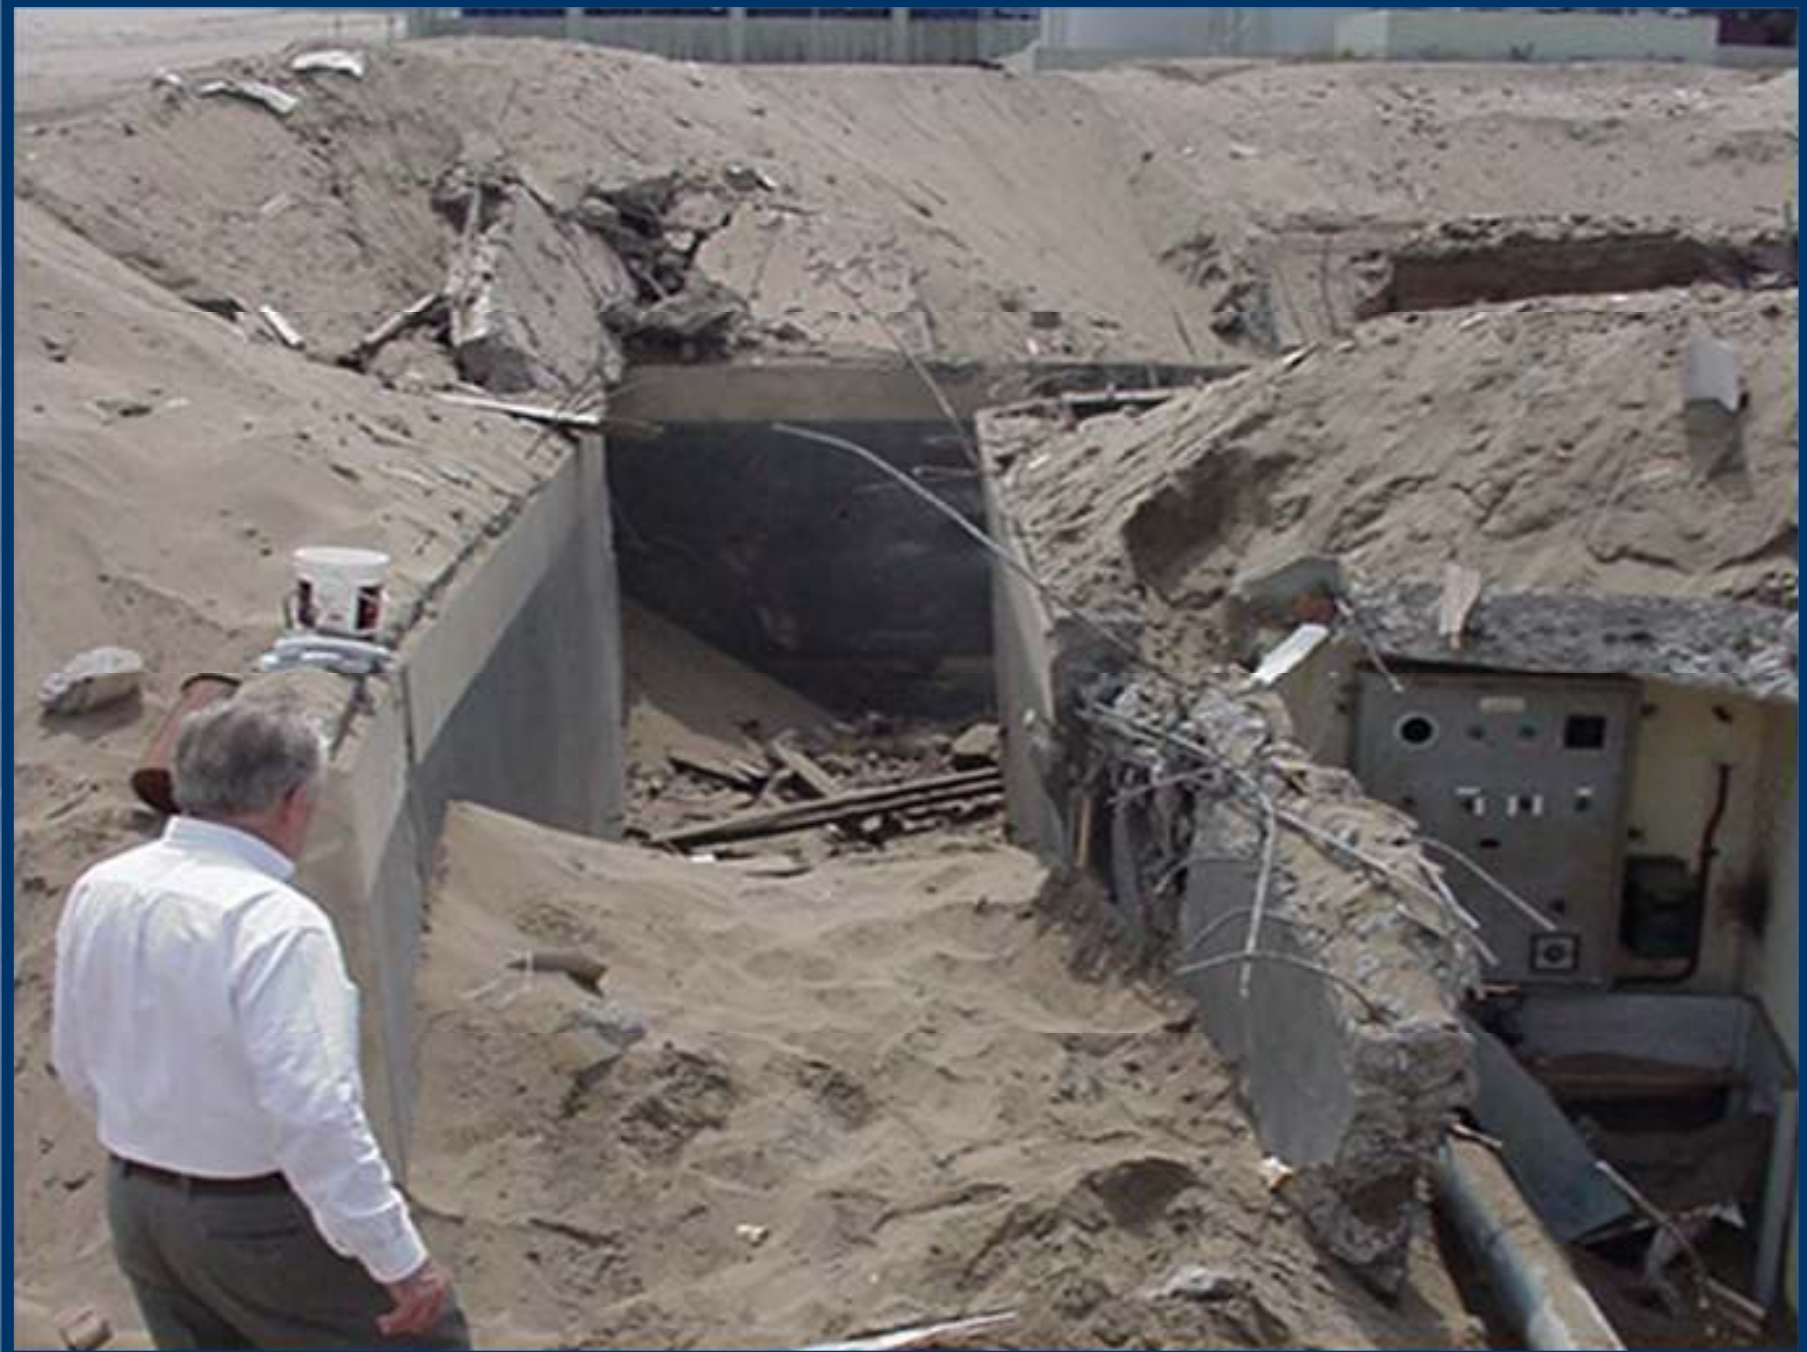
Date:	April 23, 2002
Company or entity:	EXSA S.A.
Address:	Antigua Panamericana Sur km 38.5, Lurin, Lima, Peru
Exact location:	Explosives production plant, in the Biazzi N° 5 planetary mixer for nitroglycerin-based explosives
Information source:	EXSA S.A.
Description:	A detonation occurred, when starting the daily mixing operation with a 240 kg of explosive.
Fatalities and injured:	1 dead operator and 2 injured by falling fragments
Material:	240 kg of explosive mix for dynamite production
Causes:	The operator did not secure adequately the bowl to the mixer. Detailed report has been presented at this SAFEX Congress.

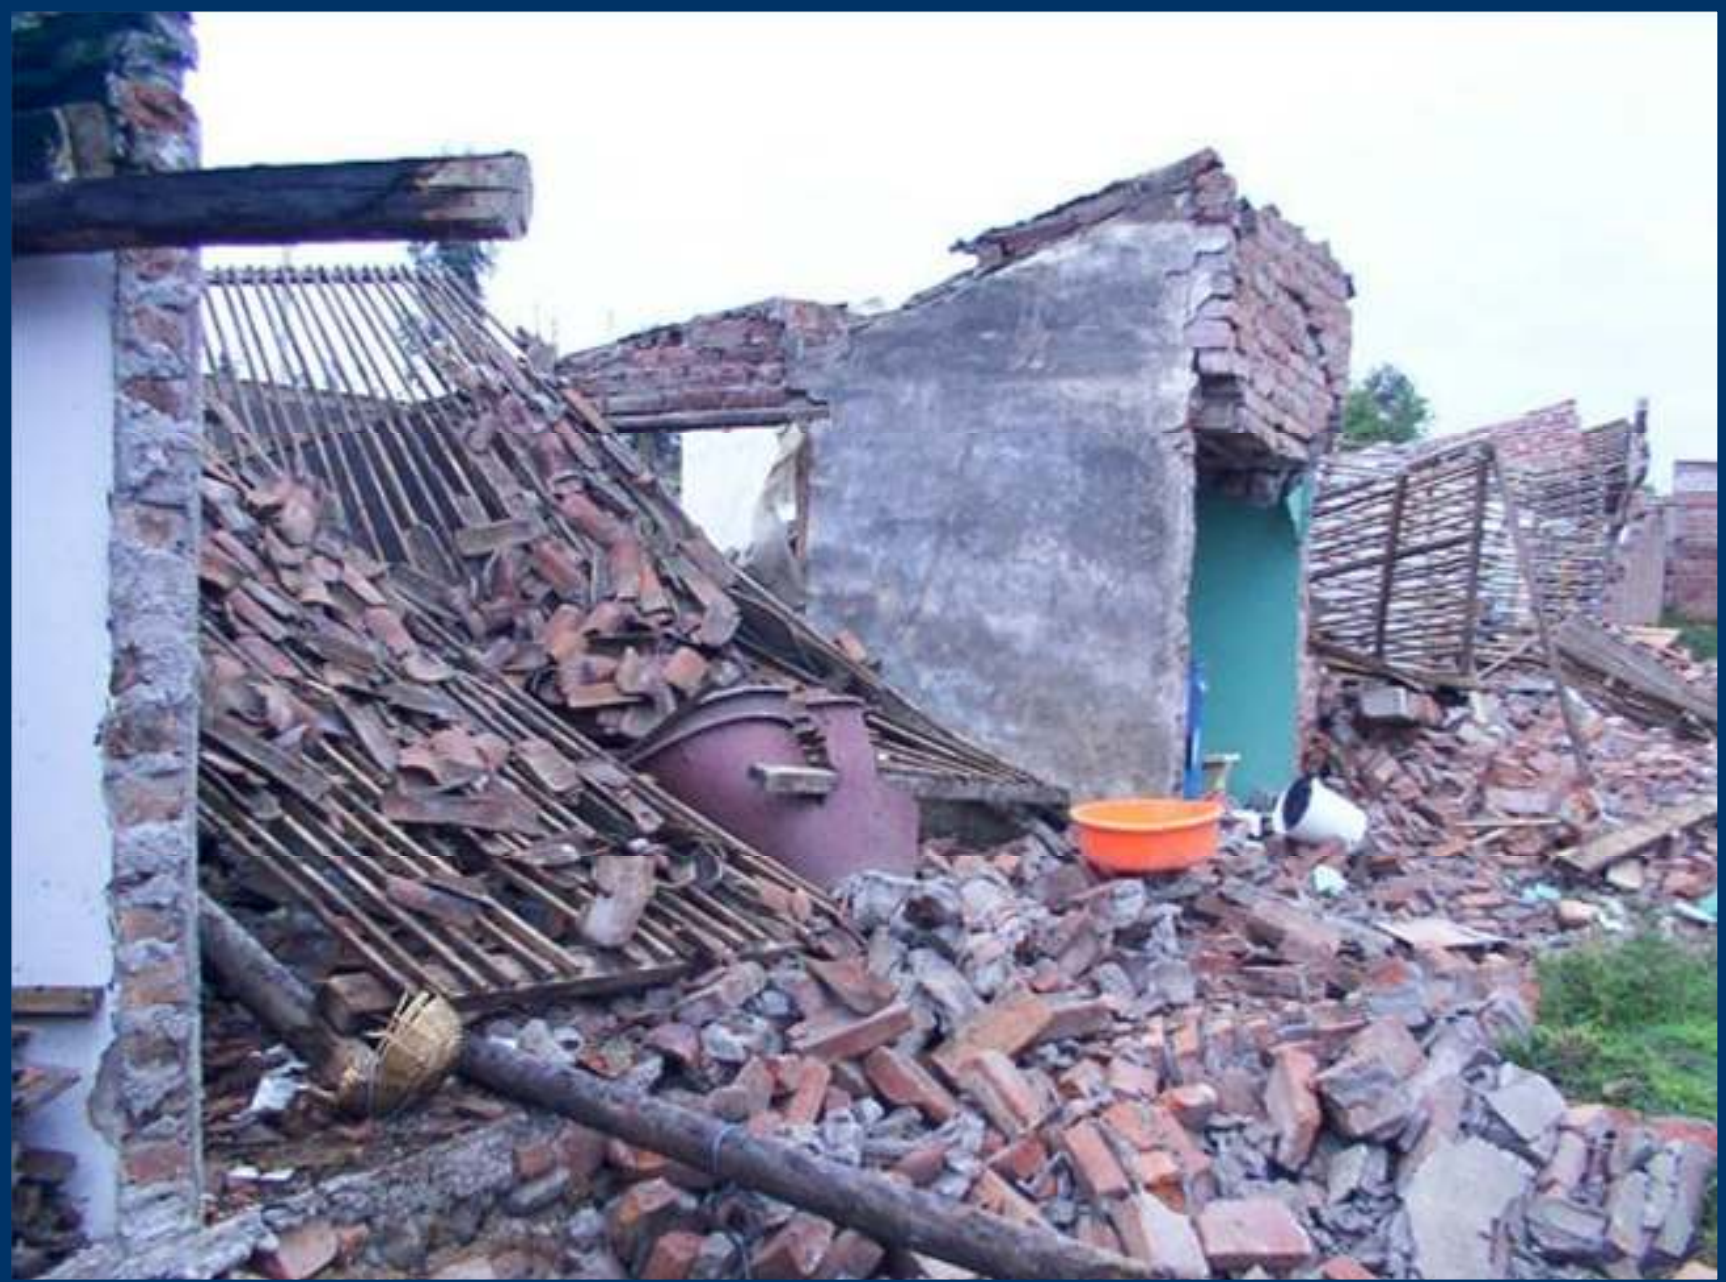
Date:	November 20, 2002
Company or entity:	Ejército de la República del Ecuador (Army of the Republic of Ecuador)
Address:	Cuartel de la Brigada de Caballería Galápagos, Chimborazo, Ecuador (Ecuadorian military barracks)
Exact location:	Army ammunition magazine
Information source:	News media
Description:	An explosion occurred inside the magazine, causing grenades and antitank rockets to be projected from the magazine dropping on different places generating detonations and fires in different areas inside the barracks.
Fatalities and injured:	7 dead and 300 injured
Material:	Unknown amounts of material
Causes:	Inadequate handling of material inside the magazine

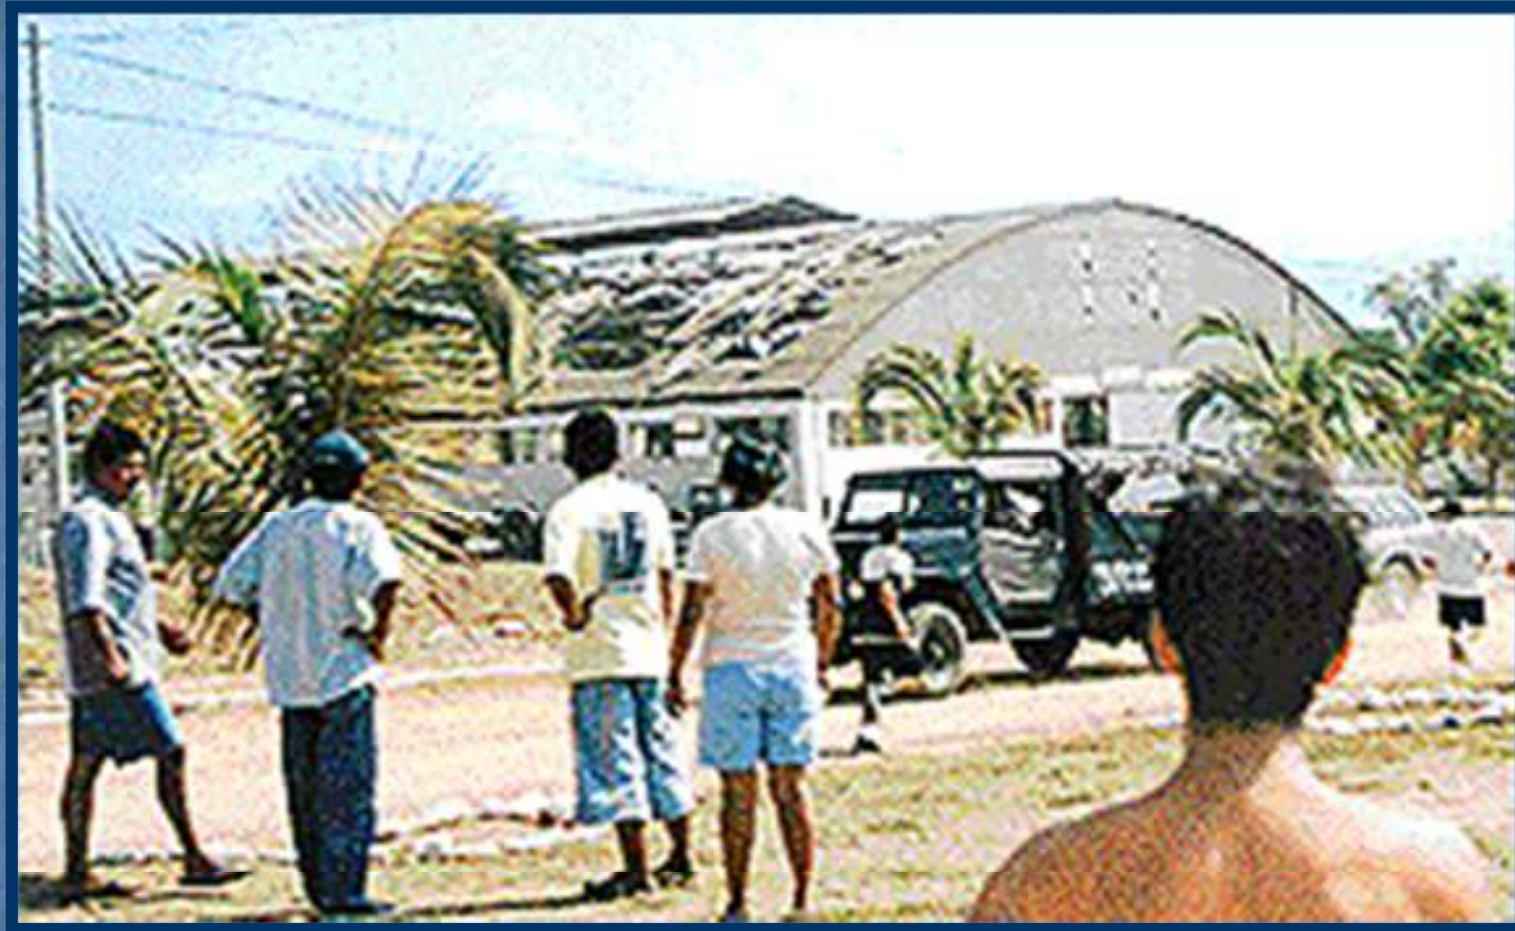
Date:	January 23, 2003
Company or entity:	Ejército de la República del Perú (Army of the Republic of Peru)
Address:	Cuartel de Ingenieros El Tablazo, Tumbes, Peru (Army engineers barracks)
Exact location:	Military ammunition magazine
Information source:	News media
Description:	An explosion occurred inside the magazine, when army personnel was handling military explosive material. The explosion affected a large part of the military facilities.
Fatalities and injured:	7 dead and 90 injured
Material:	5 tons of grenades and antitank mines mixed with industrial explosives
Causes:	Wrong handling of the material inside the magazine

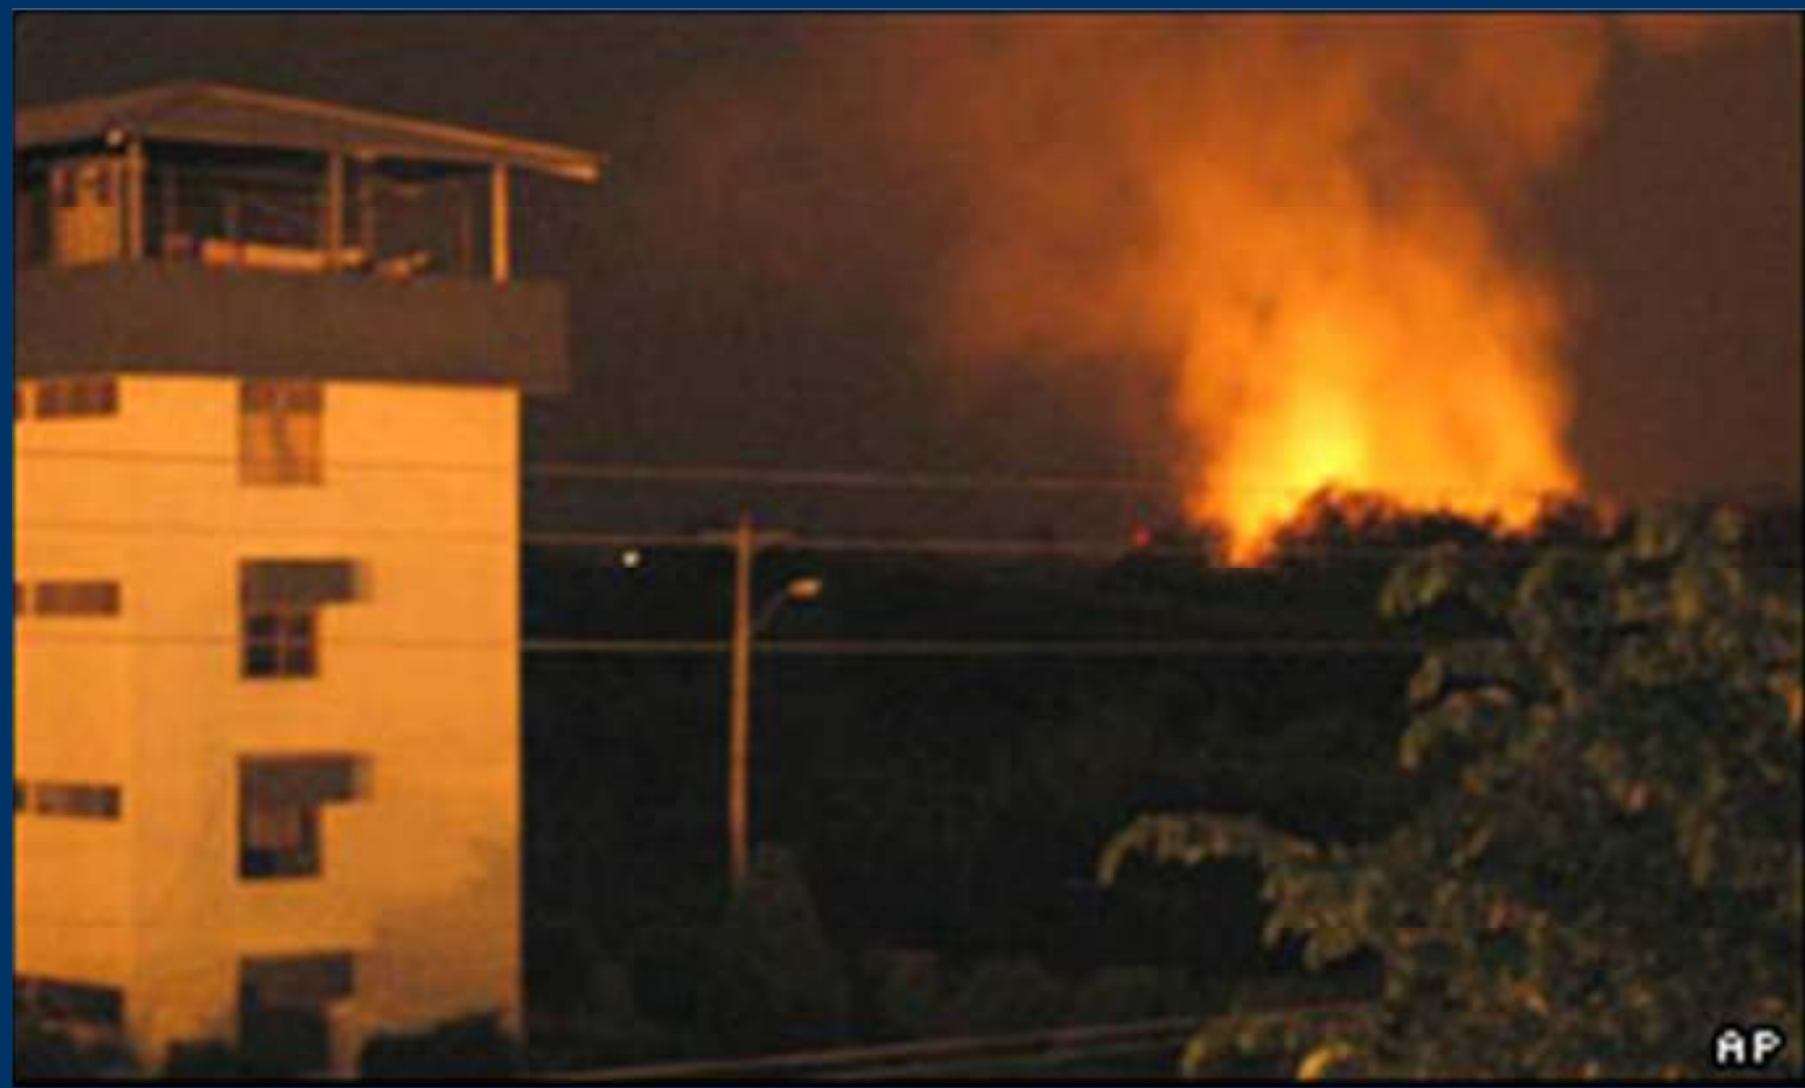
Date:	March 23, 2003
Company or entity:	Marina de la República del Ecuador (Navy of the Republic of Ecuador)
Address:	Base Naval Sur, Guayaquil, Ecuador (an Ecuadorian naval base)
Exact location:	Military ammunition magazine
Information source:	Media news
Description:	4 detonations and a fire of major proportions occurred at the naval base; detonations were felt as far as 15 kilometers away from the explosion center, affecting doors and windows of the houses close to the port.
Fatalities and injured:	30 injured
Material:	Unknown amount of medium- and low-caliber ammunition
Causes:	Ignition inside the magazine caused the explosion

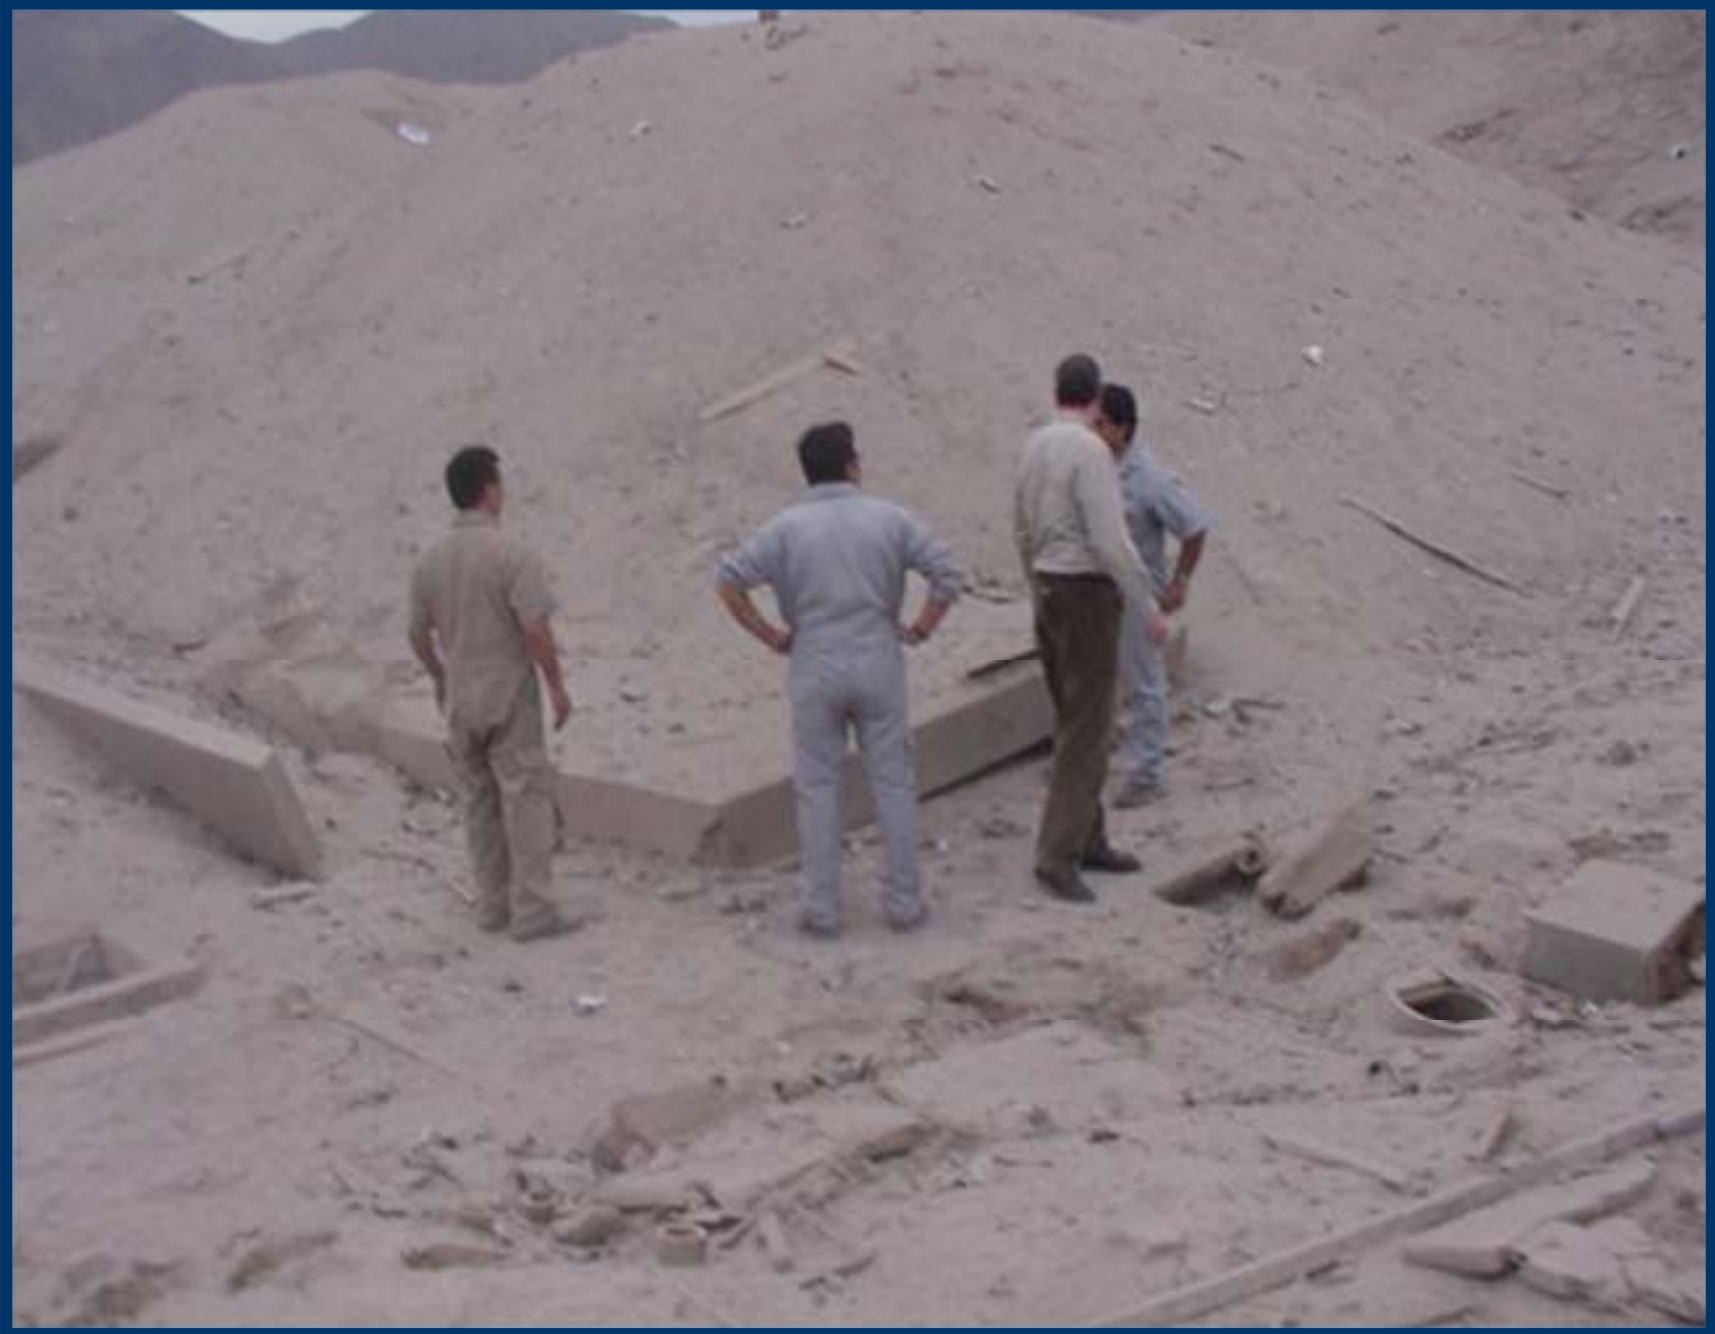
Date:	September 17, 2003
Company or entity:	EXSA S.A.
Address:	Antigua Panamericana Sur km 38.5, Lurín, Lima, Peru
Exact location:	Blasting gelatine production plant
Information source:	EXSA S.A.
Description:	The incident occurred during the blasting gelatine mixing process of nitroglycerine and nitrocellulose.
Fatalities and injured:	4 dead and 11 injured
Material:	1000 kg of nitroglycerine and 150 kg of blasting gelatine
Causes:	Investigation not yet completed

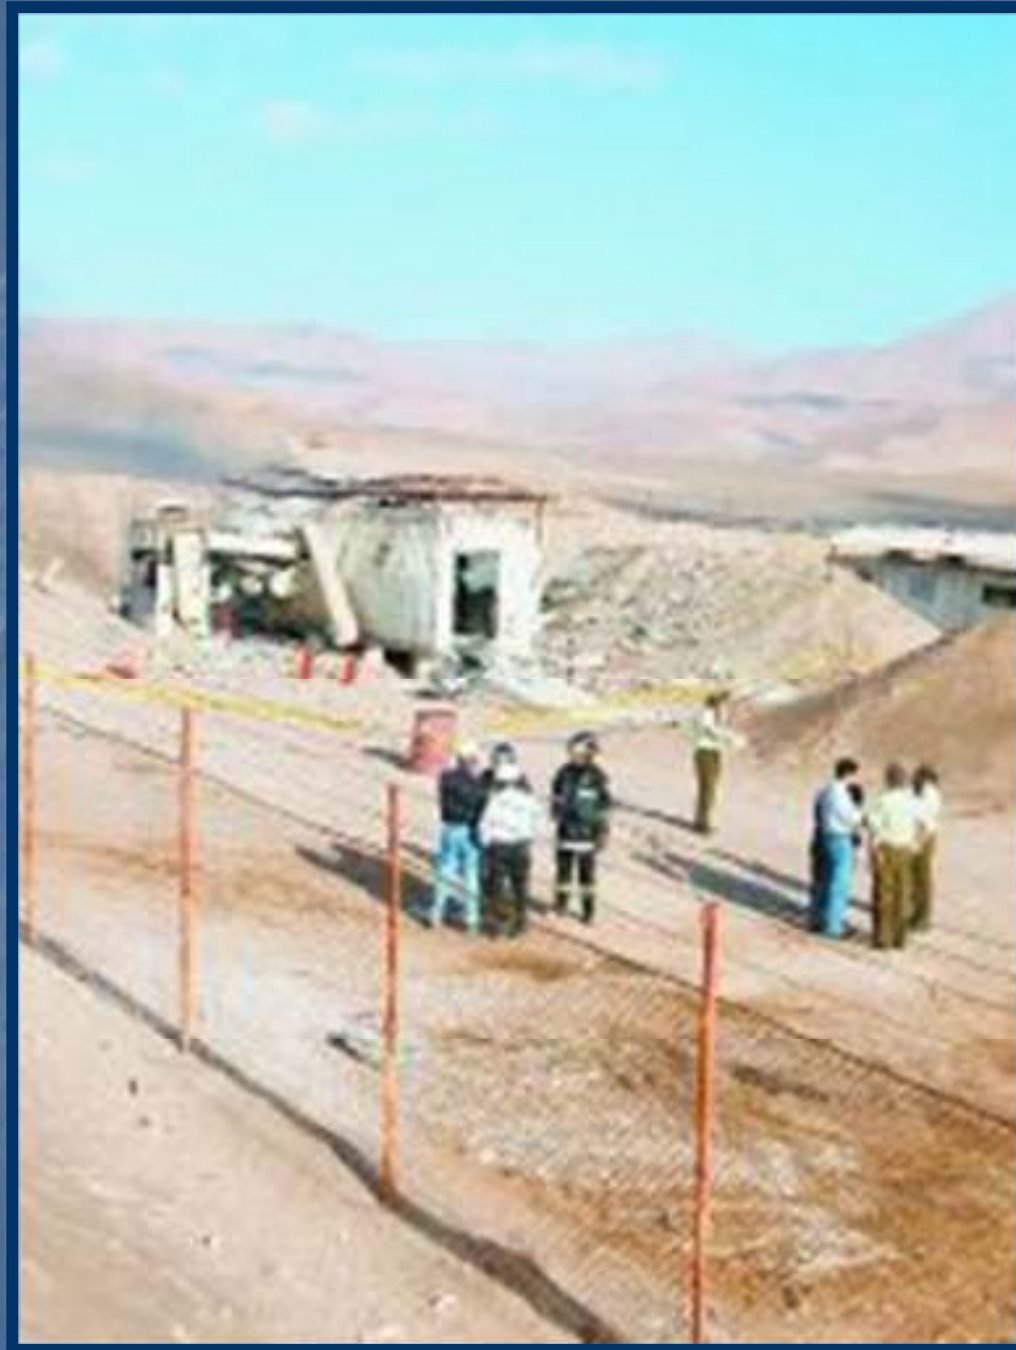
Date:	October 9, 2003
Company or entity:	EXPLONOR S.A.
Address:	Km 12 of highway A-616, Iquique, Chile
Exact location:	Non electric detonator assembly plant
Information source:	News media
Description:	Explosion in a container where non electric detonators were assembled
Fatalities and injured:	5 dead and 15 injured
Material:	Unknown quantity
Causes:	Investigation still in progress

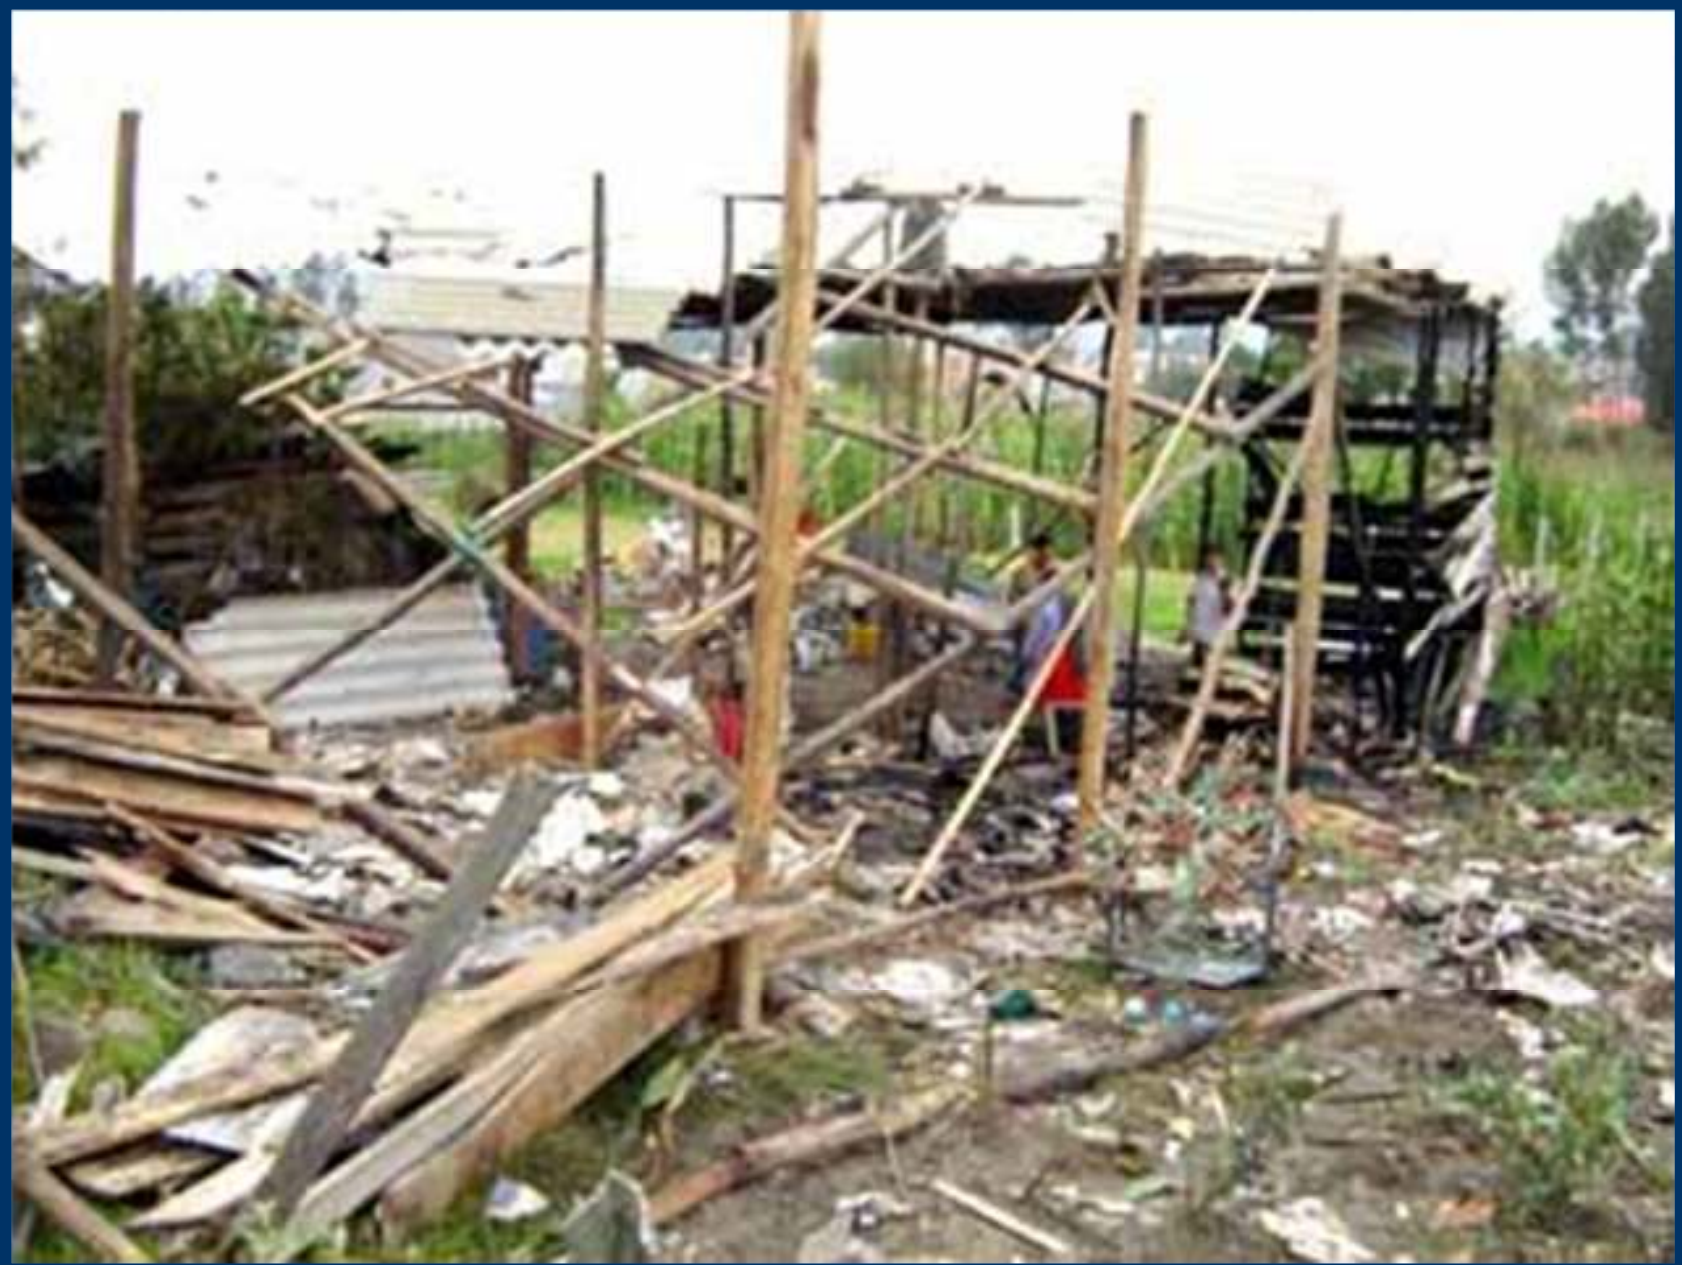
Date:	March 01, 2005.
Company or entity:	Informal fireworks manufacturer
Address:	Parroquia Ricaurte, Cuenca, Ecuador
Exact location:	A house in the locality, that functioned as informal workshop for the production of fireworks
Information source:	News media
Description:	A fire in one part of the house, where the raw materials were stored, caused an explosion that reached other rooms, where finished products were stored.
Fatalities and injured:	6 injured
Material:	Unknown quantity
Causes:	Violating existing laws on the matter; the rooms, where the raw materials and the finished material were stored, were not suitable for this purpose.
